Sanitary Survey - Review

Bigbury & Avon – 2023

Document No. – *J0591/23/01/06*

Client	Food Standards Agency (FSA)
Project Title	Sanitary Survey Review
Document Title	Sanitary Survey Review - Bigbury and Avon
Document Number	J0591/23/01/06
Revision	3.0
Date	03 April 2023

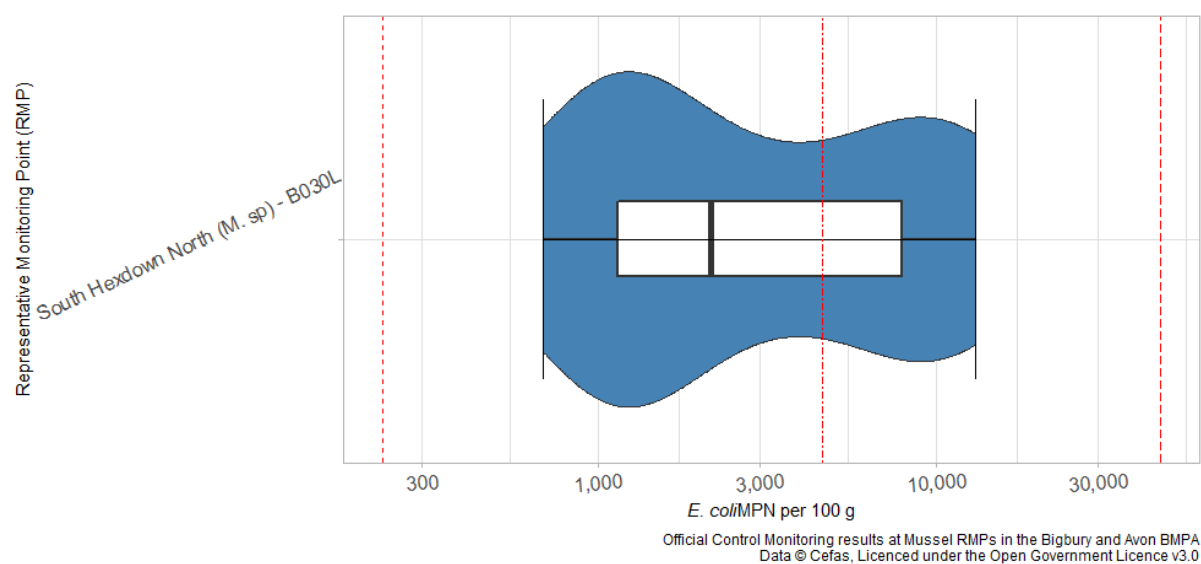
*Figure 6.2 Box and violin plots of *E. coli* concentrations at mussel RMPs in the Avon Estuary BMPA since 2010. Central line indicates median value, box indicates lower-upper quartile range and whisker indicates minimum/maximum values, excluding outliers (points >1.5 x the interquartile range). Boxplots are overlaid on the distribution of the monitoring data. Horizontal dashed lines indicate classification thresholds at 230, 4,600 and 46,000 MPN/100 g respectively.*

Figure 6.2 and Figure 6.3 present boxplots of *E. coli* monitoring at mussel and Pacific oyster RMPs in the BMPA respectively. One-way analyses of variance (ANOVA) tests were performed on the data to investigate the statistical significance of any differences between the monitoring results from the two RMPs. Significance was taken at the 0.05 level. All statistical analysis described in this section was undertaken in R (R Core Team, 2021).

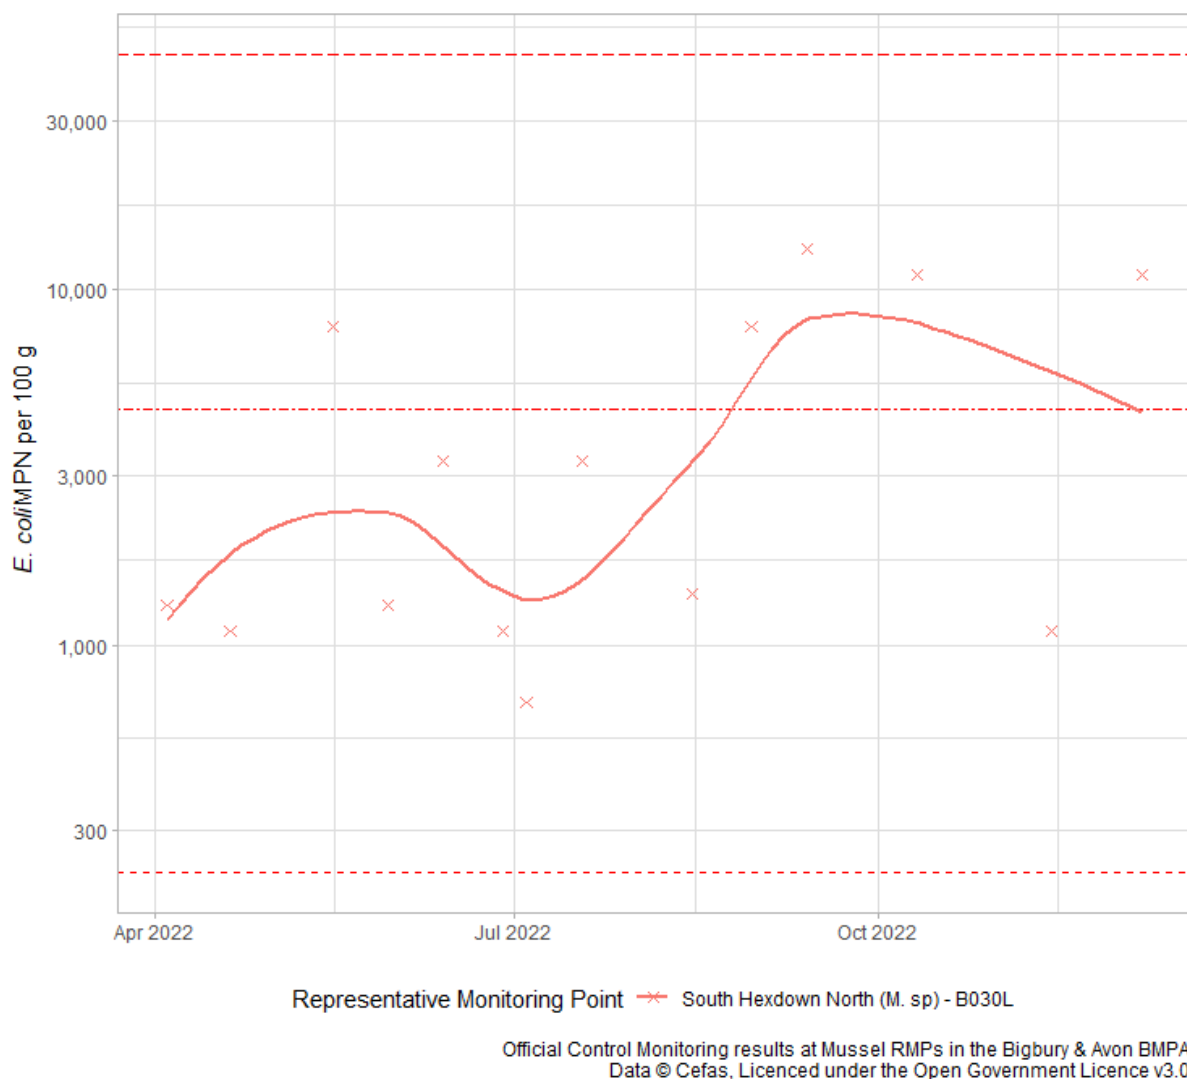
Figure 6.4 Timeseries of E. coli levels at mussel RMPs sampled in the Bigbury & Avon BMPA since 2010. Scatter plots are overlaid with a loess model fitted to the data. Horizontal lines indicate classification thresholds at 230, 4,600 and 46,000 MPN/100 g respectively.

Limited temporal trends can be drawn from the mussel data (Figure 6.4) as sampling has only been ongoing since April 2022. However, results from later in the year have tended to

be higher than those earlier in the year, possibly due to increased levels of rainfall (and therefore runoff) during these periods.

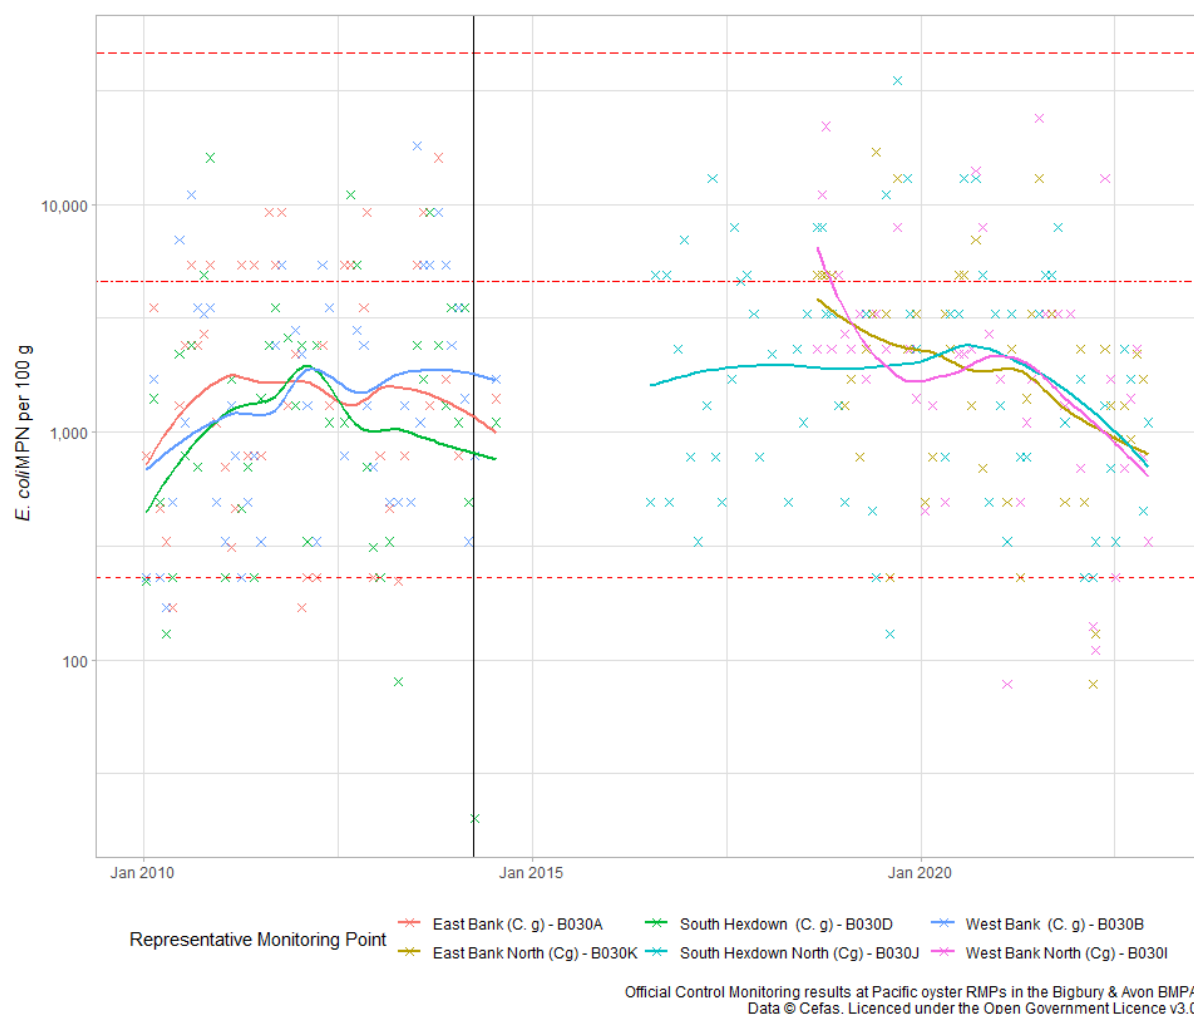
*Figure 6.5 Timeseries of *E. coli* levels at Pacific oyster RMPs sampled in the Bigbury & Avon BMPA since 2010. Scatter plots are overlaid with a loess model fitted to the data. Horizontal lines indicate classification thresholds at 230, 4,600 and 46,000 MPN/100 g respectively.*

The temporal separation of the two monitoring periods can clearly be seen in the Pacific oyster data (Figure 6.5). Prior to the publication of the original sanitary survey, the three RMPs (B030A, B030B & B030D) returned broadly similar results. The trend lines fitted to the more recently sampled RMPs (B030J, B030K & B030I) suggest that shellfish flesh monitoring results are improving, with the trend lines indicating a pattern of declining *E. coli* concentrations in samples. This is likely due to the efforts being made in this catchment to reduce the impact of agricultural sources of pollution.
