Sanitary Survey- Review

Brancaster – 2023

Document No. – *J0591/23/06/20*

Client	Food Standards Agency (FSA)
Project Title	Sanitary Survey Review
Document Title	Sanitary Survey Review of Brancaster
Document Number	J0591/23/06/20
Revision	3.0
Date	18 September 2023

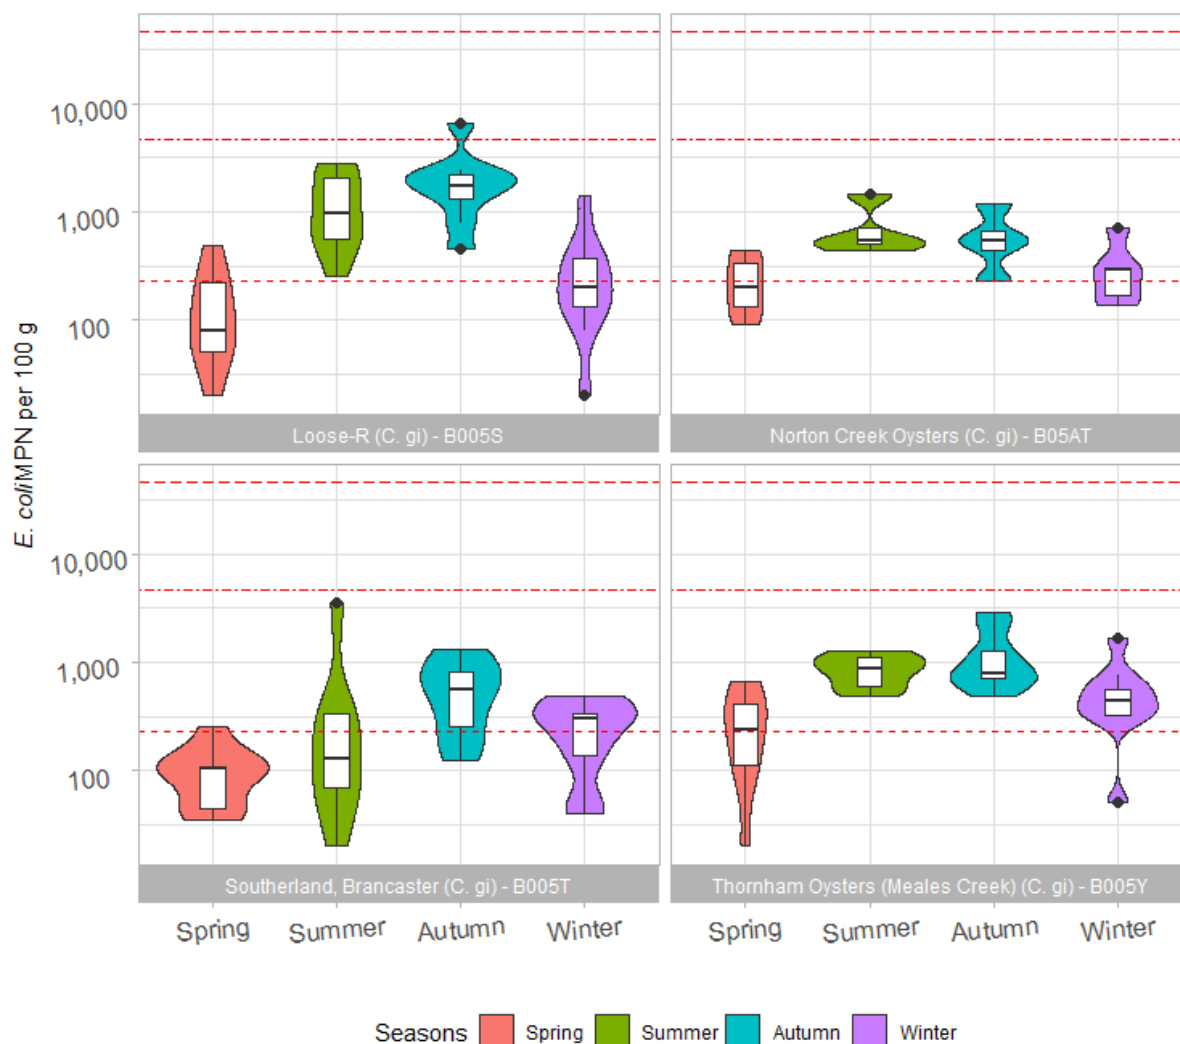
Figure 6.7 Box and violin plots of E. coli levels per season at Pacific oyster RMPs sampled within the Brancaster BMPA since 2010. Horizontal lines indicate classification thresholds at 230, 4,600 and 46,000 E. coli MPN/100 g.

The seasonal patterns of *E. coli* levels at RMPs in the Brancaster BMPA were investigated and are shown for mussels in Figure 6.6 and for Pacific oysters in Figure 6.7.
