Sanitary Survey - Review

Camel Estuary – 2023

Client	Food Standards Agency (FSA)
Project Title	Sanitary Survey Reviews
Document Title	Sanitary Survey Review of the Camel Estuary
Document Number	J0591/22/10/06
Revision	3.0
Date	02 March 2023

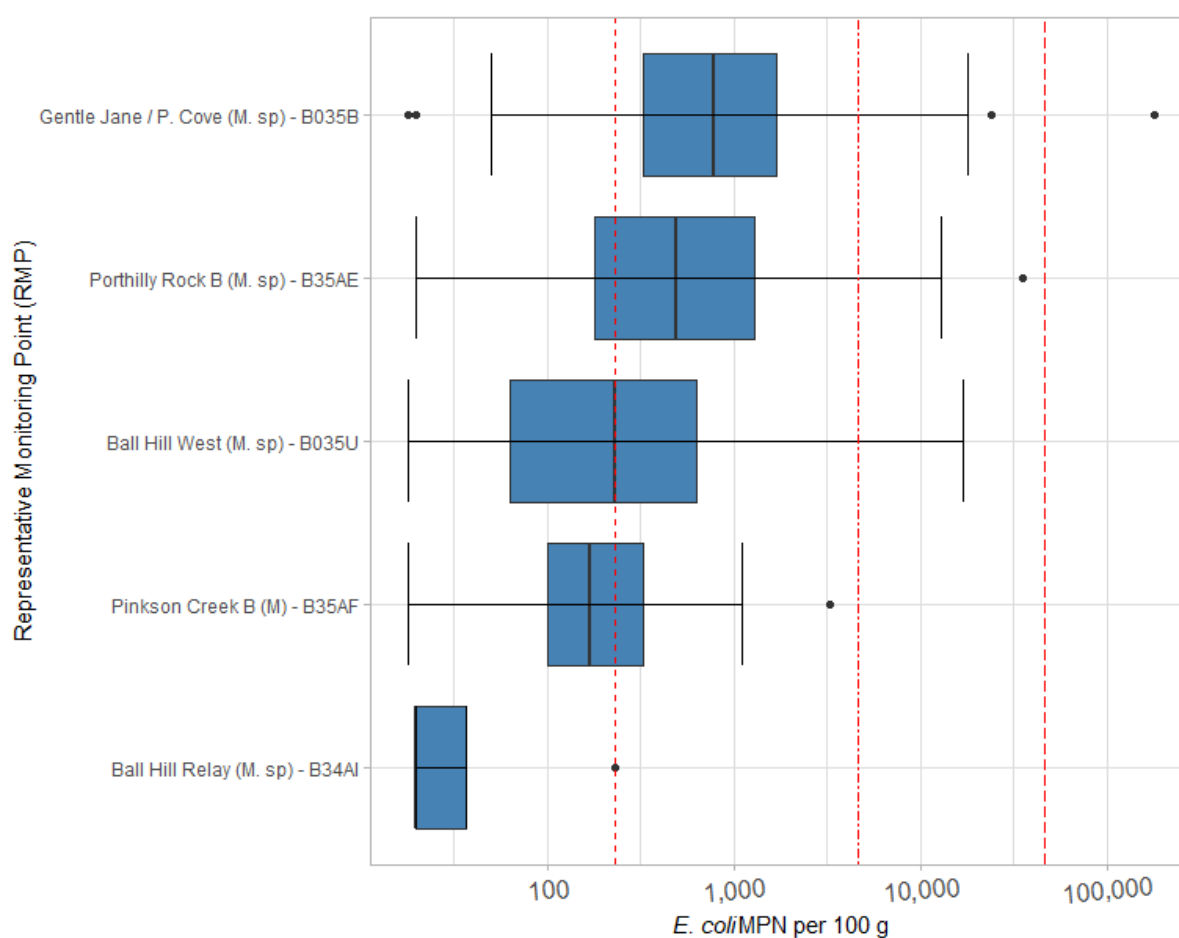
Figure 6.2 Boxplots of E. coli concentrations at mussel RMPs in the Camel Estuary BMPA since 2011. Central line indicates median value, box indicates lower-upper quartile range and whisker indicates minimum/maximum values, excluding outliers (points >1.5 x the interquartile range). Vertical dashed lines indicate classification thresholds at 230, 4,600 and 46,000 MPN/100 g respectively.

Figure 6.2 and Figure 6.3 present boxplots of *E. coli* monitoring results from the various mussel and oyster RMPs, respectively. One-way analyses of variance (ANOVA) tests were performed on the data to investigate the statistical significance of any differences between the monitoring results from the various RMPs. Comparisons are only appropriate between RMPs using the same species due to the differences in *E. coli* uptake between different species. Significance has been taken at the 0.05 level. All statistical analysis described in this section was undertaken in R ((R Core Team, 2021).

The median *E. coli* concentration at the Gentle Jane / P. Cove (B035B) RMP is the highest of all mussel RMPs, and the Ball Hill Relay (B35AI) (monitored for a limited period between April - June 2022) is the lowest (Figure 6.2). However, no significant differences were found in the mussel data ($p > 0.05$).
