Sanitary Survey Review for Carlingford Lough

With Shoreline and Bacteriological Surveys

On behalf of The Food Standards Agency in Northern Ireland

June 2021

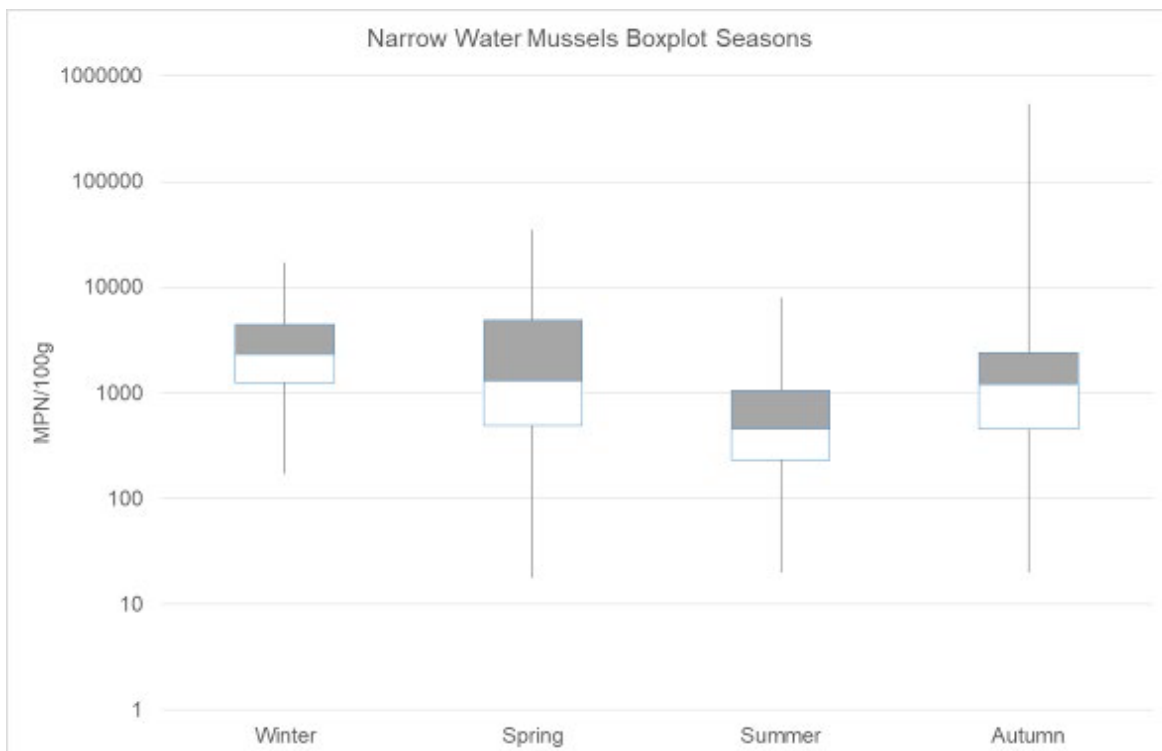
Figure 4.29: Seasonal variation of *E. coli* in mussel flesh from NW Narrow Water monitoring point.

Fairgreen oysters had significantly higher *E.coli* results in summer and autumn when compared to winter. The *E. coli* levels for autumn were also higher than spring results. NW Narrow Water mussels had significantly higher results in winter than in summer and autumn. The results for spring and autumn where also significantly higher than summer results. C1 Rostrevor mussels had significantly higher *E. coli* results for winter than spring and summer. Autumn also had significantly higher results than summer.

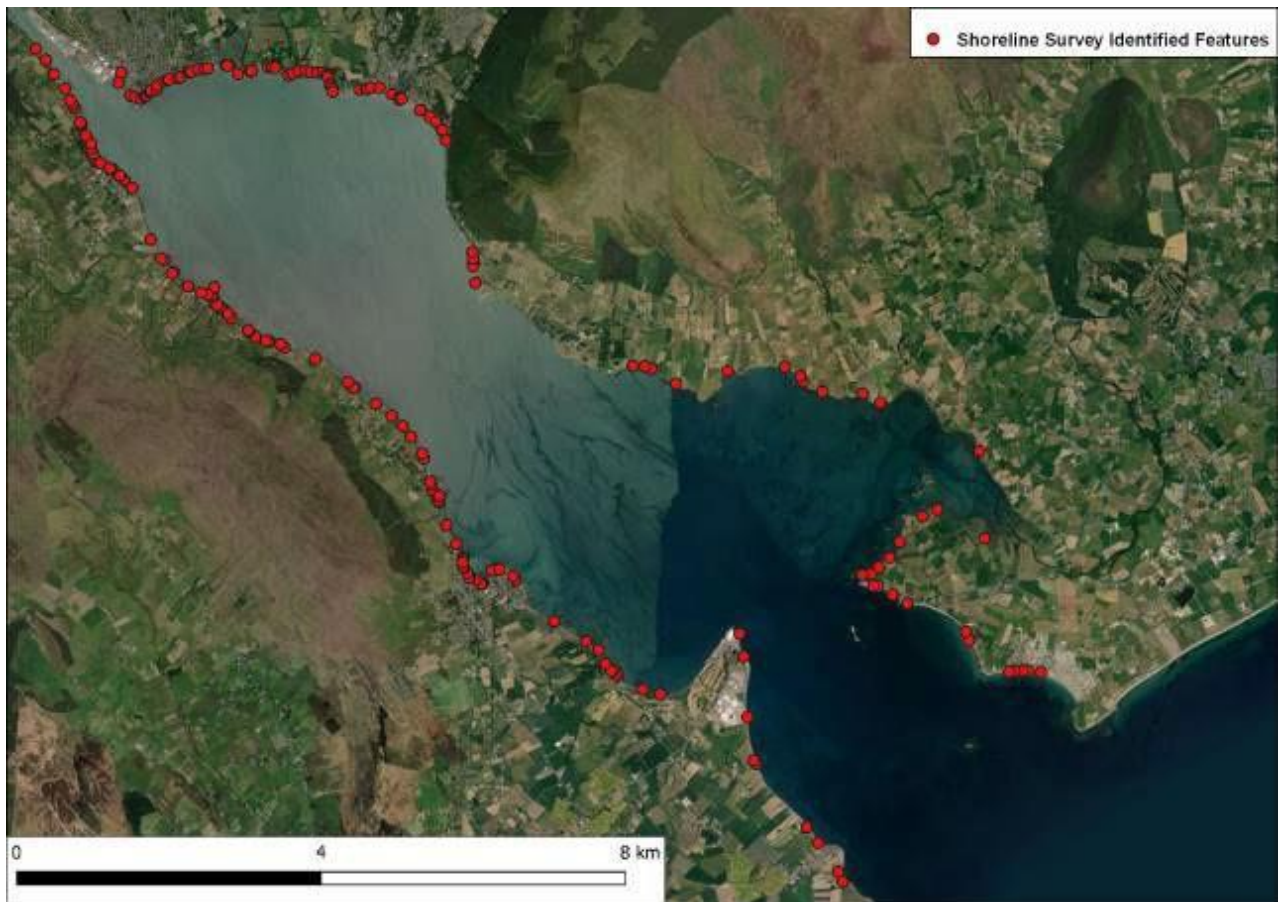
Figure 4.49: Location of features identified during shoreline survey.

Features identified during the shoreline survey include 151 discharges, 37 rivers/streams, 15 piers, 30 slipways, 8 locations with livestock and 2 locations with birds feeding on the shore. The 2010 shoreline survey recorded 69 discharges. A greenway was constructed along the southern side of the lough in 2018. Surface water discharges installed as part of this development account for a large proportion of the extra discharges. A number of extra discharge points were also recorded between Warrenpoint and Rostrevor, which were mostly for road runoff or land drainage from private properties. Overall, very few of the discharges and watercourses recorded during this survey showed any signs of nutrient enrichment or contamination.

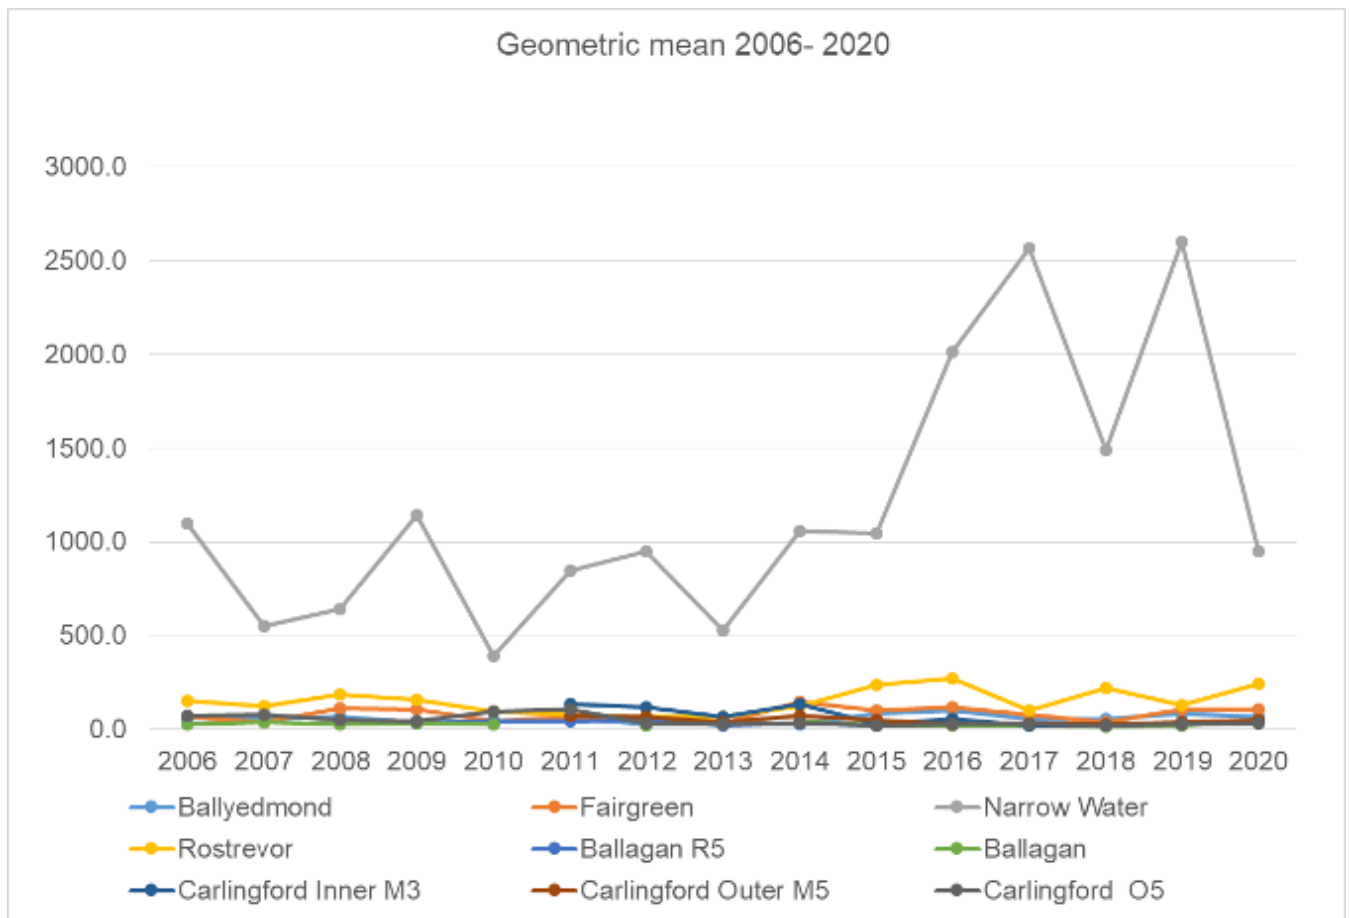
Figure 5.80: Trend in geometric mean of *E. coli* levels from 2006 to June 2020 for all 9 monitoring points.

The geometric mean of *E. coli* levels was highest for mussels at NW Narrow water (1055.2 MPN/100g), followed by mussels at C1 Rostrevor (135.9 MPN/100g) and oysters at C11 Fairgreen (76.7 MPN/100g). The lowest geometric mean was for oysters at Ballagan (28.8 MPN/100g).
