# Sanitary Survey- Review

*Chichester Harbour – 2021*

<b>Client</b>	Food Standards Agency (FSA)
<b>Project Title</b>	Sanitary Survey Review
<b>Document Title</b>	Chichester Harbour Sanitary Survey Review
<b>Document Number</b>	J0591/21/08/06
<b>Revision</b>	3.0
<b>Date</b>	12 October 2021

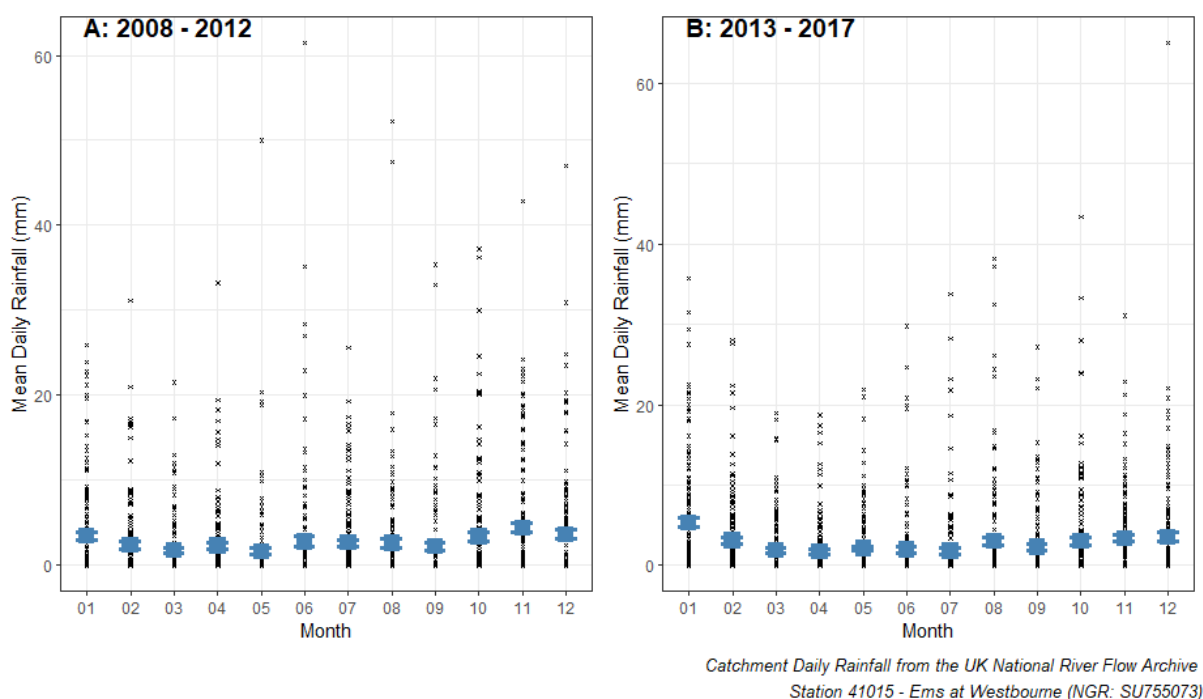
*Figure 5.1 Mean daily rainfall (mm) per month for the Ems at Westbourne (NGR: SU755073) monitoring station for the period (A) 2008 - 2012 and (B) 2013 - 2017.*

Whilst rainfall has fallen slightly since the original sanitary survey was published, two sample t-tests indicated that there was no significant difference ( $p = 0.812$ ) in the mean daily rainfall per month between the 2008 – 2012 and 2013 – 2017 periods.

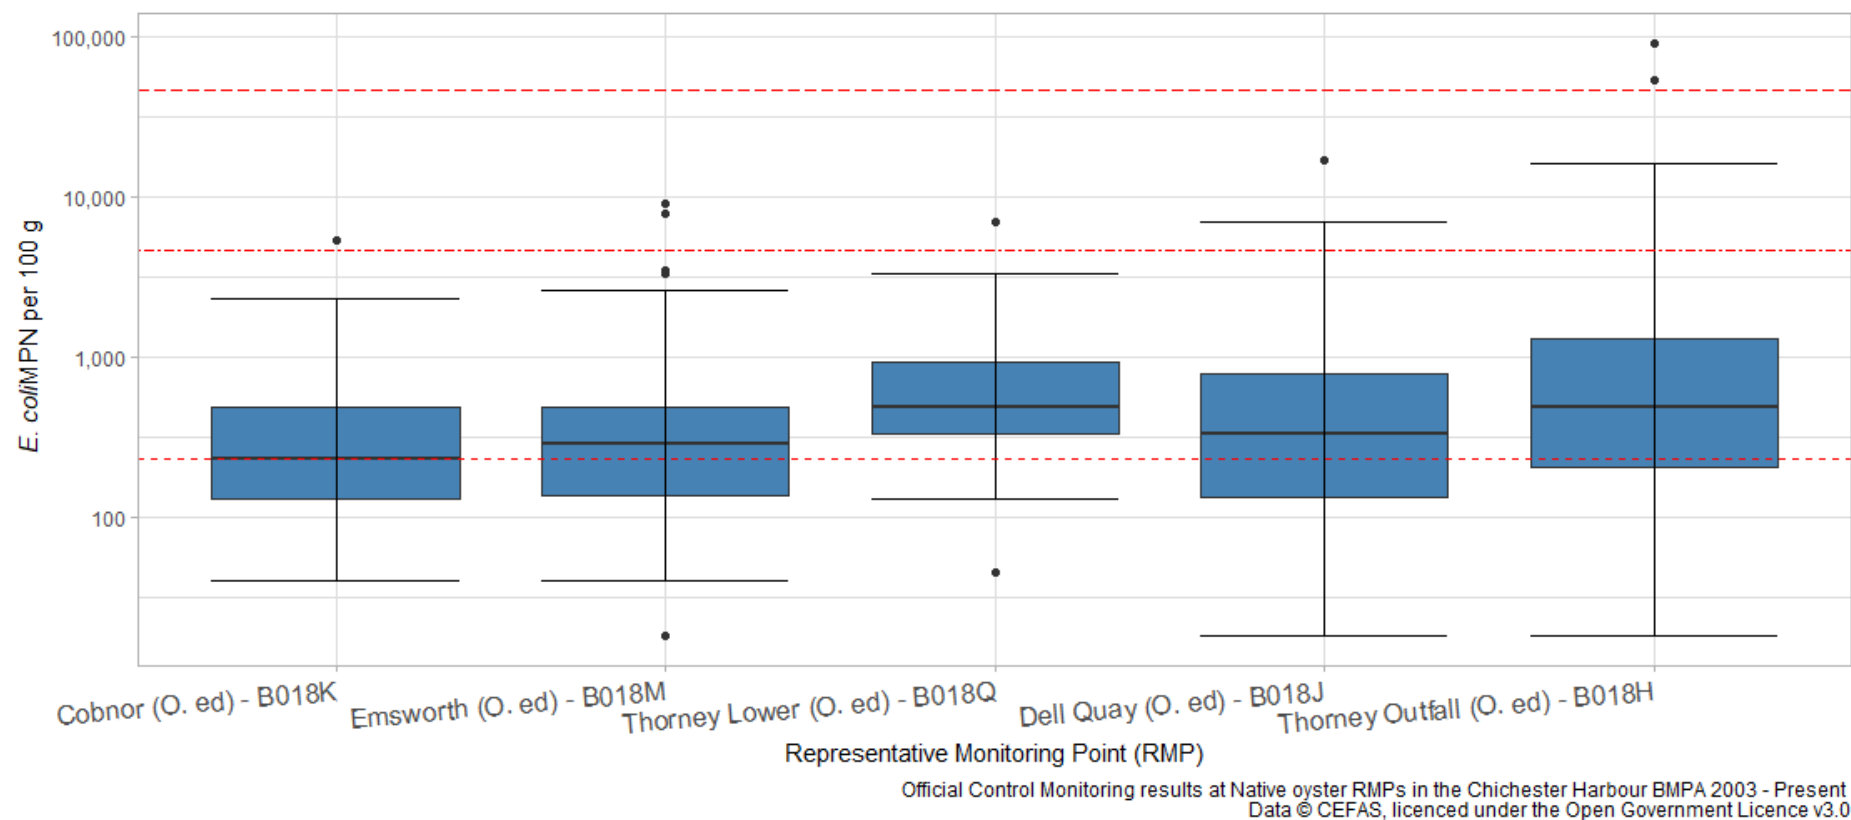
Figure 6.2 Boxplots of *E. coli* levels at native oyster RMPs sampled within the Chichester Harbour BMPA 2003 – Present. Central line indicates median value, box indicates lower – upper quartile range and whisker indicates minimum / maximum values excluding outliers (points  $>1.5 \times$  the interquartile range).

Figure 6.2 presents a boxplot of *E. coli* monitoring results from native oyster RMPs within the Chichester Harbour BMPA. One-way analyses of variance (ANOVA) tests were used to investigate the statistical significance of any differences between monitoring results from the various RMPs. All statistical analysis described in this section was undertaken in R (R Core Team, 2020). Despite some visual differences in the mean values, the tests indicated that there were no significant differences between the monitoring results ( $p = 0.147$ ). This could be due to large variance in the data, where even though the Thorney Outfall (B018H) RMP has a higher mean, frequent low results at this RMP have also occurred.

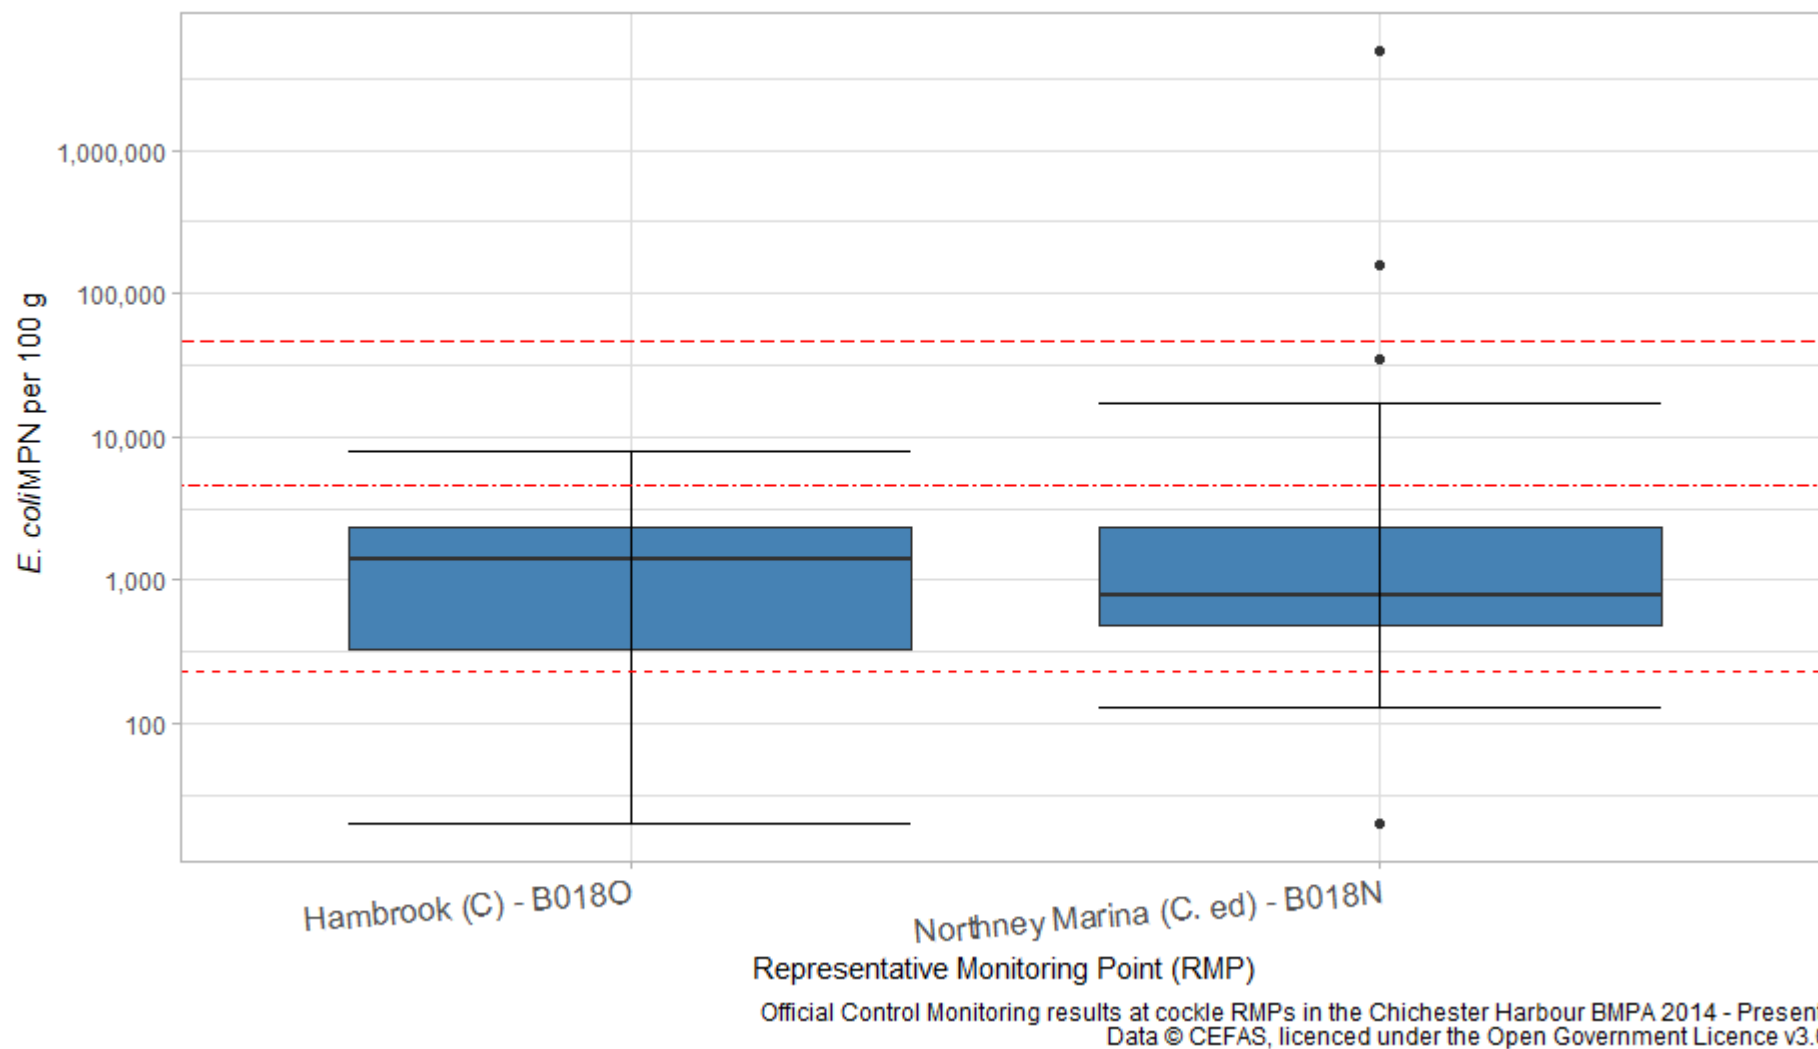
Figure 6.3 Boxplots of *E. coli* levels at cockle RMPs sampled within the Chichester Harbour BMTA 2014 – Present.

Figure 6.3 presents the boxplots of monitoring results from cockle RMPs within the Chichester Harbour BMPA. ANOVA testing indicated that there is no significant difference between the monitoring results from the two RMPs ( $p = 0.448$ ). The boxplot of monitoring results from the Hambrook *Tapes* RMP is presented in Figure 6.4. It is not appropriate to compare the results from RMPs for different species due to the variation in rates of *E. coli* up-take by different species.

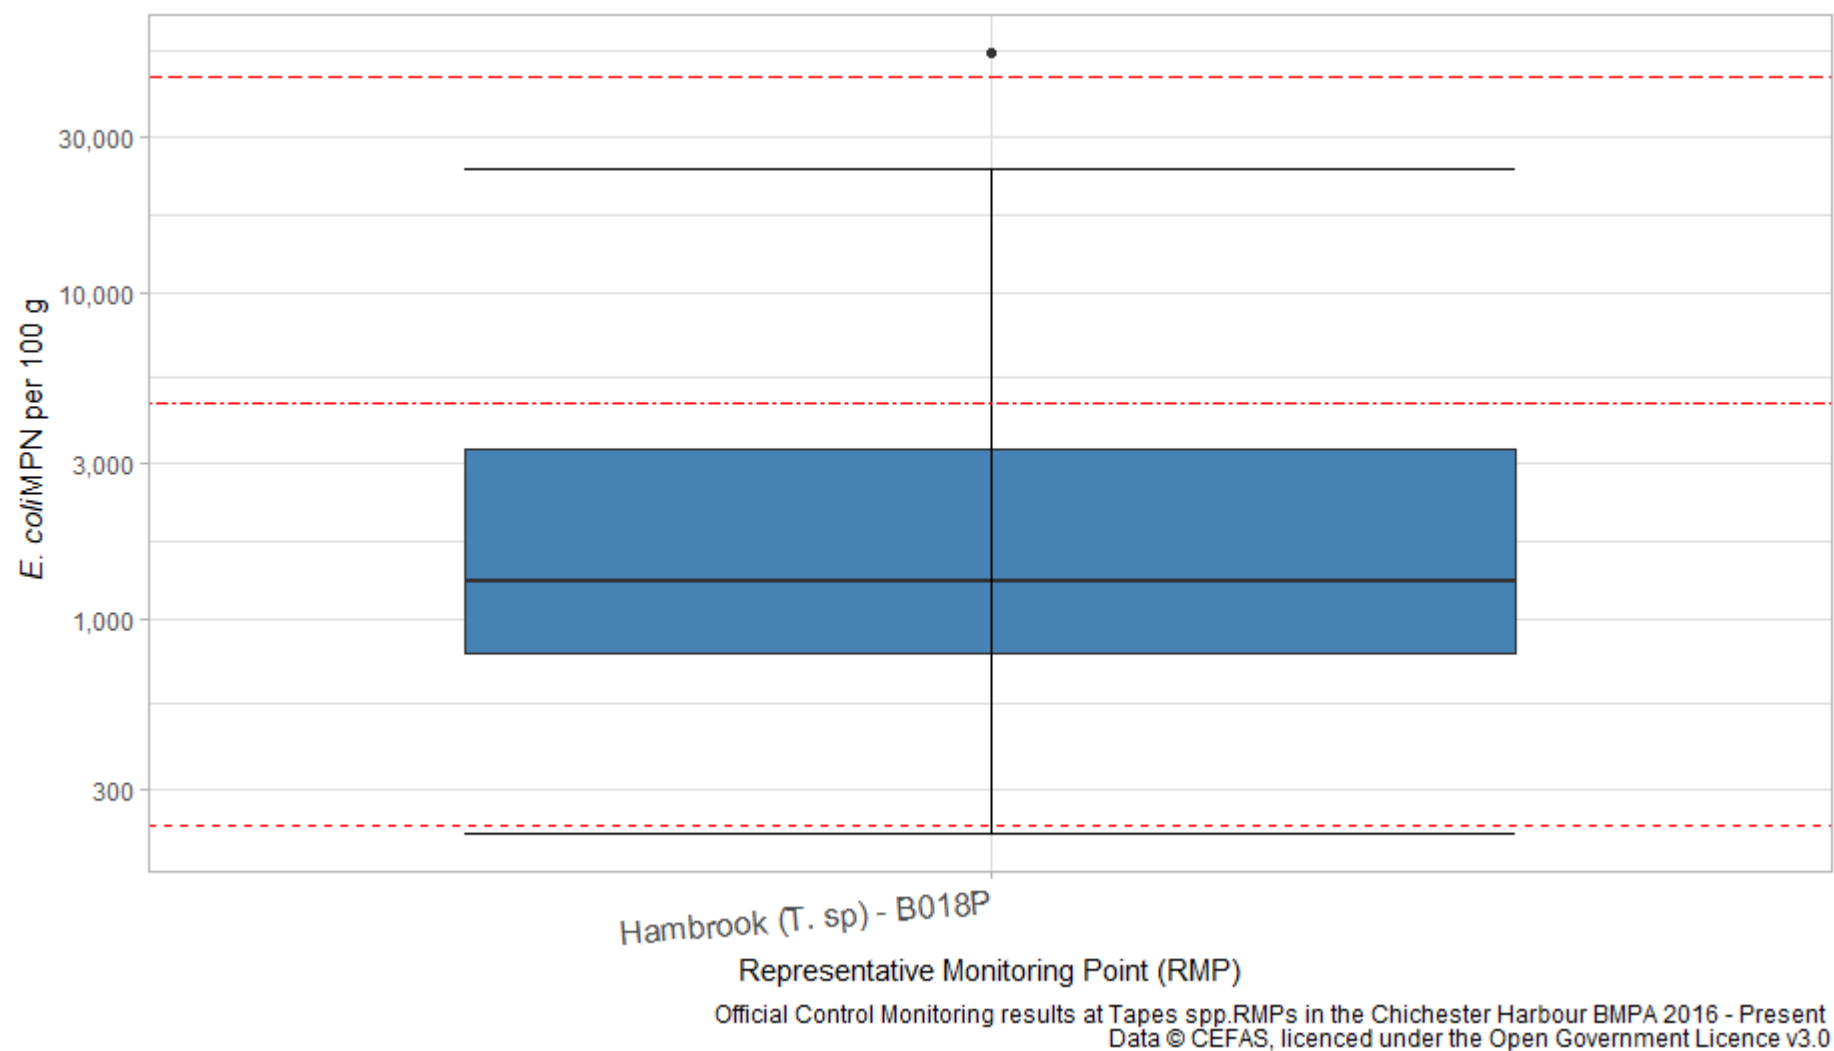
Figure 6.4 Boxplot of *E. coli* levels at *Tapes* spp. RMPs sampled within the Chichester Harbour BMTA 2016 - Present.

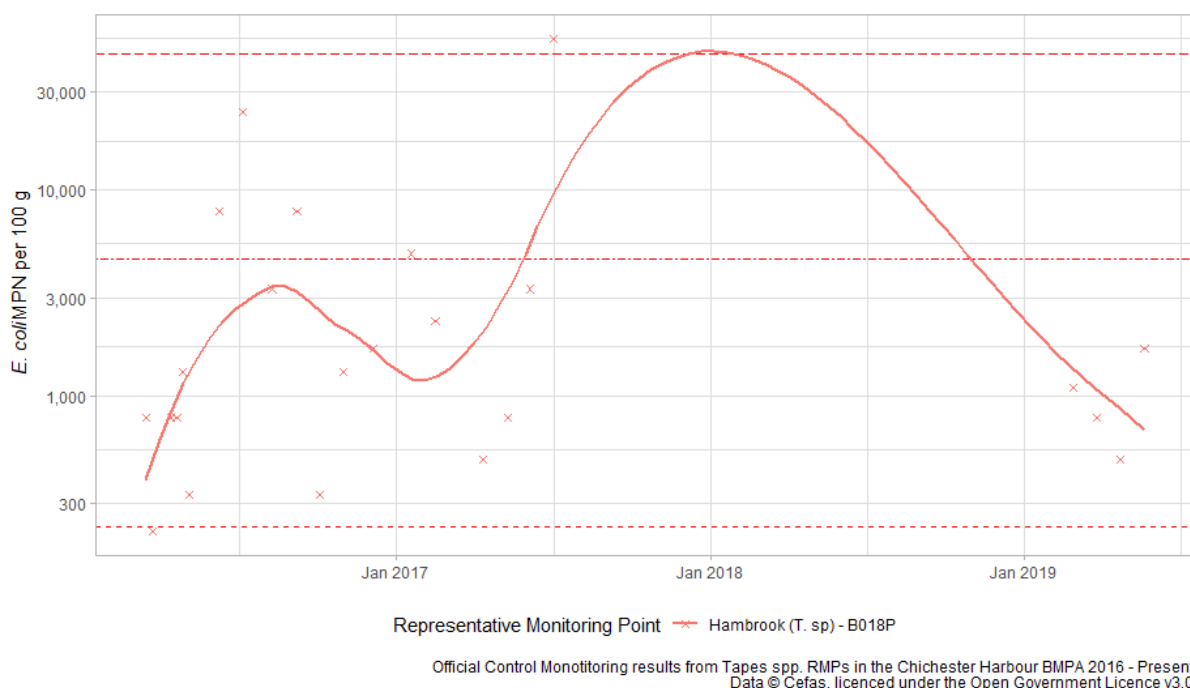
*Figure 6.7 Timeseries of *E. coli* levels at Tapes spp. RMPs sampled within the Chichester Harbour BMPA 2016 – Present. Scatter plot is overlaid with a loess model fitted to the data.*

Figure 6.6 and Figure 6.7 present the timeseries of monitoring results from RMPs for cockles and *Tapes* spp. respectively. The monitoring results from Northney Marina (B018N) show a relatively stable trend, although occasional exceptionally high results are visible within the scatter plot. Results from Hambrook (B018O) show a trend of decreasing monitoring results (i.e., improving water quality) until sampling stopped in May 2016. The monitoring results from the Hambrook (B018P) RMP begin with very low values, although the trend after this is very variable. No sampling at either the Northney Marina (B018N) and Hambrook (B018P) RMPs was undertaken over the winter of 2017/2018, following a string of high results. This gap in sampling may have skewed the loess model fitted to the data (Figure 6.7).

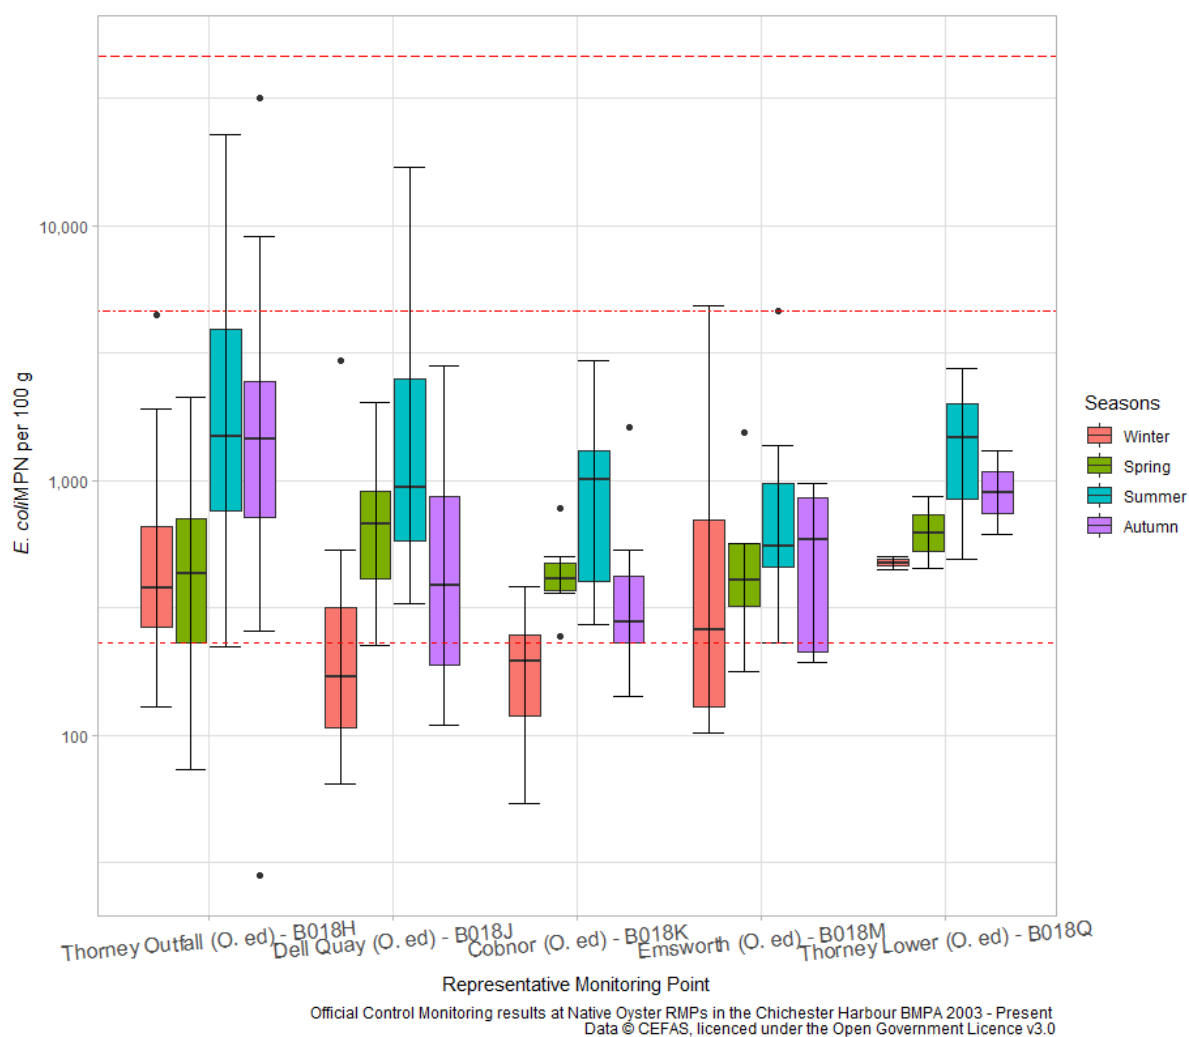
*Figure 6.8* Boxplots of *E. coli* levels per season at native oyster RMPs sampled within the Chichester Harbour BMPA 2003 - Present.

Two-way ANOVA tests revealed that results from Summer were significantly greater than those from Spring ( $p = 0.00752$ ), but that no other significant differences were found either across native oyster RMPs or within the data from an individual RMP. The elevated values from summer may be due to the high levels of tourism (both on land and visiting pleasure craft) that use Chichester Harbour in summer months.

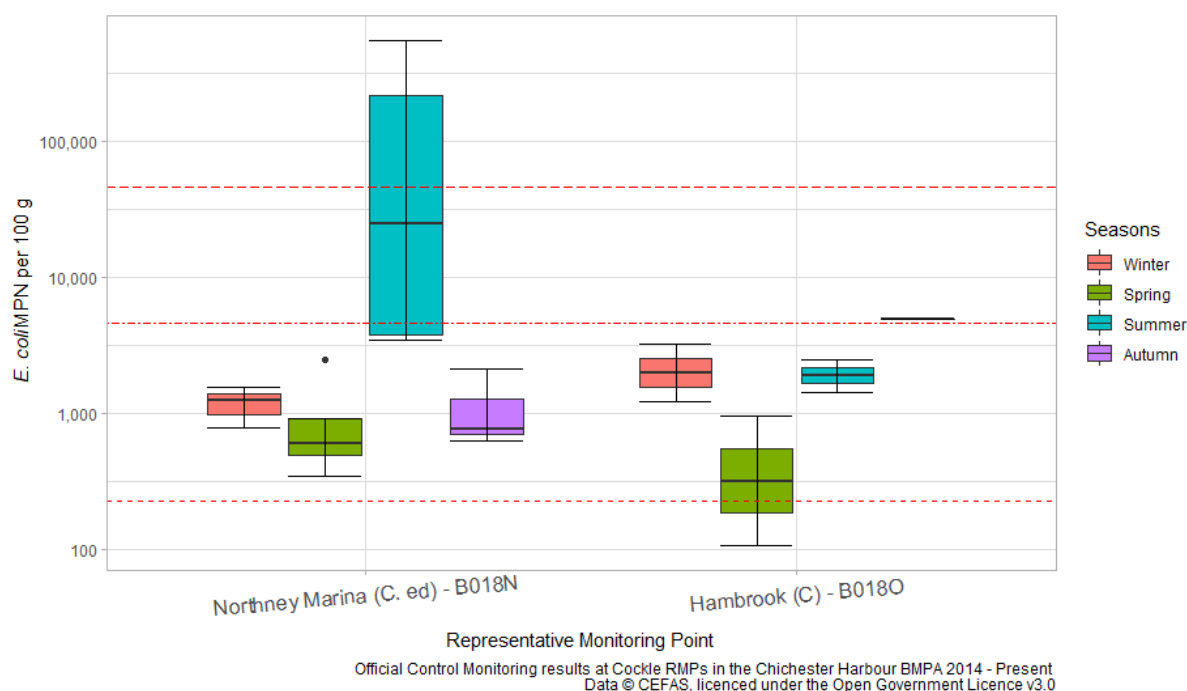
**Figure 6.9** Boxplots of *E. coli* levels per season at cockle RMPs in the Chichester Harbour BMA from 2014 – Present.

Figure 6.9 and Figure 6.10 show the seasonal patterns in *E. coli* results at cockle and *Tapes* RMPs respectively. Despite the results from summer months at the Northney Marina (B018N) RMP being much greater than the results from other times of year, and the results from Hambrook (B018O) being lower in spring than at other times of year, no seasonal differences were found when data from RMPs was either considered individually or pooled across RMPs.

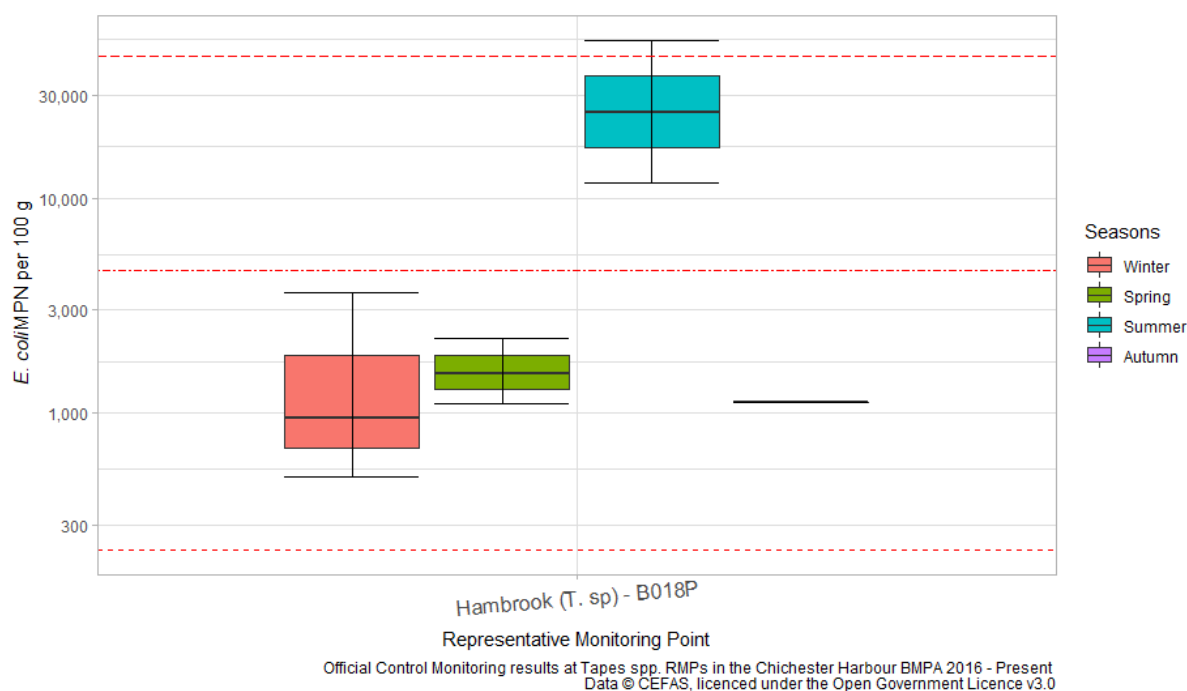
**Figure 6.10** Boxplots of *E. coli* levels per season at Tapes spp. RMPs in the Chichester Harbour BMA from 2016 - Present.
