Sanitary Survey - Review

Exe Estuary - 2021

Document No. - J0591/20/07/16

Client	Food Standards Agency (FSA)
Project Title	Sanitary Survey Review
Document Title	Review of the sanitary survey of the Exe Estuary
Document Number	J0591/20/07/16
Revision	4.1
Date	20 January 2021

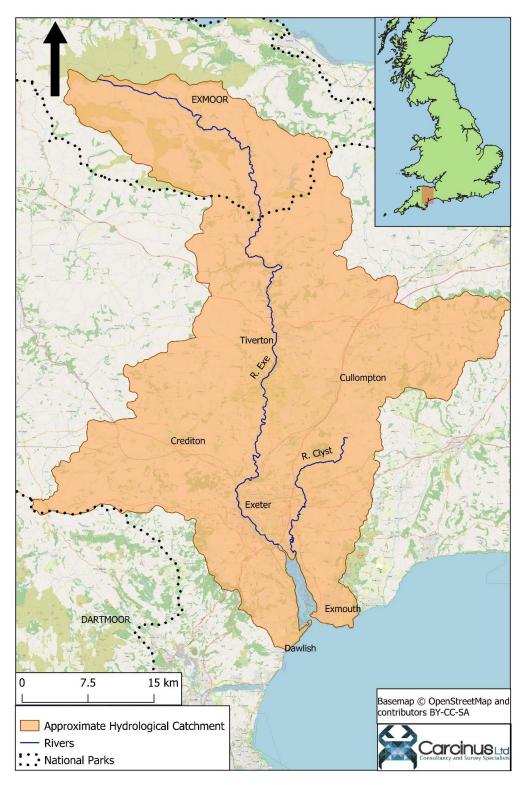
Figure 1.1: Location of Exe Estuary

This report reviews information and makes recommendations for a revised sampling for existing Mussel (*Mytilus sp.*), Pacific oyster (*Crassostrea gigas*) and surf clam (*Spisula solida*) classification zones in the Exe Estuary (Figure 1.1). This review explores any changes to the main microbiological contamination sources that have taken place since the original sanitary survey was conducted. Data for this review was gathered through a desk based study and consultation with stakeholders.
