**Larne Lough
Sanitary Survey Review
May 2015**

Report Title	Larne Lough Sanitary Survey Review
Project Name	Northern Ireland Sanitary Surveys
Client/Customer	Food Standards Agency in Northern Ireland
Cefas Project Reference	C6316F
Document Number	C6316F_2014_01
Revision	1.1
Date	27/05/2015

A sanitary survey was undertaken by AFBI in 2009 for Larne Lough. The survey was conducted to identify the location, extent and nature of the shellfishery and the potential sources of faecal contamination to the shellfishery, and to recommend sampling plans for the classified licensed sites within the lough.

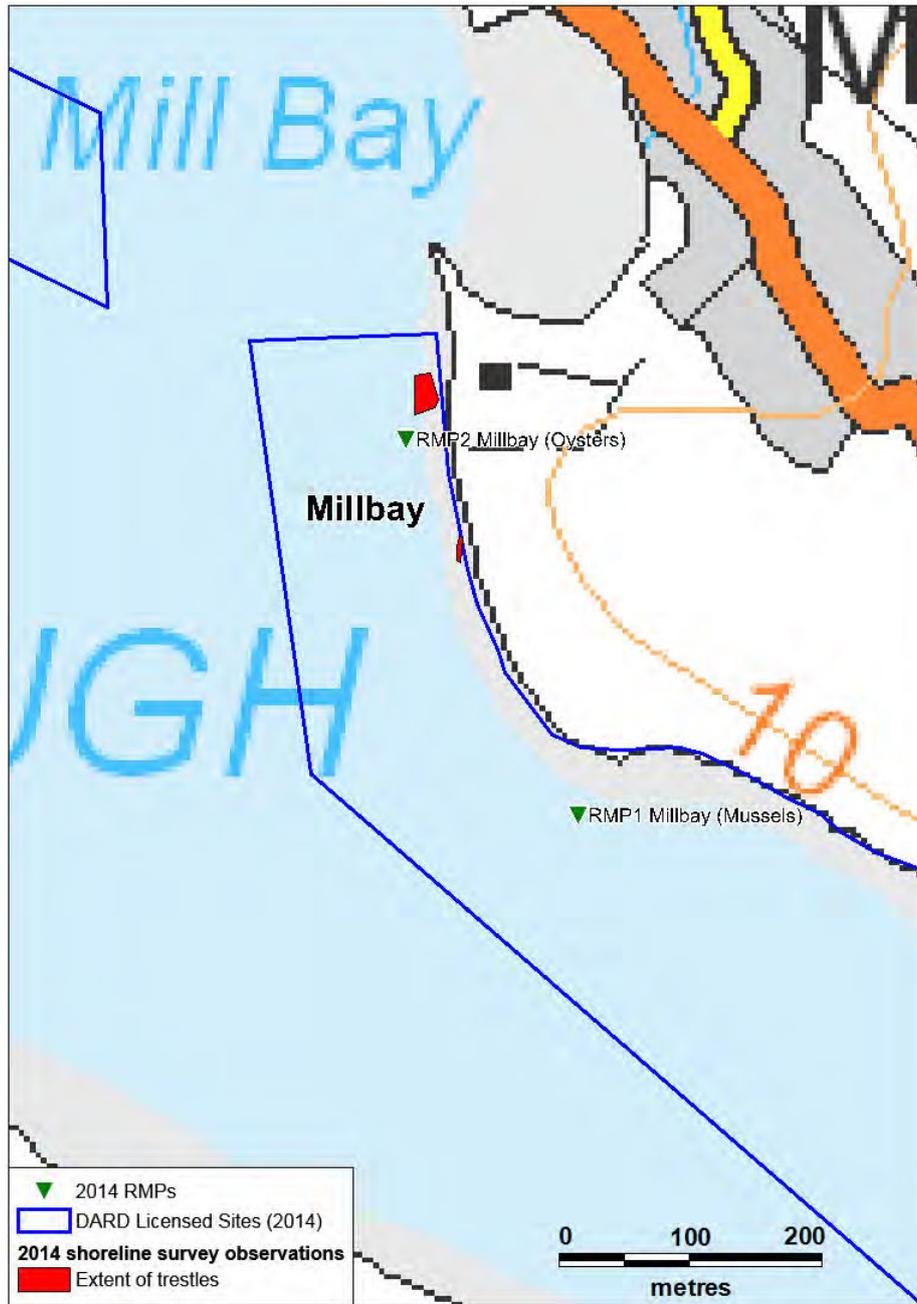
Millbay (L5): This is primarily a Pacific oyster site comprised of two trestle areas; split into northerly and southerly areas. Empty poches and broken trestles were littered along much of the shoreline between these two areas and extending southward beyond the southerly area. The northerly trestle area mainly consisted of empty oyster trestles, lying in disarray. The southerly area consisted of 12 predominantly empty trestles. Three poches containing native oysters were noted on a trestle at the southwest extent of the site. A concreted area on the foreshore adjacent to the southerly site was being used to store 56 trestles and 12 empty poches. No observations were made of the Millbay (L5) mussel site.

© Crown copyright and database right 2014 ES&LA210.15
Figure 1.3 Larne Lough Millbay (L5) shellfishery observations

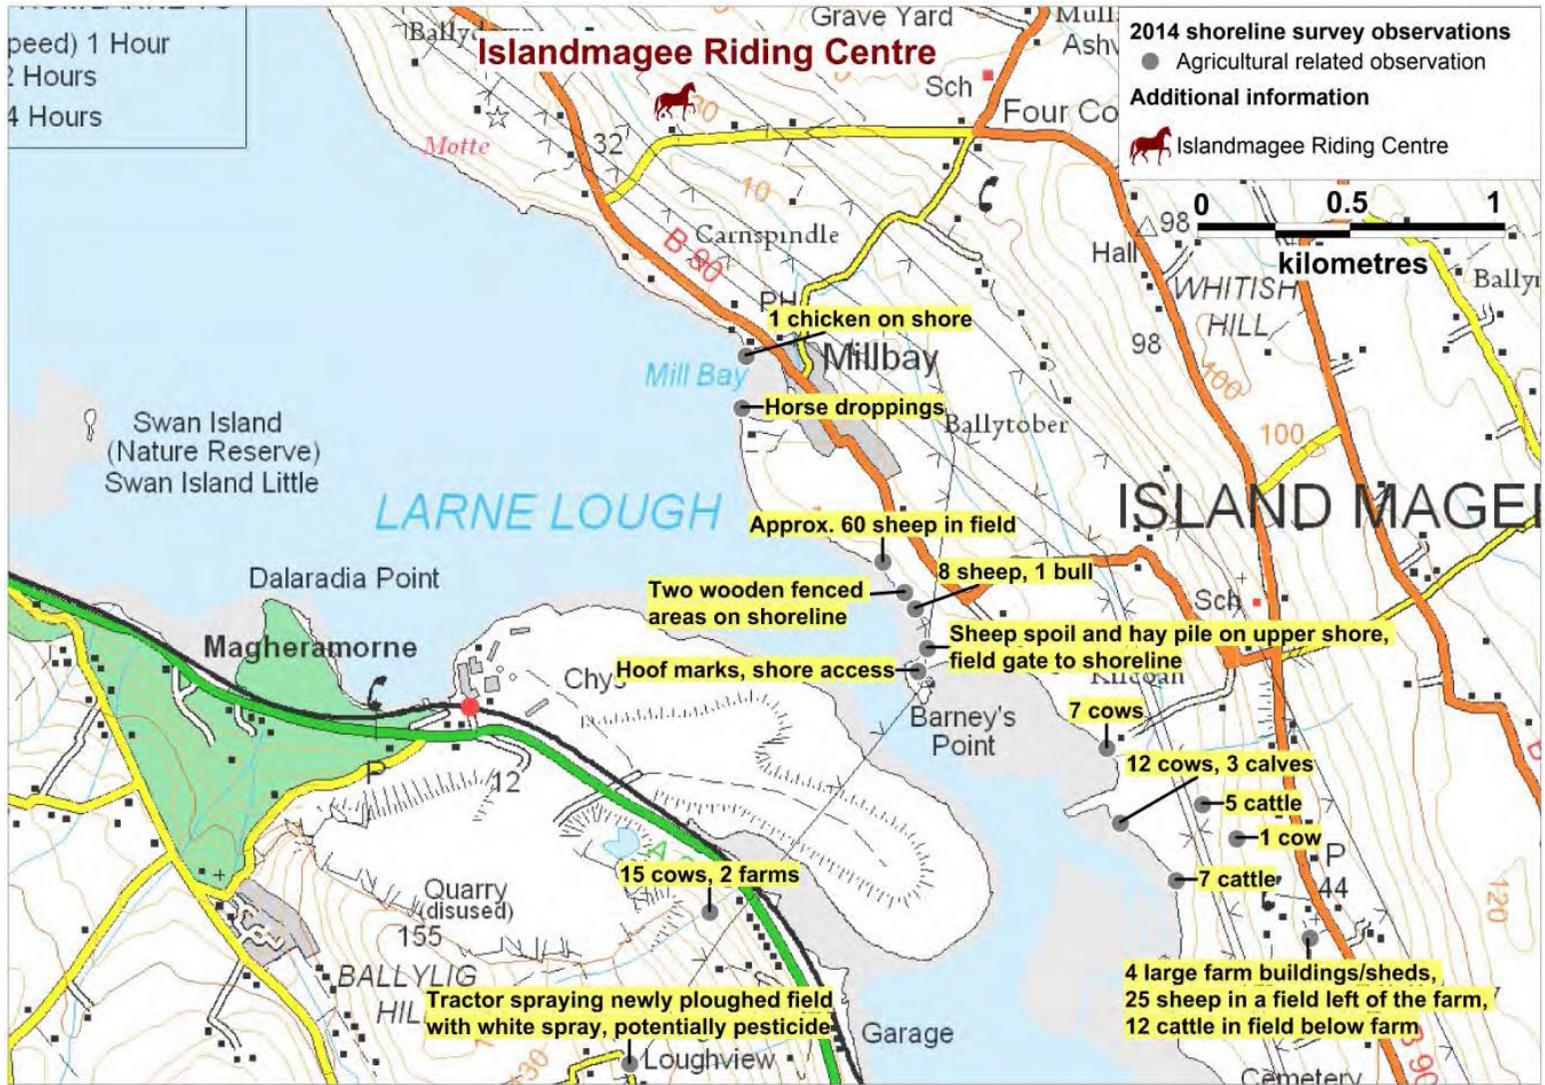
The majority of agriculture-related observations made during the 2014 shoreline survey were for locations on the east side of the lough on Islandmagee. Fenced areas of improved grassland dominated land adjacent to the shoreline. Ninety-three sheep and 41 cattle (including three calves) were observed along this shoreline. Two farms and 15 cattle were seen near Magheramorne quarry. Observations made during the survey are dependent upon the viewpoint of the observer some animals may have been obscured by the terrain. A large farm consisting of four large

Fields of improved grassland containing 15 cattle were noted around two farms located on the hillside south of the Magheramorne quarry. A tractor was also observed from the opposite shoreline to be applying a white spray to a recently ploughed field on the hillside southwest of the quarry.

Two empty wooden structures were noted just north of Barney's Point on Islandmagee. Their purpose remained unclear, though it may be suggested they are used as feeding stations. Cattle hoof prints were noted on the muddy shoreline at Barney's Point, where the sampling officer stated he had previously seen cattle. In the adjacent field there was a gate to the shoreline, where a hay pile and sheep spoil were also noted on the foreshore. Horse droppings were noted on the grassy verges around Mill Bay, where a chicken was also noted on the shore.

Figure 3.1 Map of farm animals and associated observations made during the 2014 shoreline survey

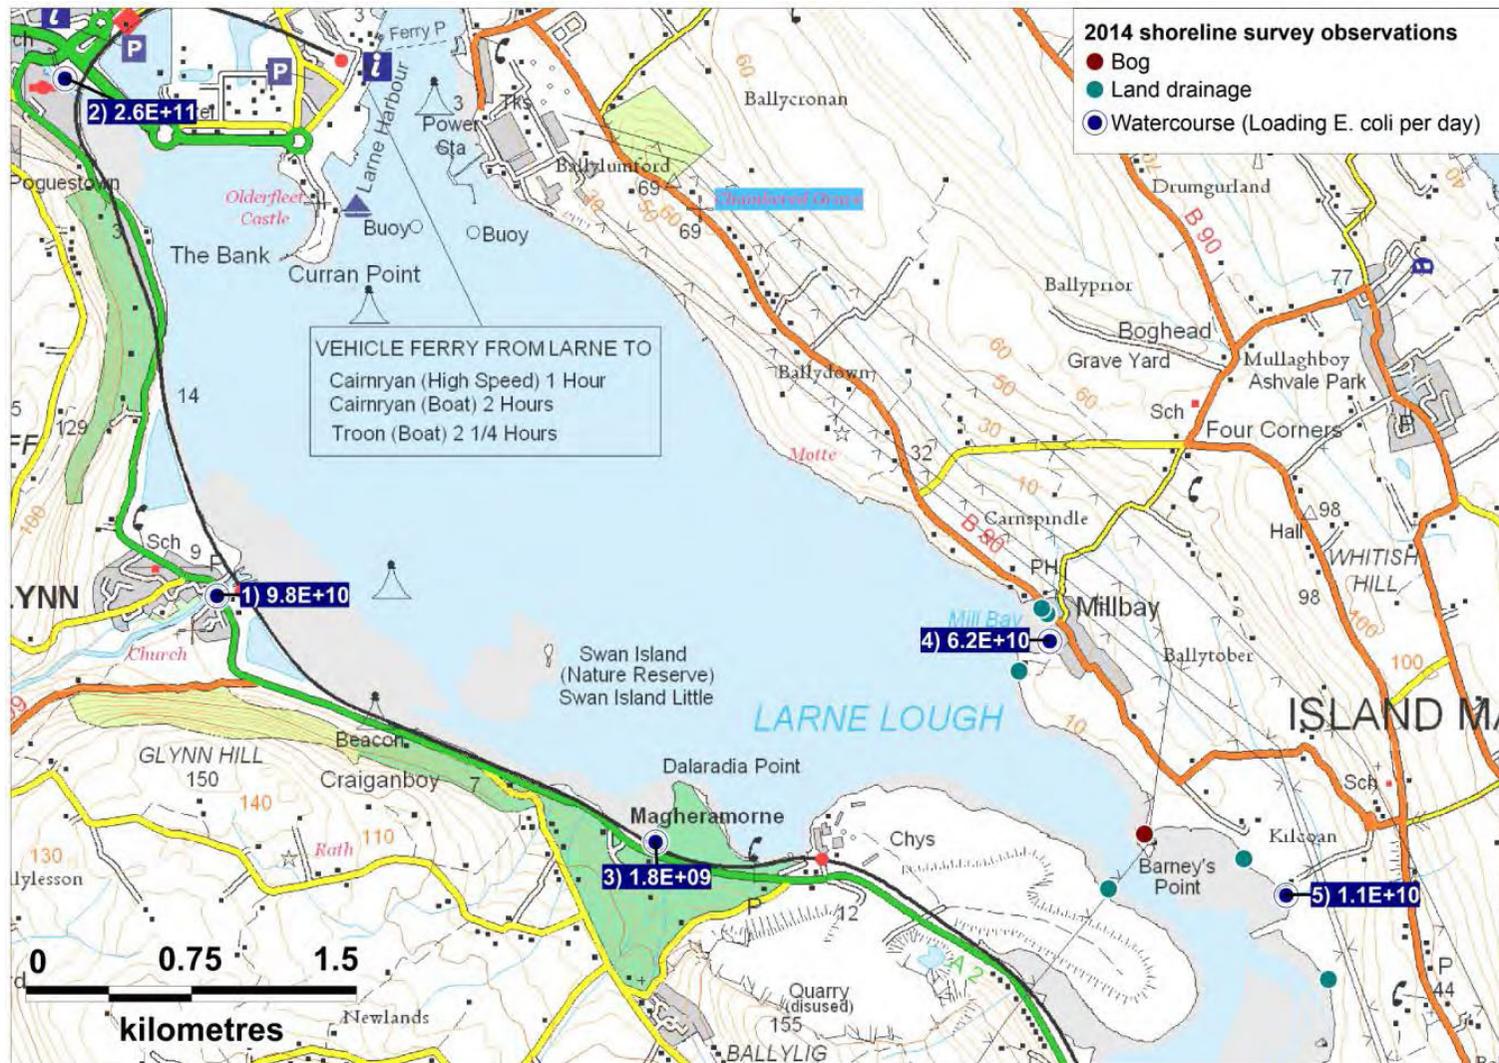
The highest estimated loadings were associated with the Rivers Larne and Glynn. These enter the outer lough area and are located >3 km from the nearest shellfish site. Depending on particle transport distance, these may impact at the northern end of the sites or at least contribute to background levels within the lough. The other recorded watercourses may directly impact on the fisheries, especially on the oyster sites on or close to shore. Other watercourses located in the eastern lough may also contribute to contamination at the fisheries.

Figure 5.1 Watercourse loadings at Larne Lough, 2014 shoreline survey

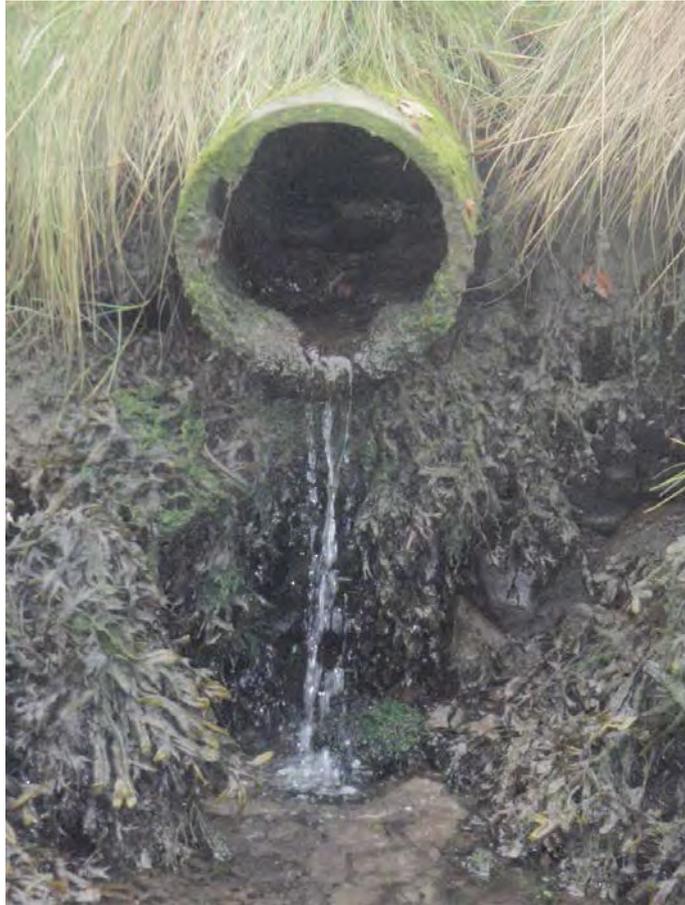
Figure 3 Discharge pipe associated with NIW asset and sample LLFW01.

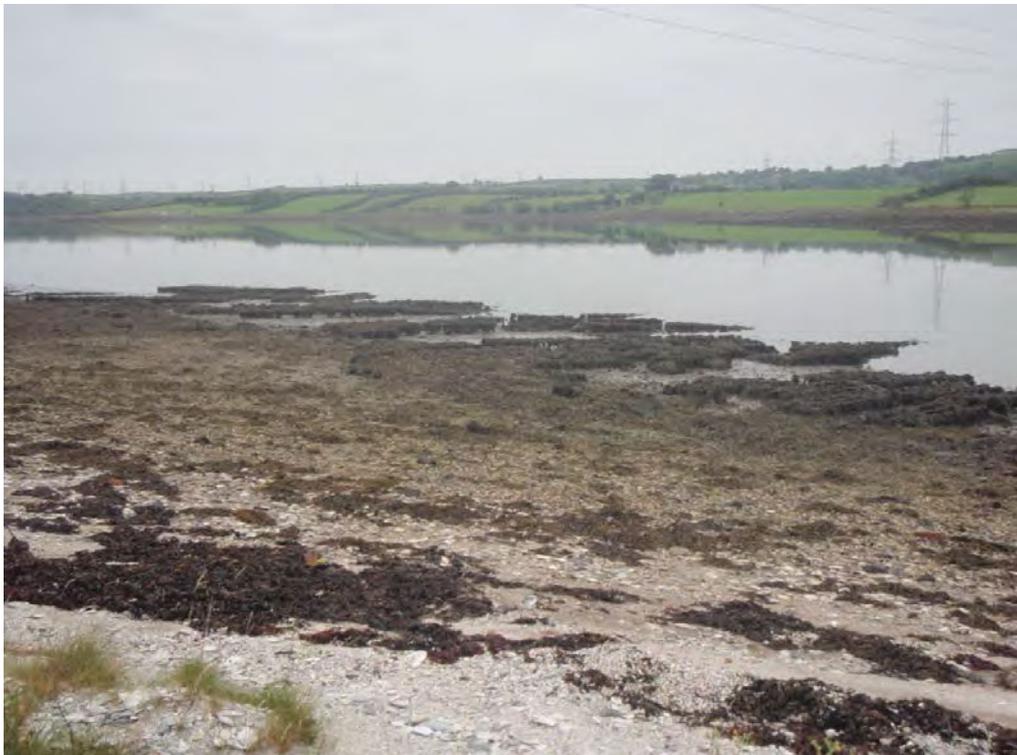
Figure 4 Trestle area south of Magheramorne Quarry.

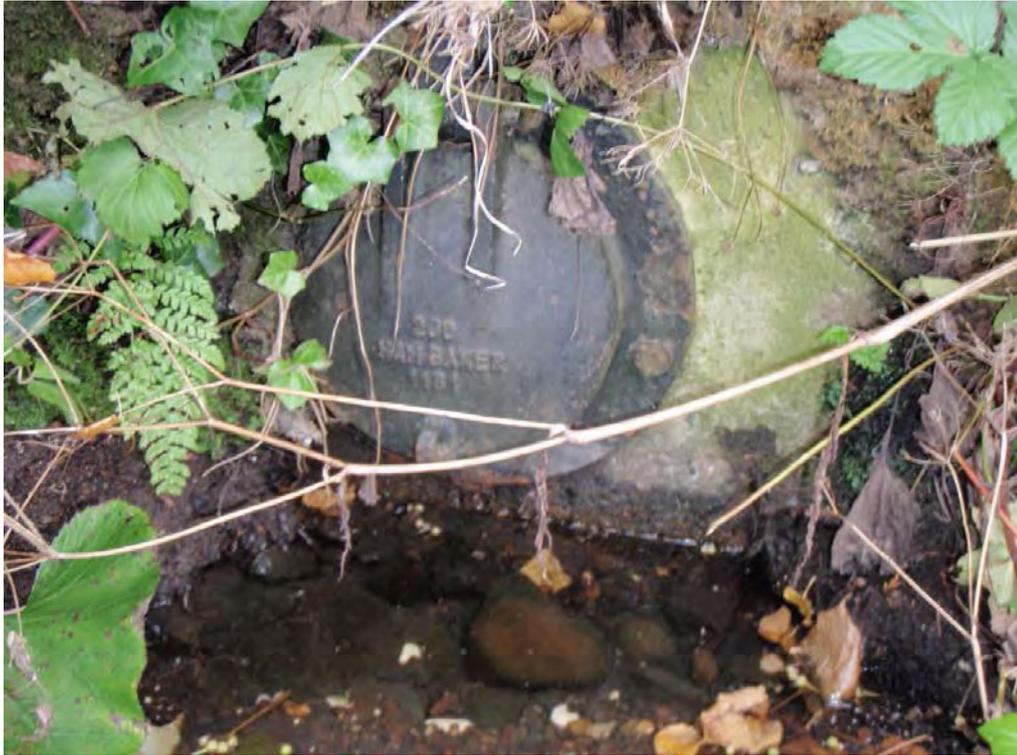
Figure 5 Sewage pipe (dry) to the side of Glynn River.

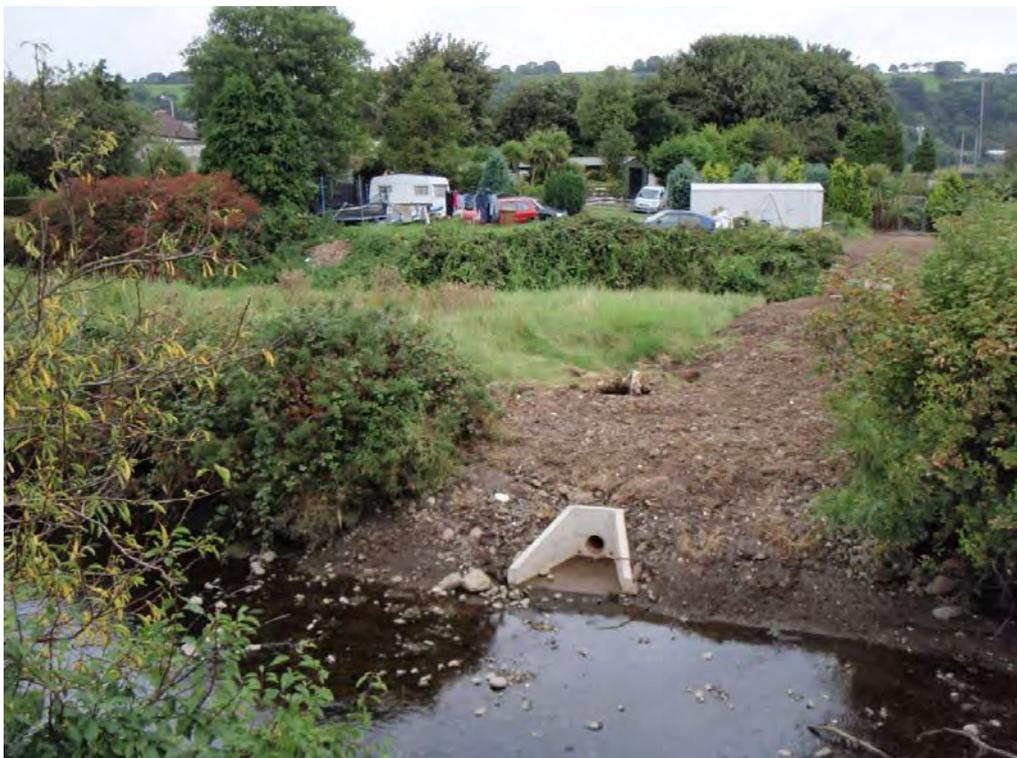
Figure 6 Glynn PS discharge pipe, with lived-in caravan in field behind house.

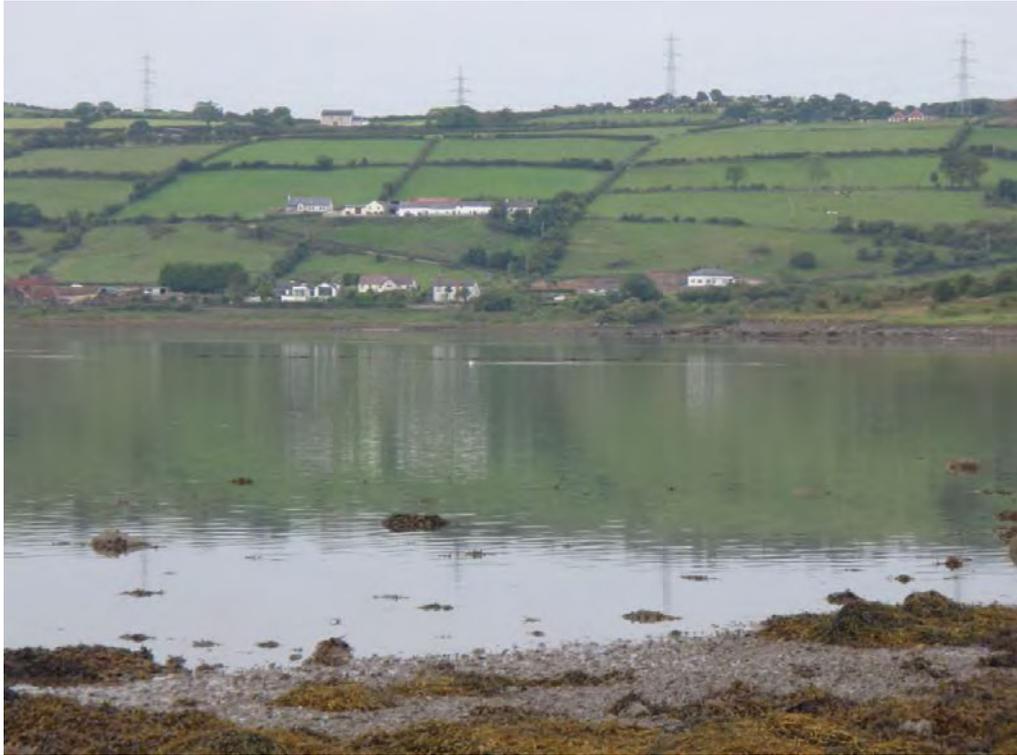
Figure 9 Island Shellfishery – clam bed eastern extent.

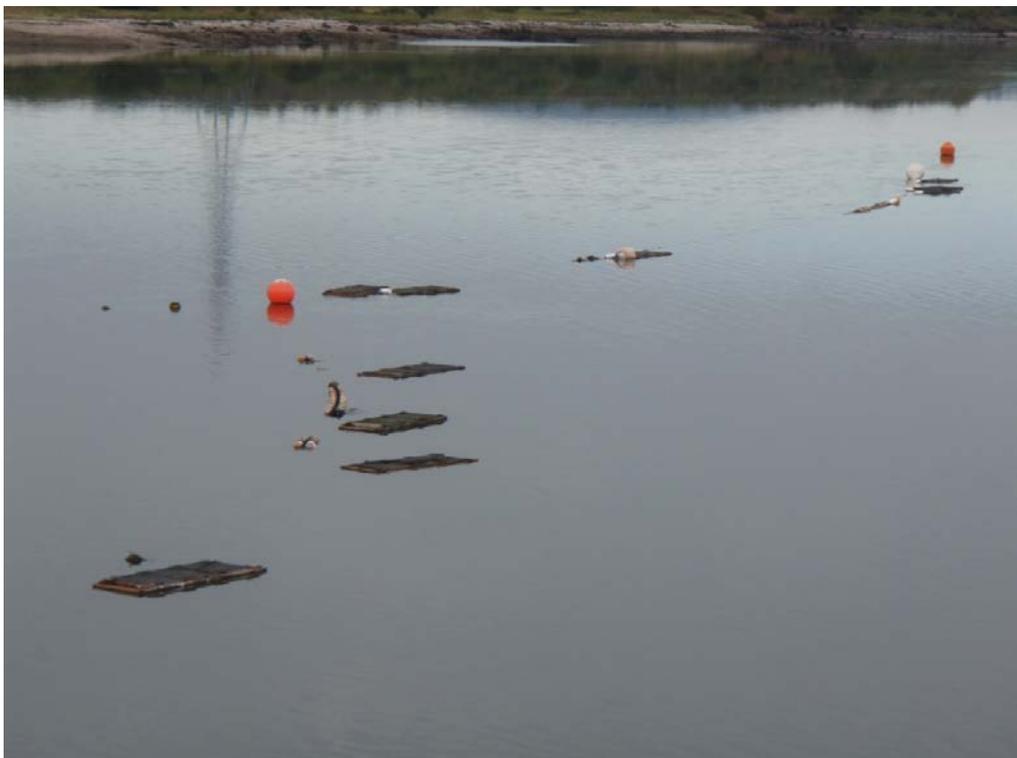
Figure 10 White Quay fishery, spat collectors and a trial floating cage system for oyster cultivation.

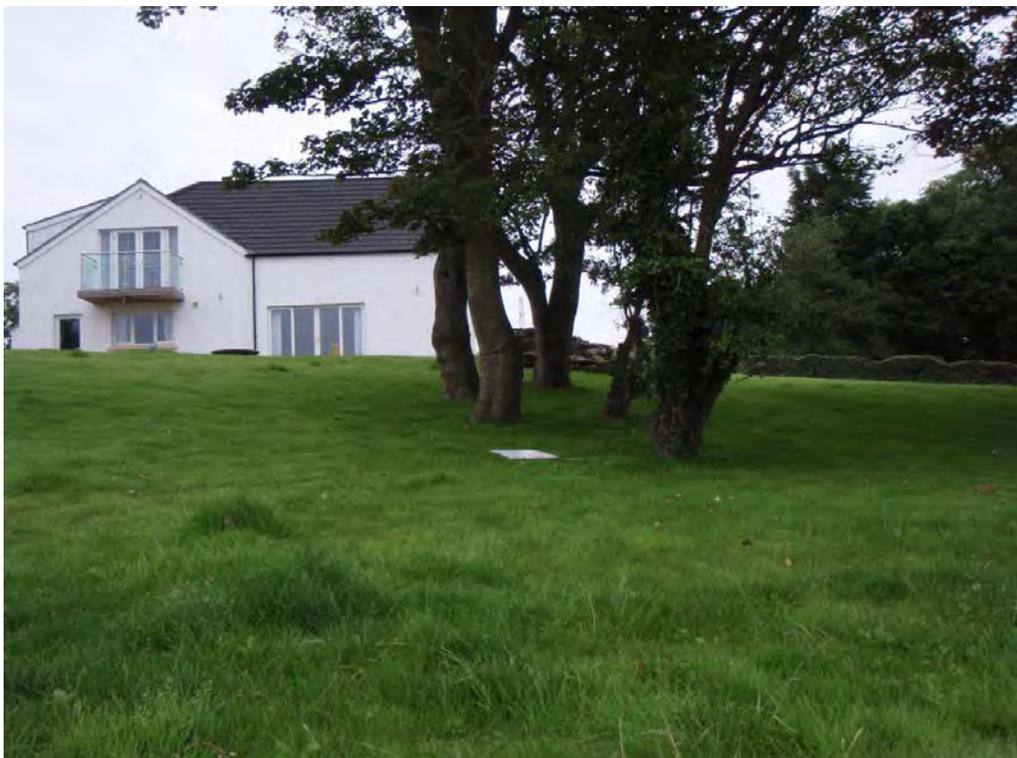
Figure 12 Possible ST hatch in garden below house.

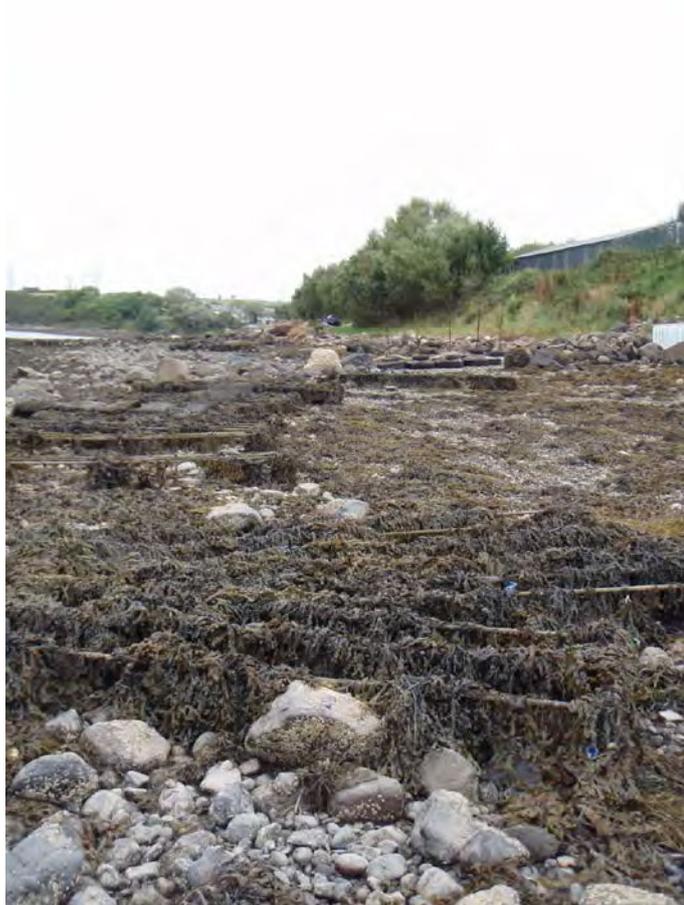
Figure 13 Trestles, mostly empty, at Millbay.

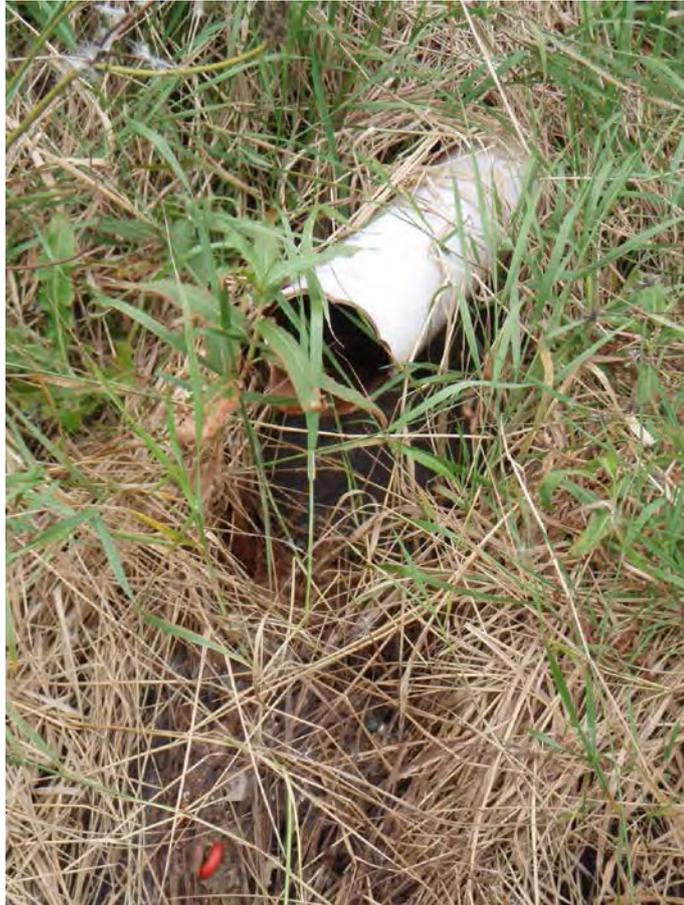
Only one sewage input was observed within the inner lough area, which was located adjacent to the Millbay oyster fishery and was associated with a boat/scrap yard. Surveyors observed a dripping pipe with grey sewage and sewage fungus on the surrounding shoreline. A sample taken from the dripping pipe returned a high result of 400,000 *E. coli* cfu/100 ml, though a seawater sample taken adjacent to the pipe returned a low result of 1 *E. coli* cfu/100 ml. The latter result would indicate that the output from the pipe may not have been causing significant contamination of the surrounding seawater at the time of the shoreline survey, this would depend on the water movement in the vicinity.

Figure 14 Dripping sewage pipe from the boat/scrap yard adjacent to Millbay fishery.
