Food Standards Agency in Northern Ireland

Sanitary Survey Review and Sampling Plan for Lough Foyle

AQUAFACT Ref: PM0412290

August 2025

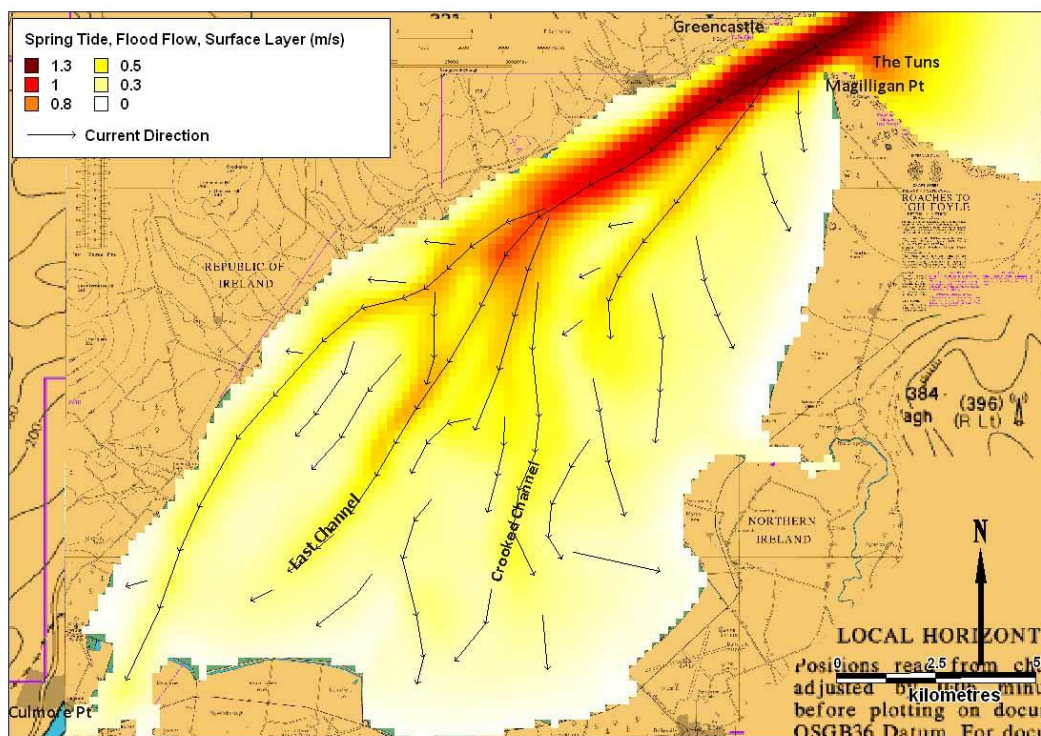
Figure 4-2: Surface layer current velocities (m/s) and direction during a spring tide, flood flow at 16:30:00 November 13th, 2008 (source: Deltares Delft3D-FLOW model, 2009).

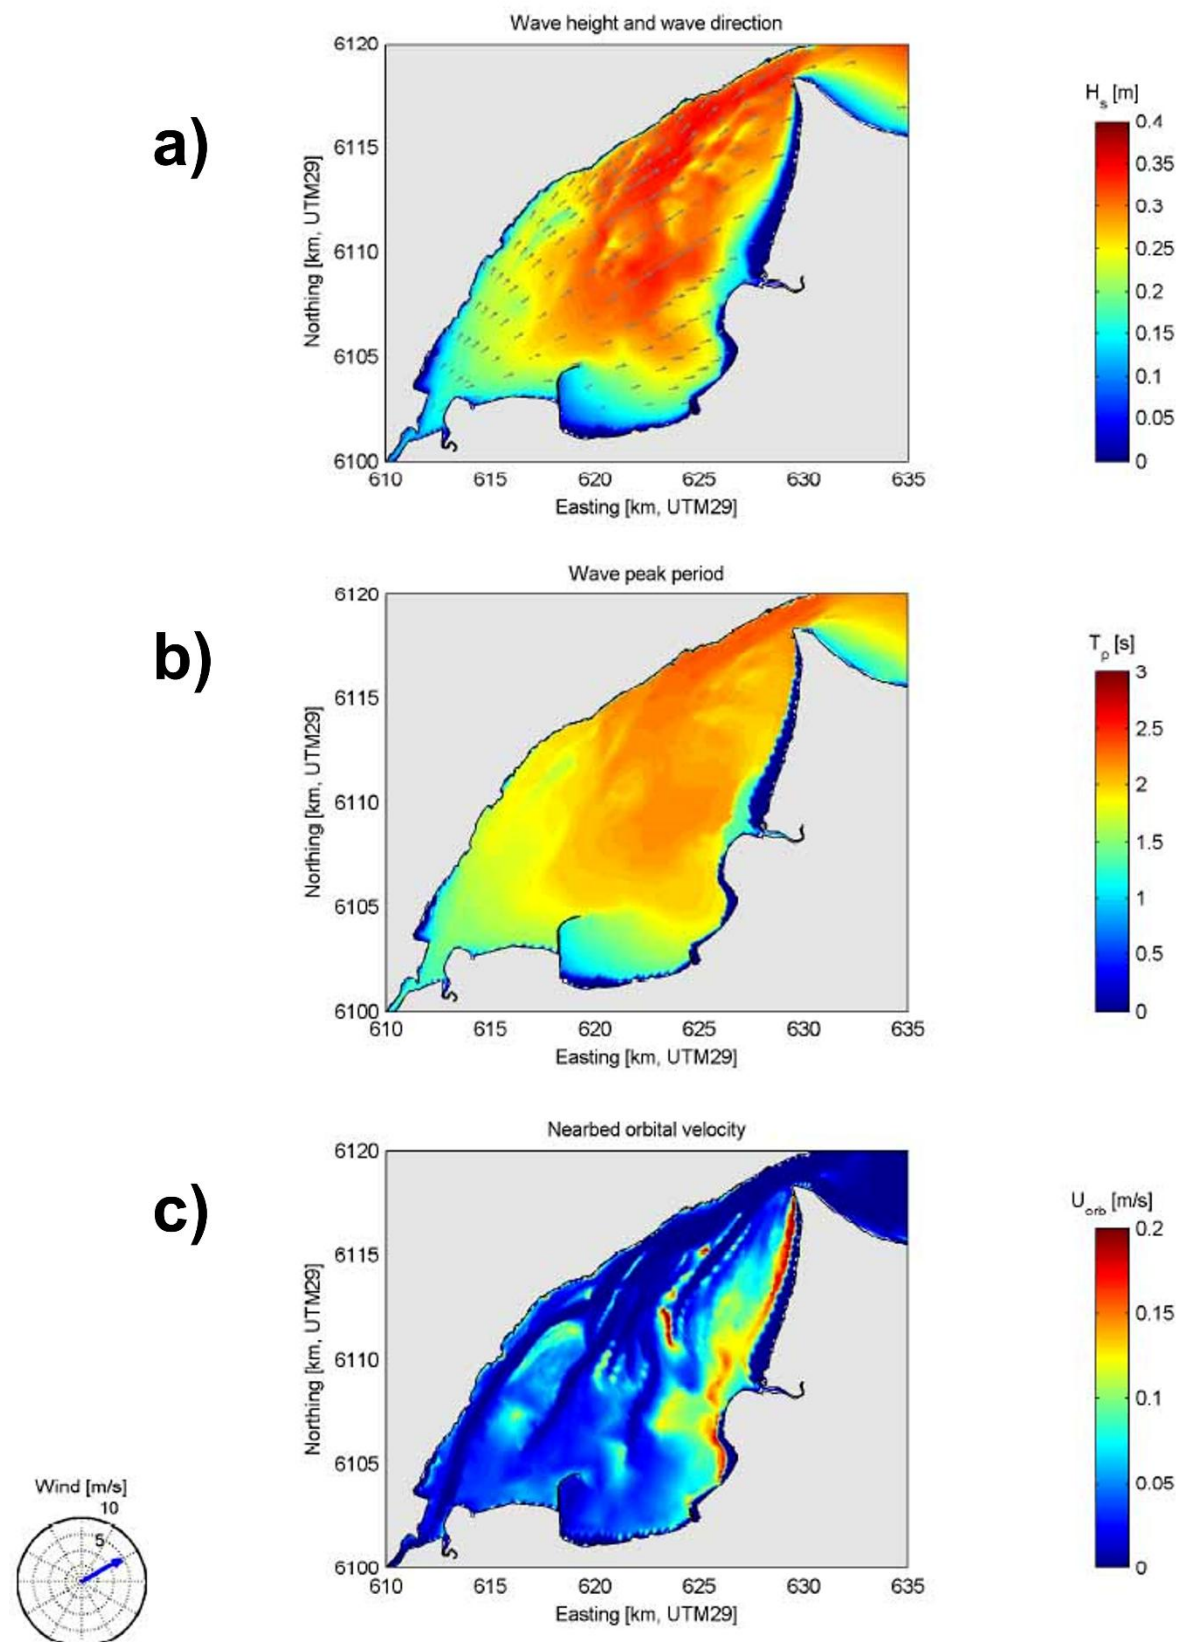
Figure 4-13: Computed wave height (m) (a), peak period (s) (b), and near-bed orbital velocity (c) for wind speed of seven m/s and a wind direction of 240 west-southwest (source: Deltares, 2009).

Deltares (2009), through consultation with the relevant port authorities, found no significant offshore wave penetration into Lough Foyle beyond Greencastle. Offshore wave energy is predicted to dissipate on a shallow area east of the entrance of Lough Foyle known as “The Tuns”. This is a shallow bank which disrupts waves before they reach the narrow entrance channel (within North/South Channel) (Deltares, 2009). As such, local wind-induced waves are the strongest force determining wave climate conditions in the lough (Deltares, 2009).

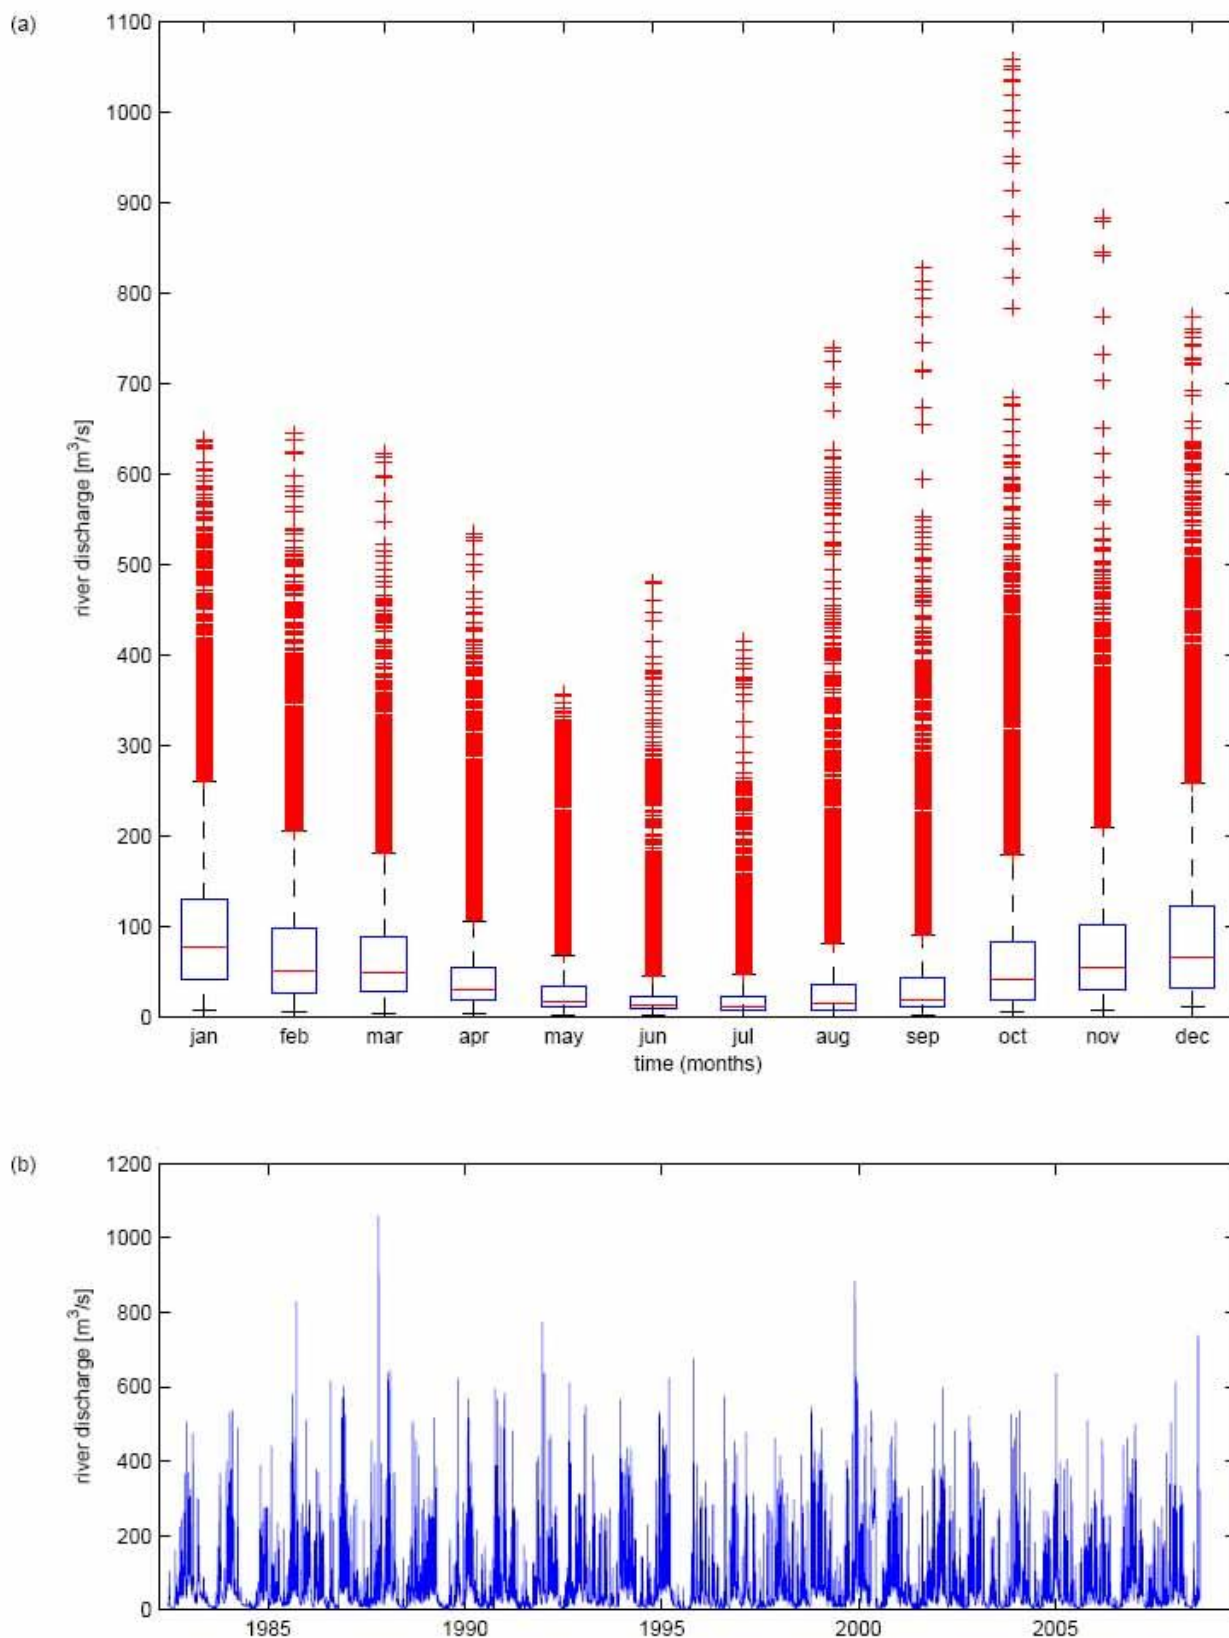
Figure 4-16: The Mourne River (tributary to the Foyle River) discharge (m^3/s) a) boxplot distribution of discharge per month and b) recorded time series (source: Deltares, 2009).

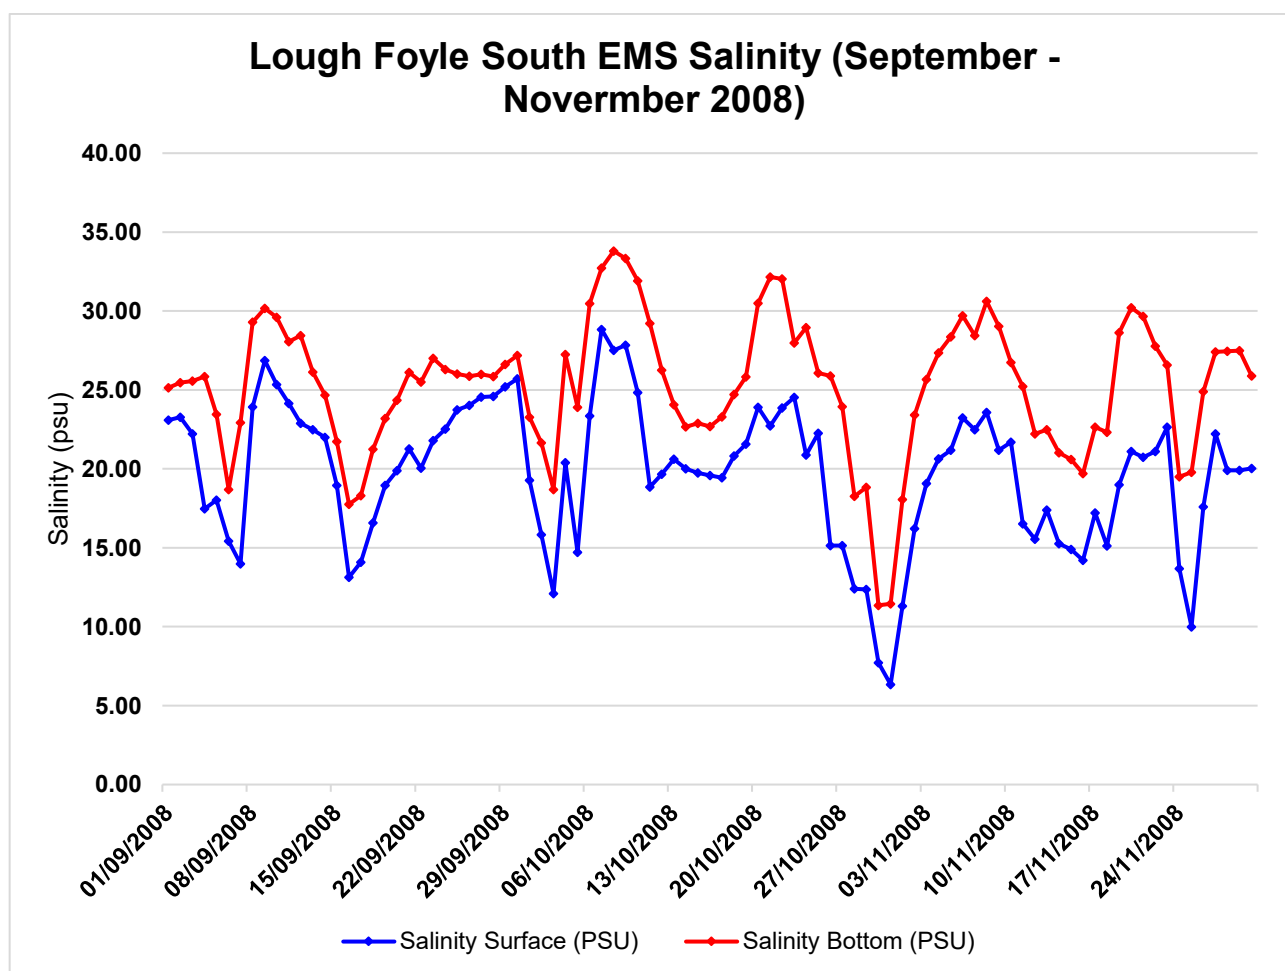
Figure 4-21: Salinity (psu) profile at Lough Foyle South Environmental Monitoring Station (EMS) from September to November 2008 (source: Loughs Agency).

Salinity levels show less recorded variation at the North EMS (Magilligan Point) in 2008 (**Figure 4-23**) compared to the South EMS (Black Braes) located in the inner lough (**Figure 4-21**). Surface levels ranged from 8.27 psu (October 2008) to 30.91 psu (September 2008) and bottom salinity levels ranged from 28.53 psu (October 2008) to 33.4 psu (September 2008). The variability observed can be associated with the tidal cycle and river discharge levels.

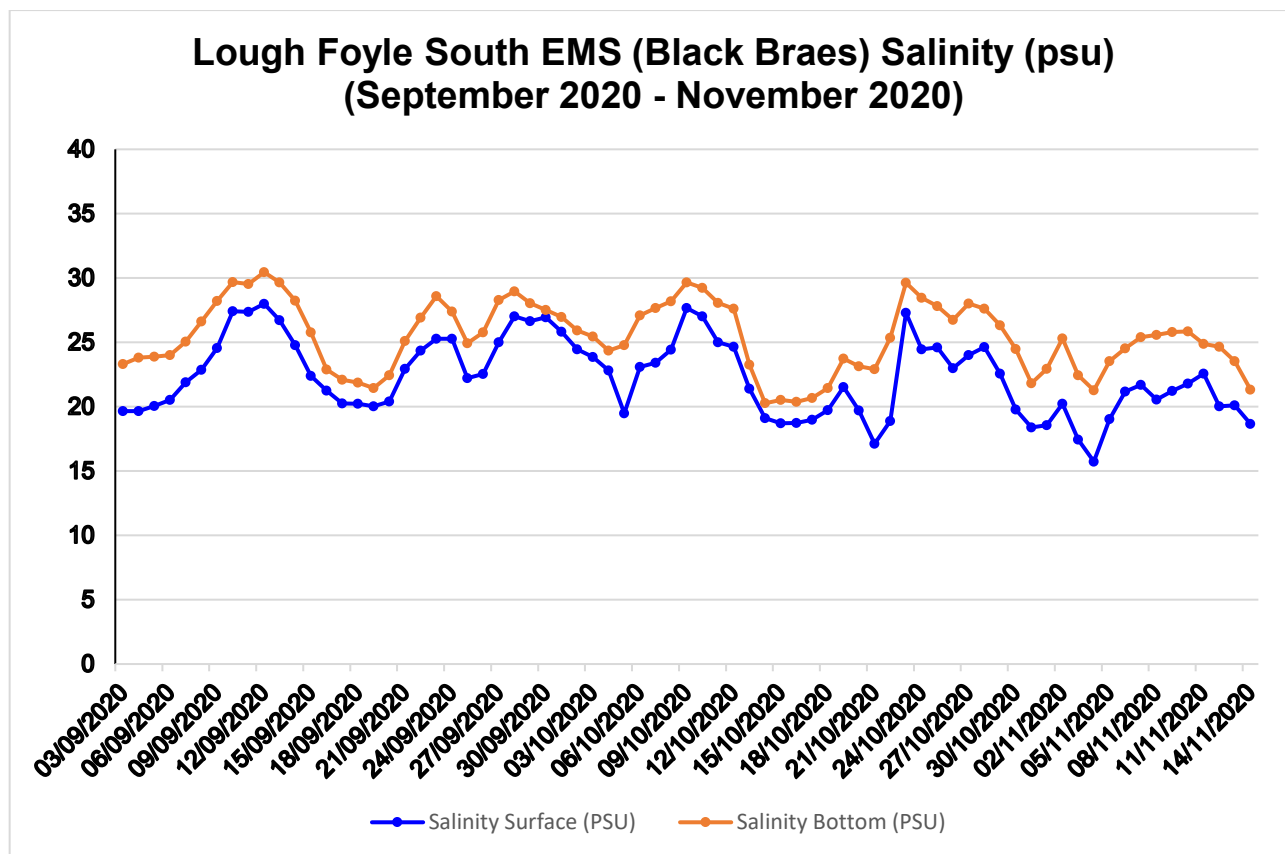
Figure 4-22: Salinity (psu) profile at Lough Foyle South Environmental Monitoring Station (EMS) at Black Braes from September 2020 to November 2020 (source: Loughs Agency).

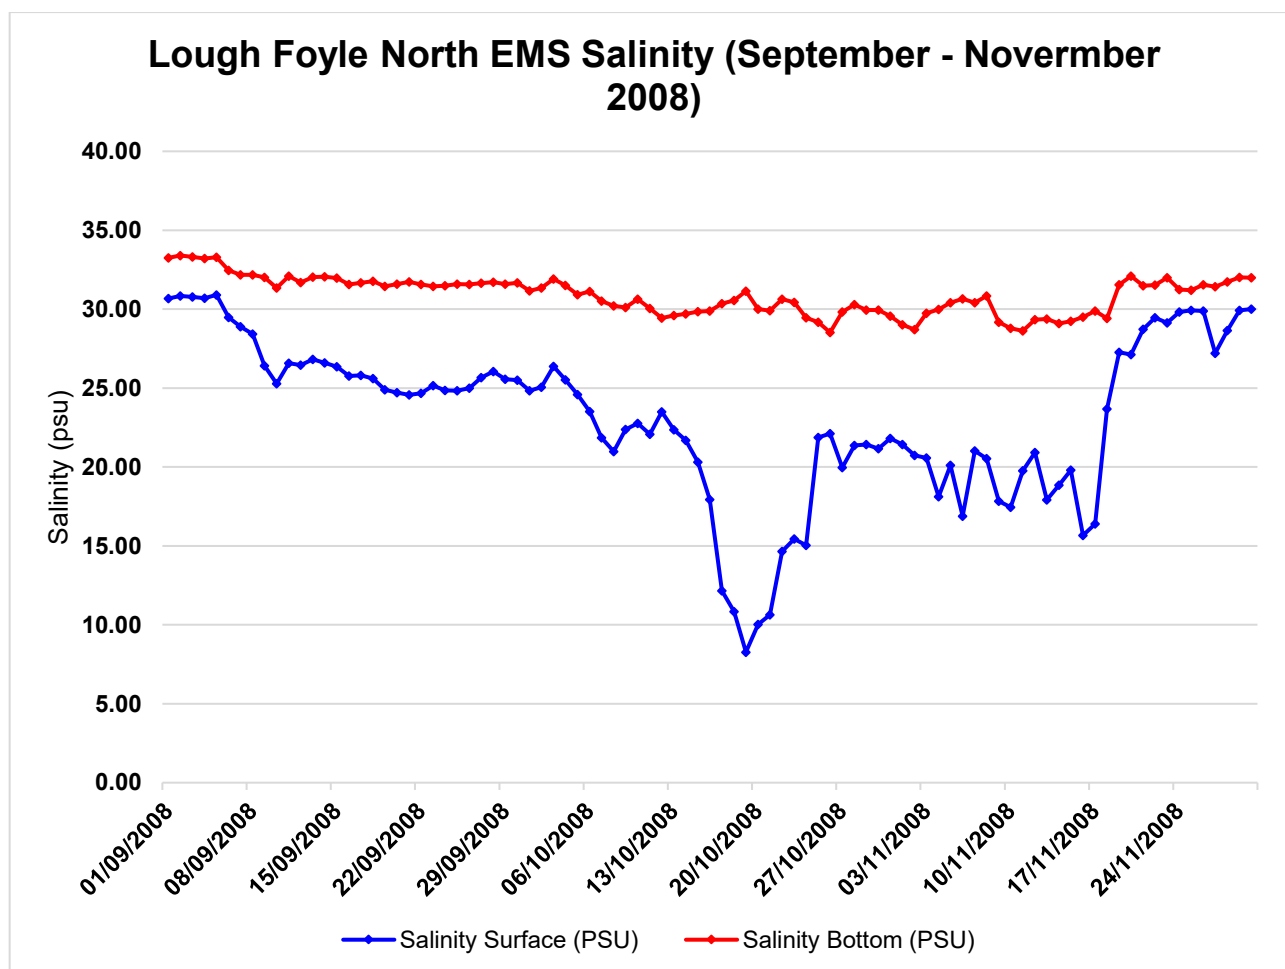
Figure 4-23: Salinity (psu) profile at Lough Foyle North Environmental Monitoring Station (EMS) from September to November 2008 (source: Loughs Agency).

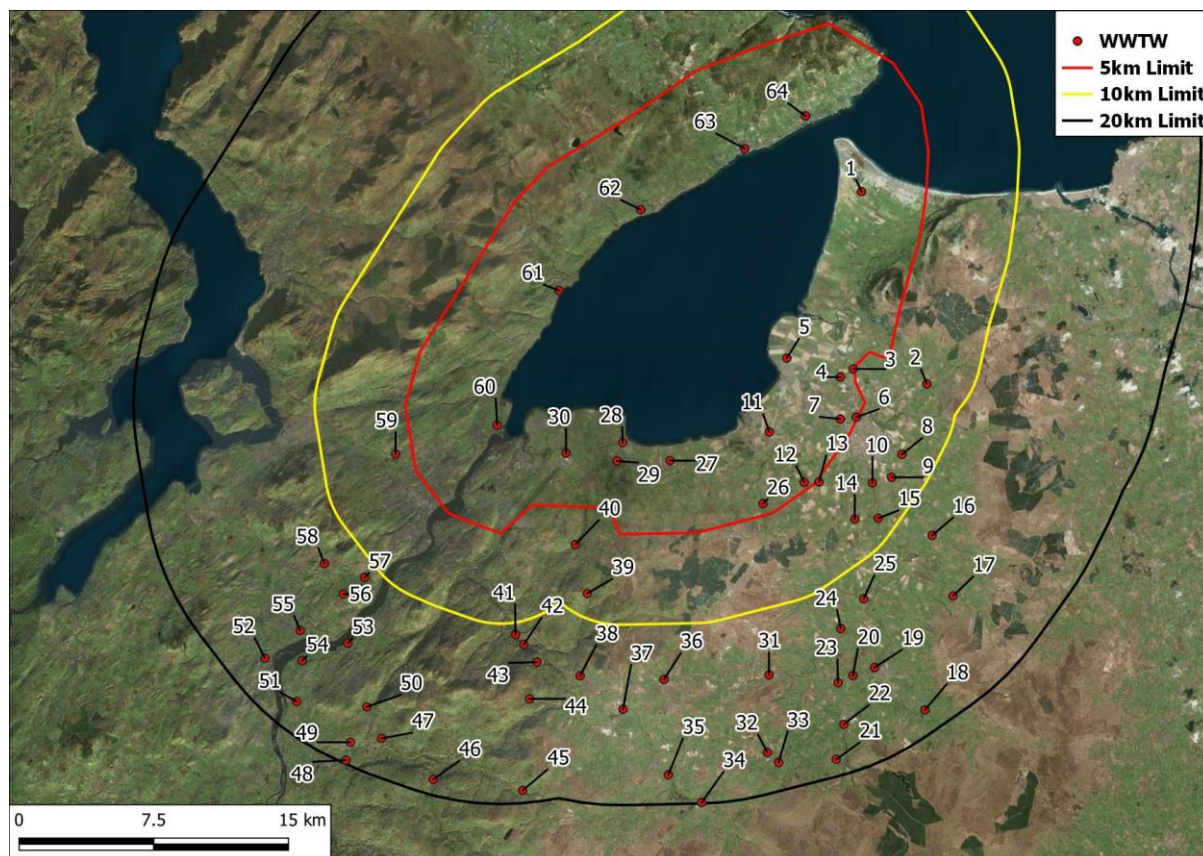
Figure 5-8: WwTW within Lough Foyle contributing catchment (source: Northern Ireland Water and see UWW Plant Locations at [EPA Maps](#)). Map IDs are cross-referenced to Table 5-2.

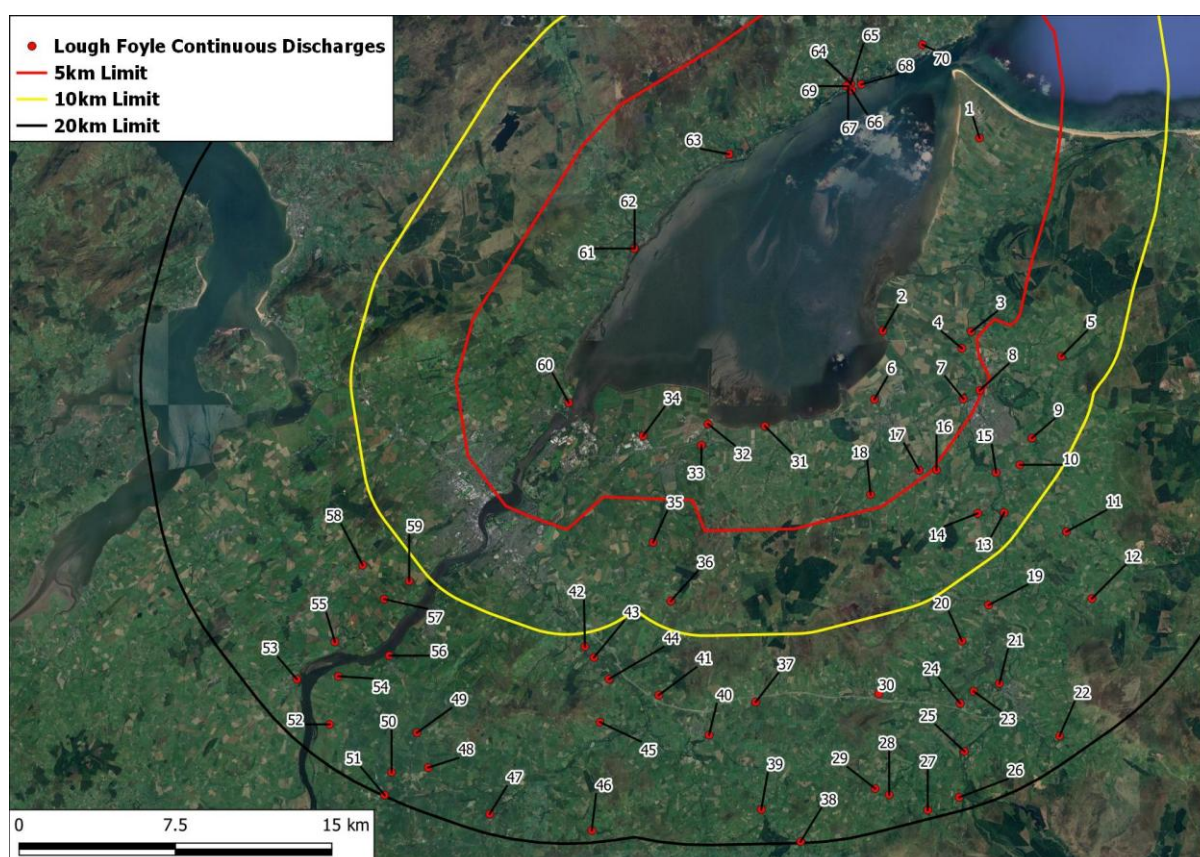
Figure 5-9: Location of continuous sewage discharges within Lough Foyle contributing catchment (source: Northern Ireland Water/[EPA Maps](#)). Map IDs are cross-referenced to Table 5-3.

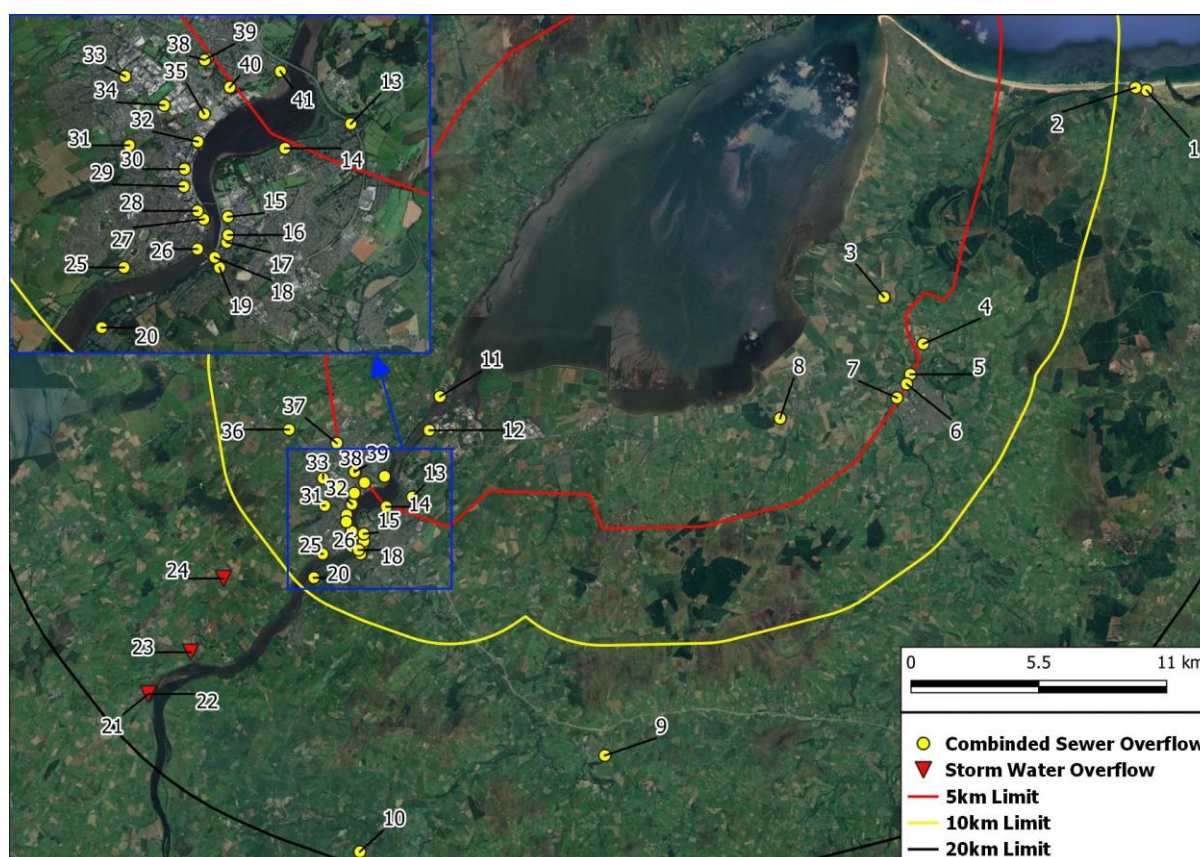
Figure 5-10: All storm water and combined sewer overflow discharges within Lough Foyle contributing catchment (source: Northern Ireland Water/[EPA Maps](#)). Map IDs are cross-referenced to Table 5-4.

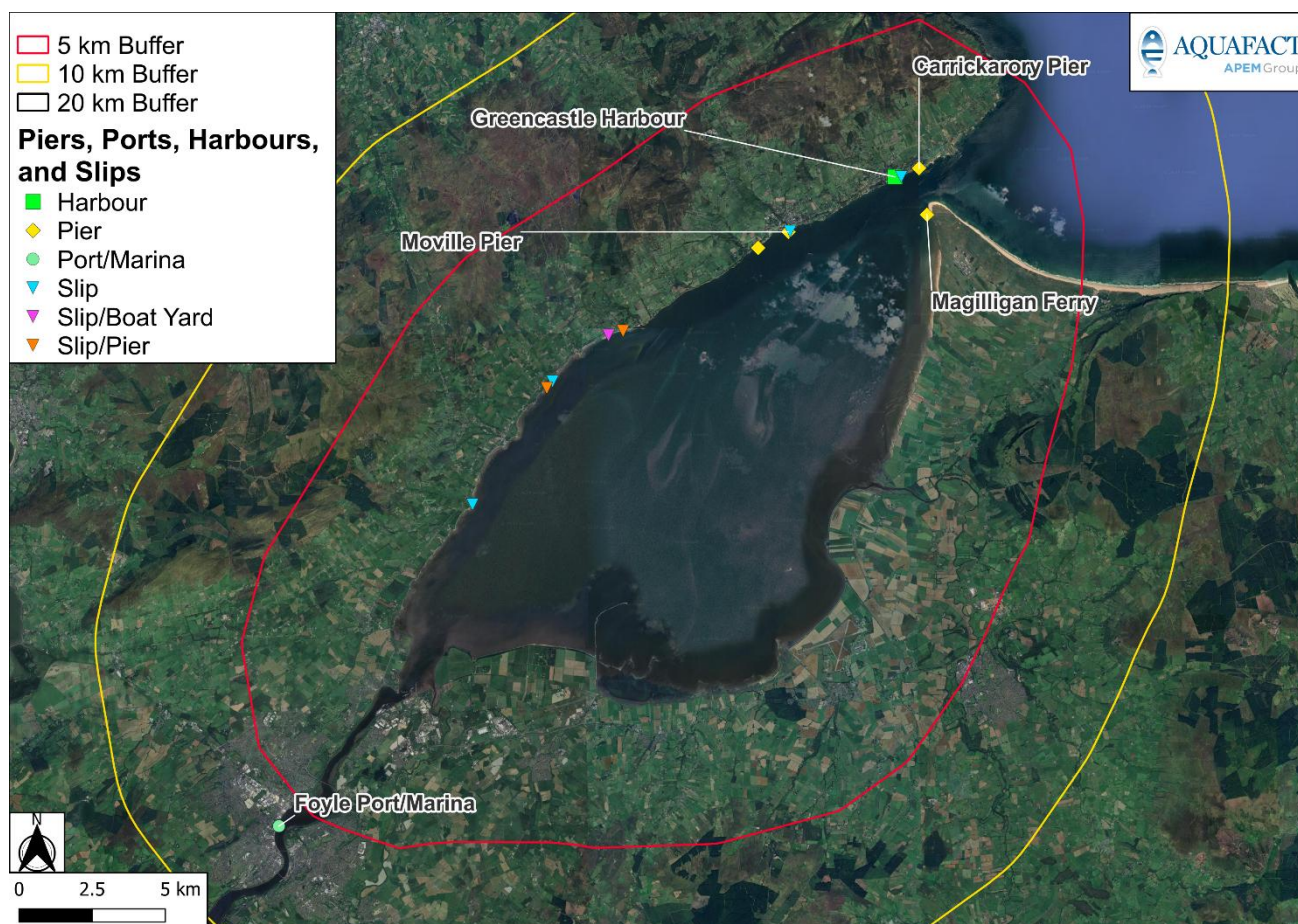
Figure 5-40: Piers, ports, harbours, and slips identified by the 2023 shoreline survey. Magilligan Ferry (pier) and Foyle Port/Marina were not identified during the shoreline survey. Piers/ports/slips/harbours were labelled where available from the desktop or shoreline survey.

Piers, ports, harbours, and slips identified during the sanitary survey review are illustrated in **Figure 5-40**. Foyle Port is a commercial port and represents the largest freight port in the northwest (Marine Institute, 2020). It extends across Lough Foyle from Craigavon Bridge northward to Greencastle and Magilligan Point (Marine Institute, 2020). It encompasses a 400 m berth space with a large capacity for visitor's to berth ([Northern Ireland Marine Map Viewer](#)). The tonnage of goods has increased by 6.8% from 1,760,000 tons in 2020 to 1,889,000 tons in 2022 (NISRA, 2022). A larger increase was observed between 2009 and 2020 of 8% from 1,619,000 tons to 1,760,000 tons (NISRA, 2022). Cargo passing through Foyle Port in 2022 included agricultural products (e.g., grain, soya, tapioca), coal, ores,

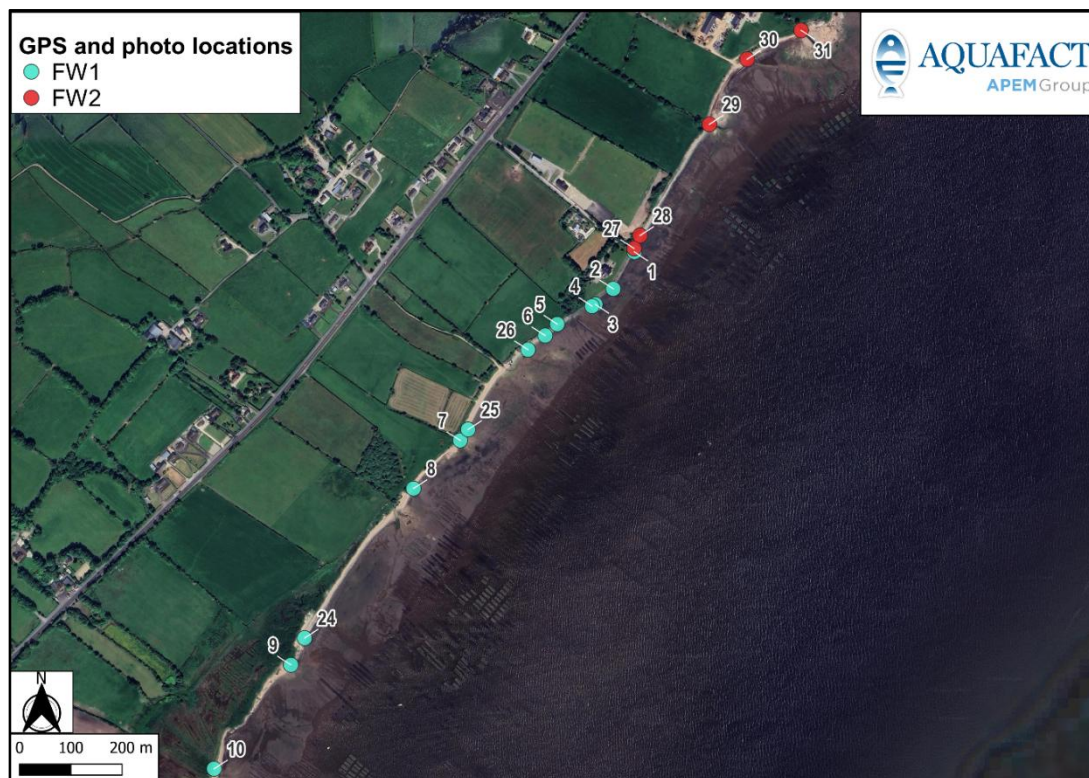
Figure 5-44: GPS and photo locations for features 1 – 10 and 24 – 31 from the Foyle West (FW) 1 transect and Foyle West (FW) 2 transect (see Figure 5-43 for FW1 and FW2 features).

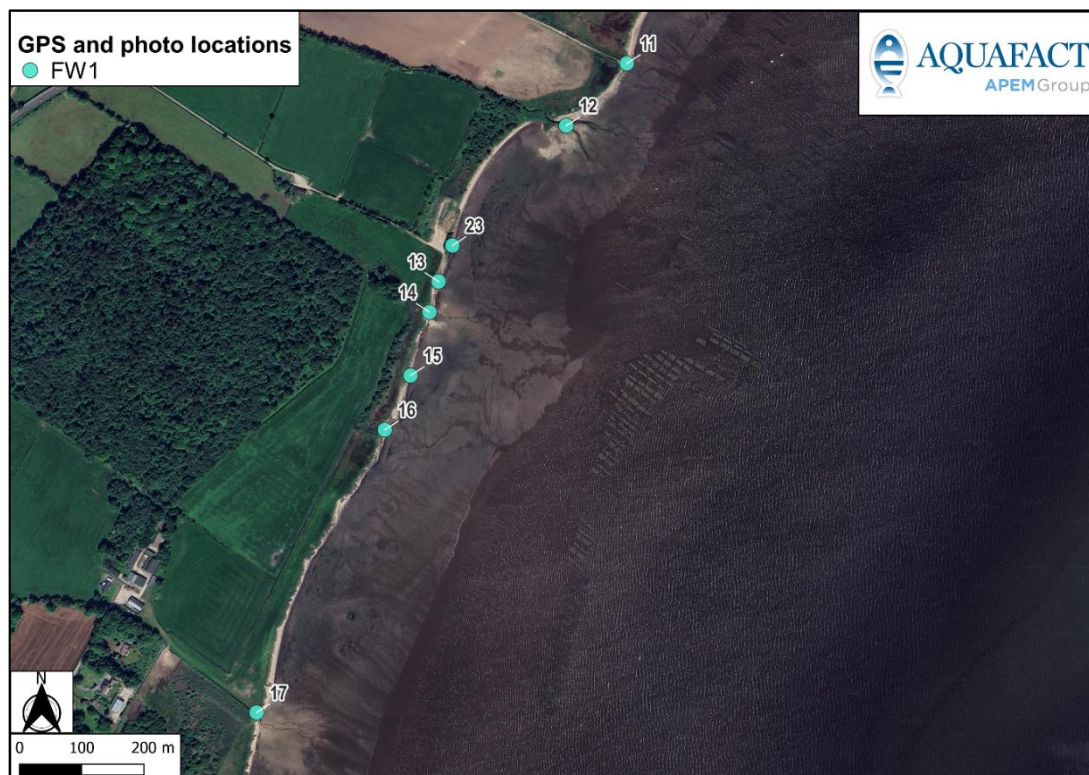
Figure 5-45: GPS and photo locations for features 11-17 and 23 from the Foyle West (FW) 1 transect (see Figure 5-43 for FW1 features).

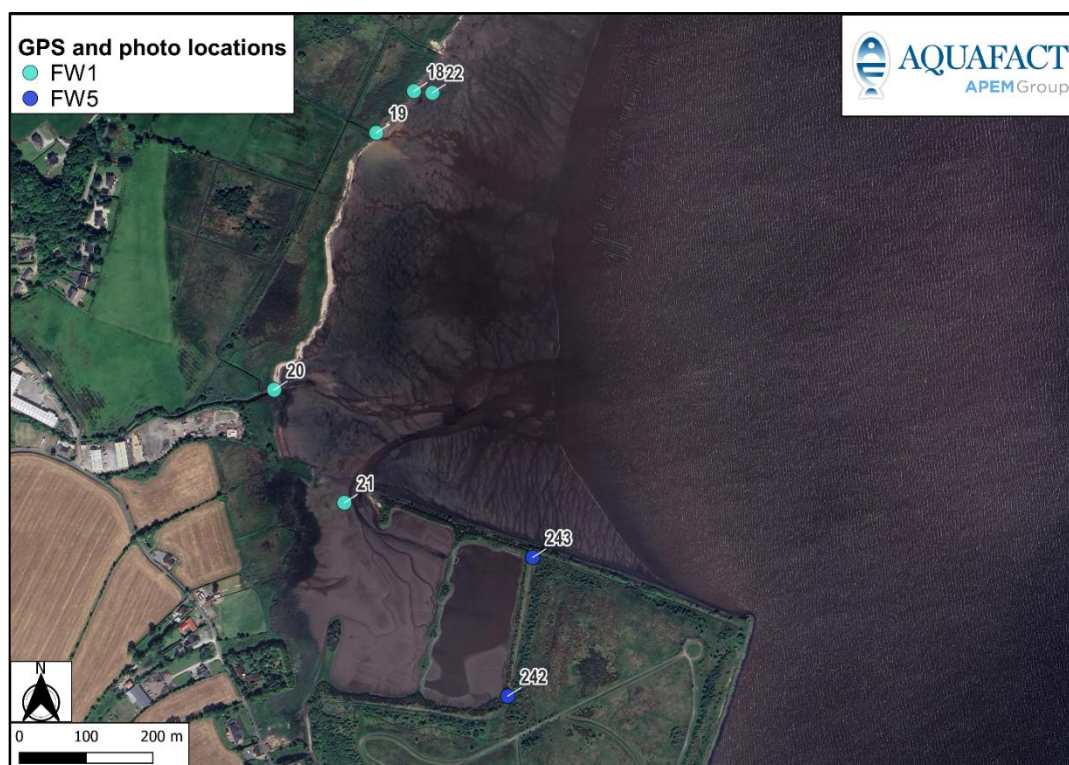
Figure 5-46: GPS and photo locations for features 18-22 and 242 to 243 from the Foyle West (FW) 1 and Foyle West (FW) 5 transect (see Figure 5-43 for FW1 and FW5 features).

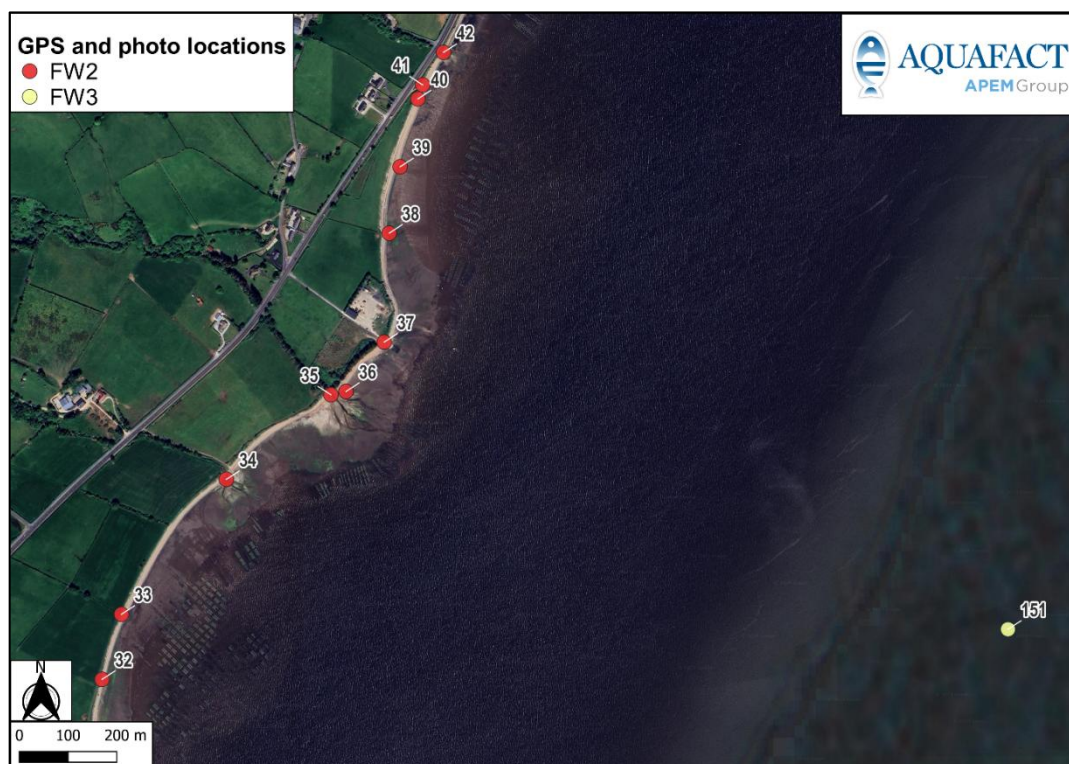
Figure 5-47: GPS and photo locations for features 32-42 and 151 from the Foyle West (FW) 2 transect and Foyle West (FW) 3 transect (see Figure 5-43 for FW2 and FW3 features).

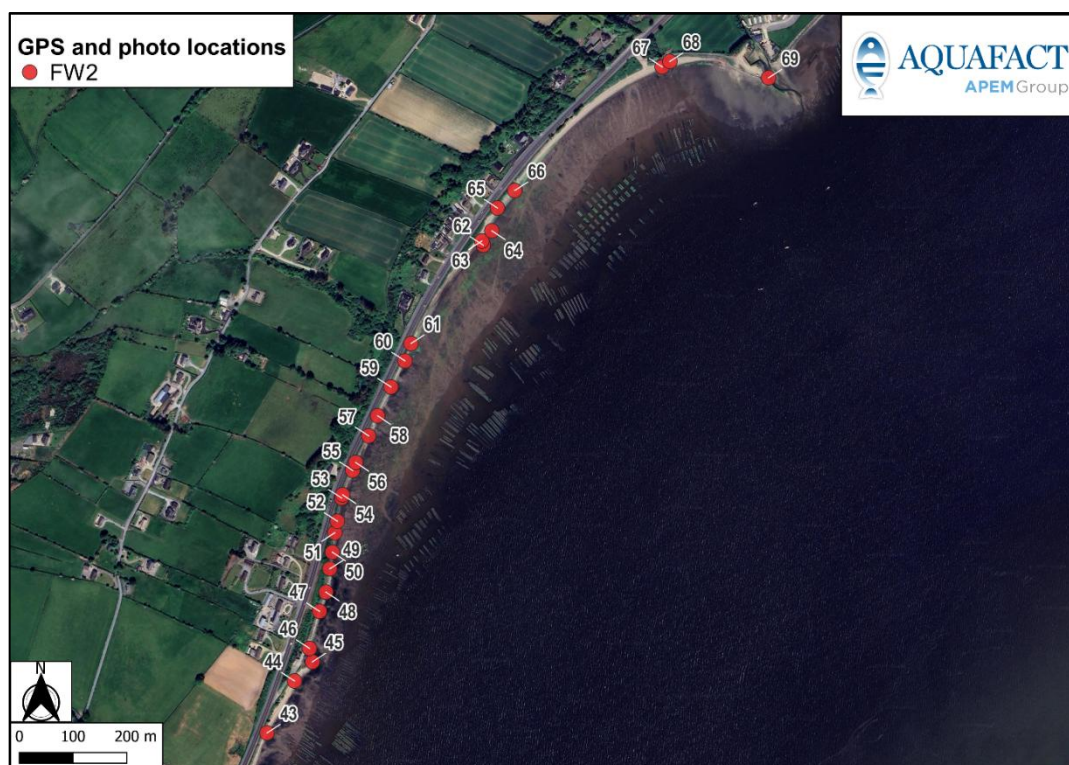
Figure 5-48: GPS and photo locations for features 43-69 from the Foyle West (FW) 2 transect(see Figure 5-43 for FW2 features).

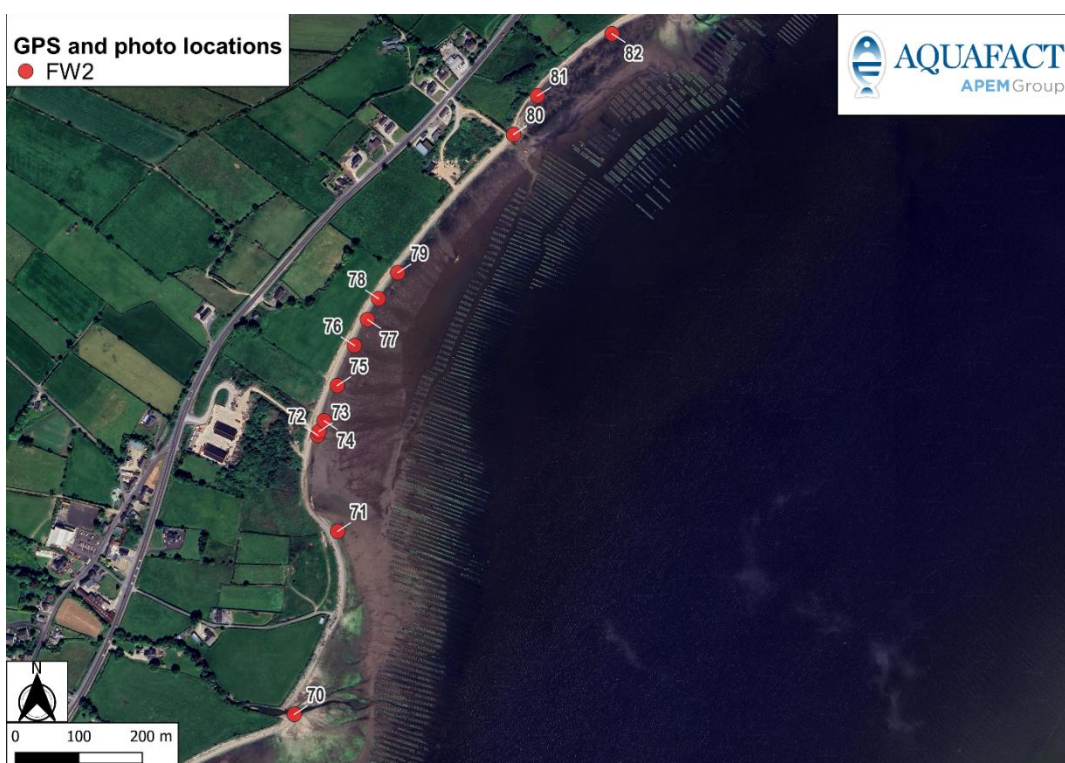
Figure 5-49: GPS and photo locations for features 70-82 from the Foyle West (FW) 2 transect(see Figure 5-43 for FW2 features).

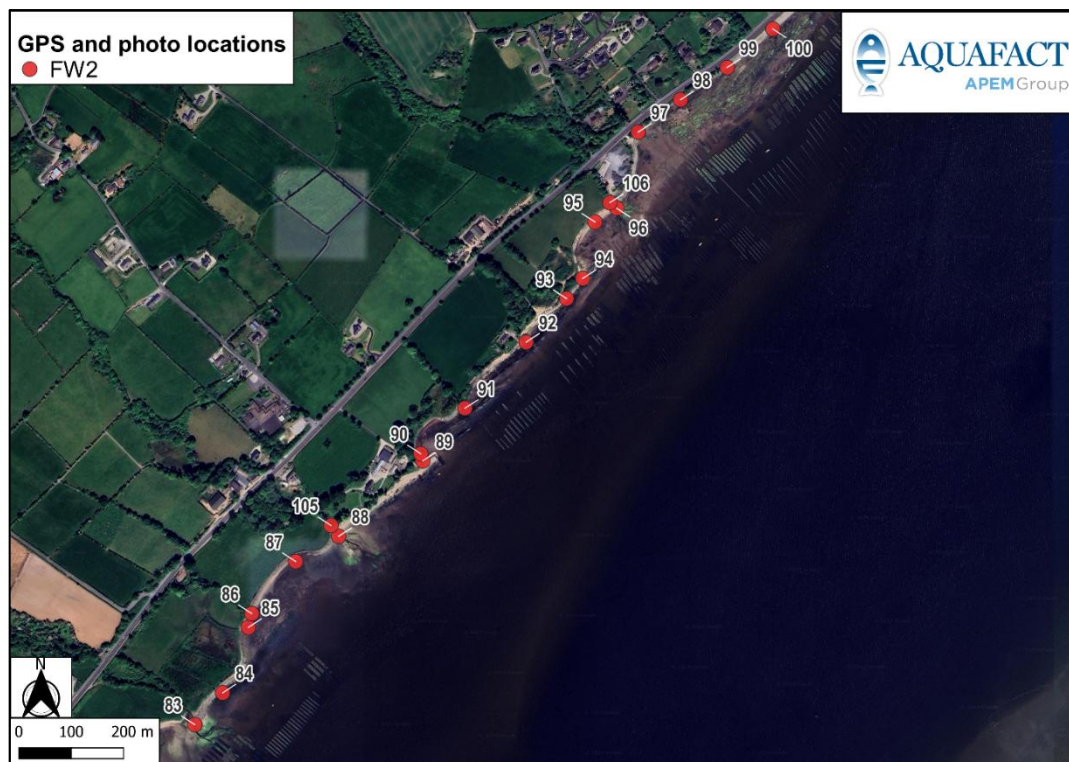
Figure 5-50: GPS and photo locations for features 83-100 and 105-106 from the Foyle West (FW) 2 transect (see Figure 5-43 for FW2 features).

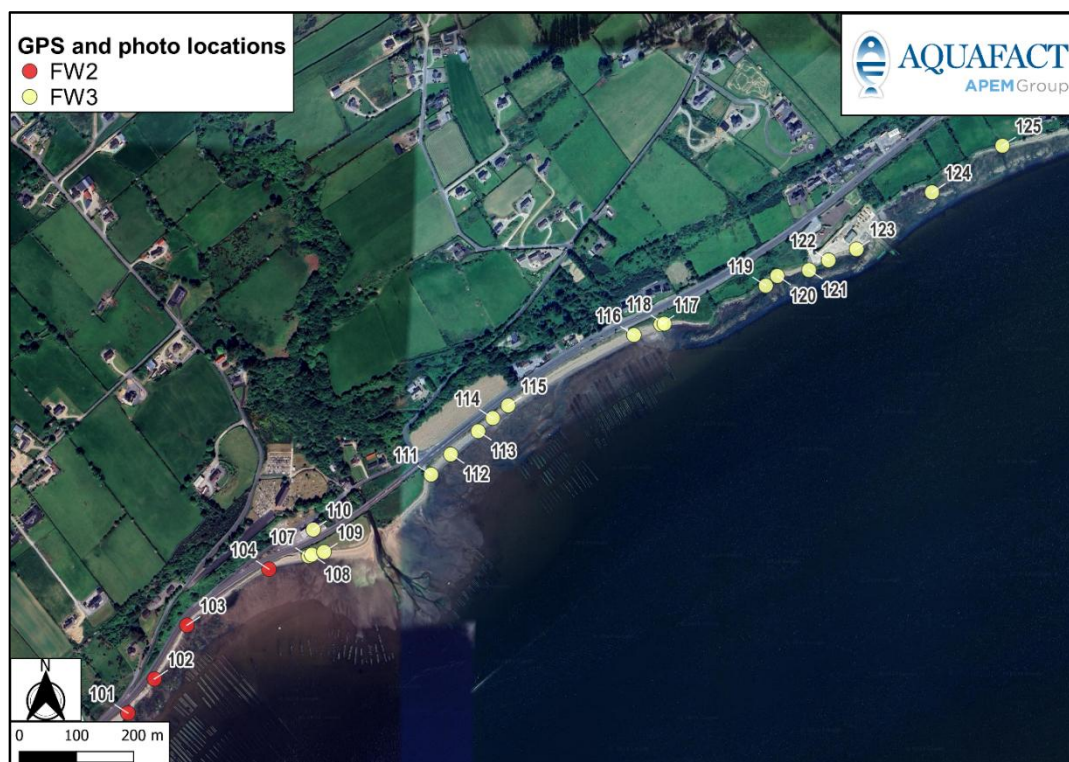
Figure 5-51: GPS and photo locations for features 101-104 and 107-125 from the Foyle West (FW) 2 transect and Foyle West (FW) 3 transect (see Figure 5-43 for FW2 and FW3 features).

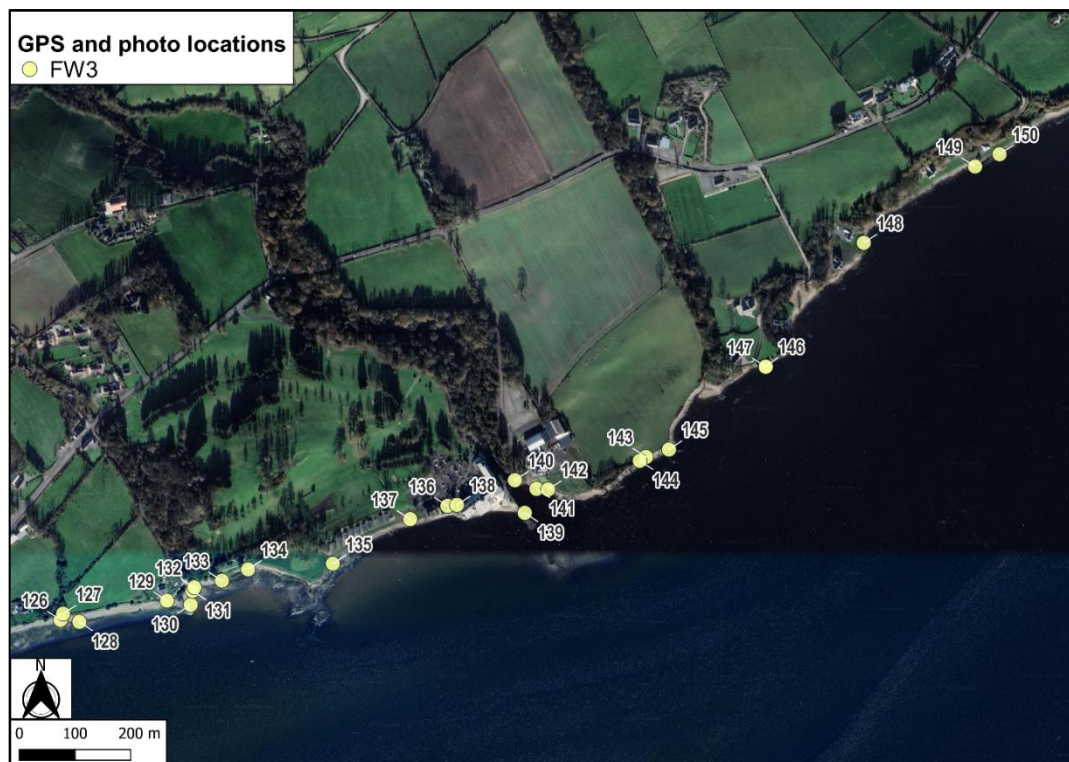
Figure 5-52: GPS and photo locations for features 126-150 from the Foyle West (FW) 3 transect (see Figure 5-43 for FW3 features).

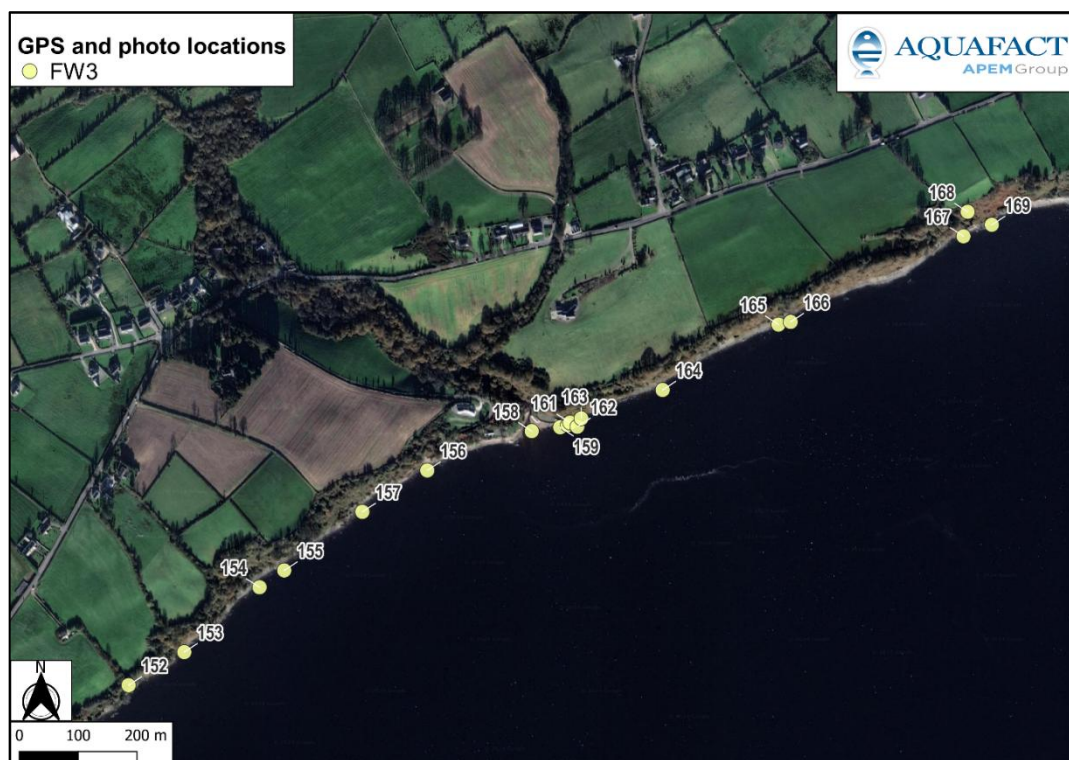
Figure 5-53: GPS and photo locations for features 152-159 and 161-169 from the Foyle West (FW) 3 transect (see Figure 5-43 for FW3 features).

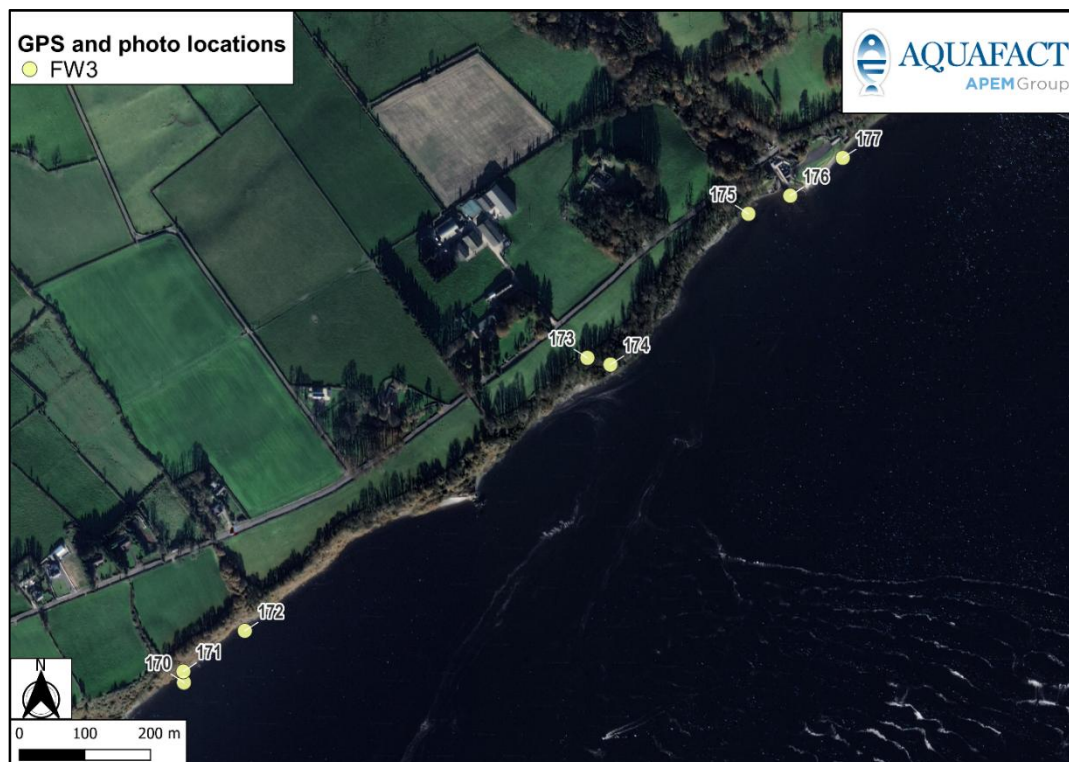
Figure 5-54: GPS and photo locations for features 170-177 from the Foyle West (FW) 3 transect (see Figure 5-43 for FW3 features).
