Food Standards Agency in Northern Ireland

Sanitary Survey Review and Sampling Plan for Lough Foyle

AQUAFACT Ref: PM0412290

August 2025

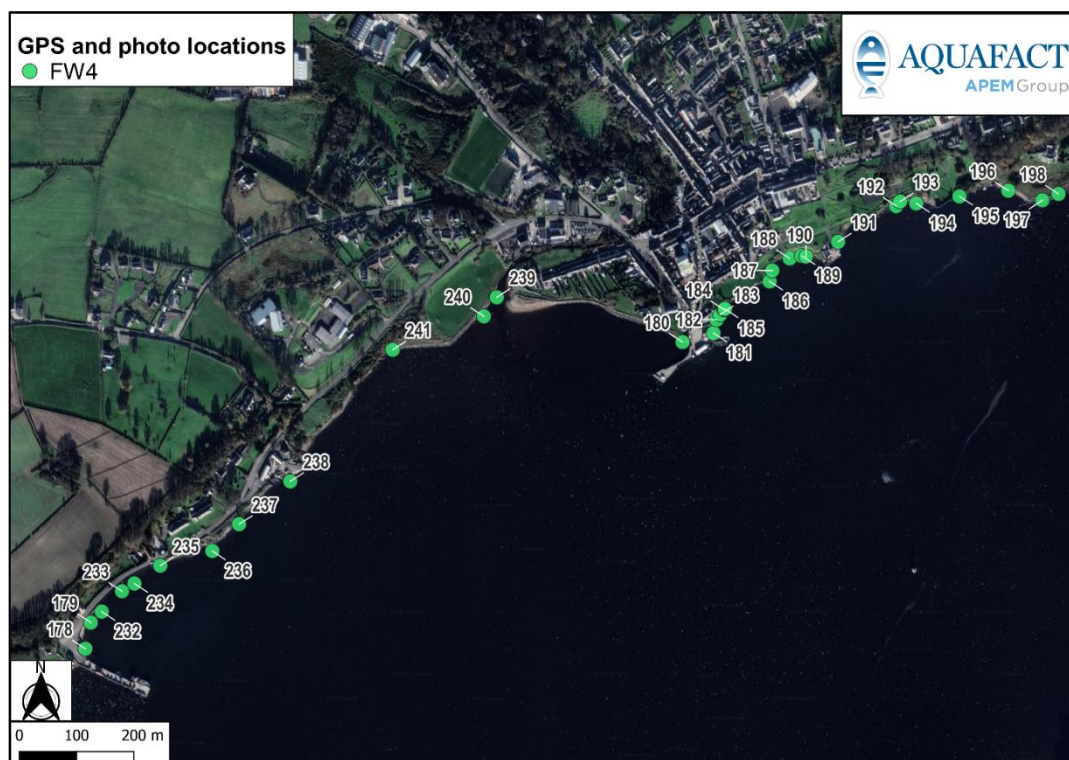
Figure 5-55: GPS and photo locations for features 178-198 and 232-241 from the Foyle West (FW) 4 transect (see Figure 5-43 for FW4 features).

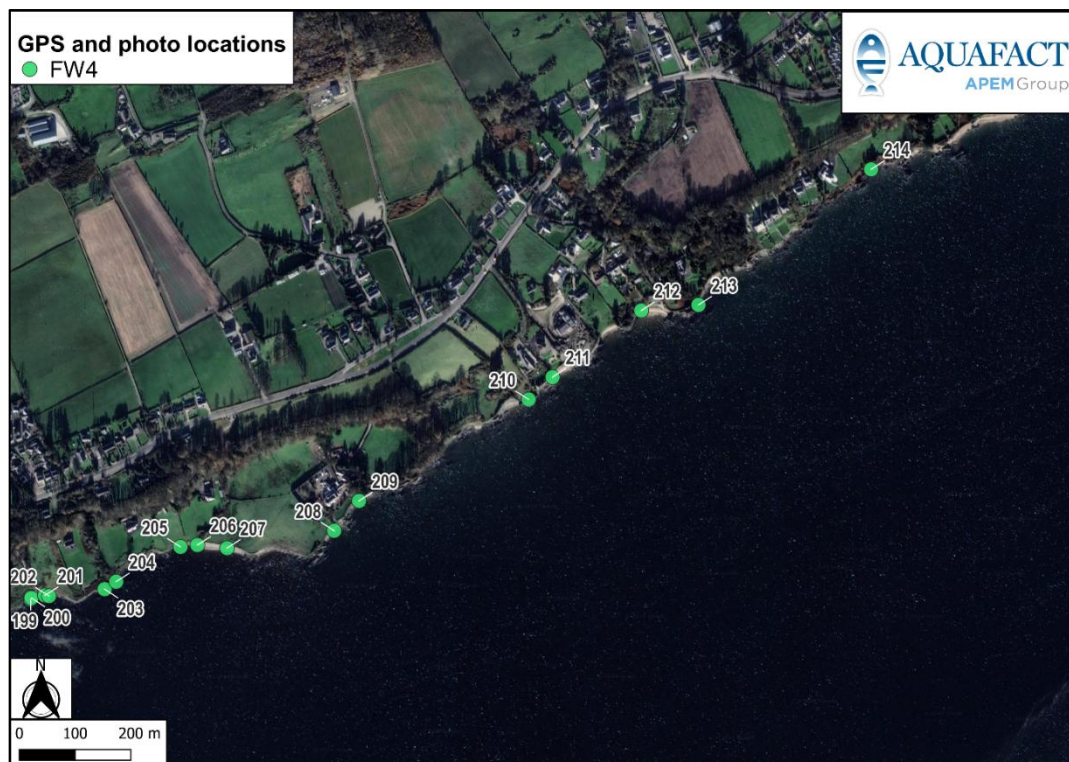
Figure 5-56: GPS and photo locations for features 199-214 from the Foyle West (FW) 4 transect (see Figure 5-43 for FW4 features).

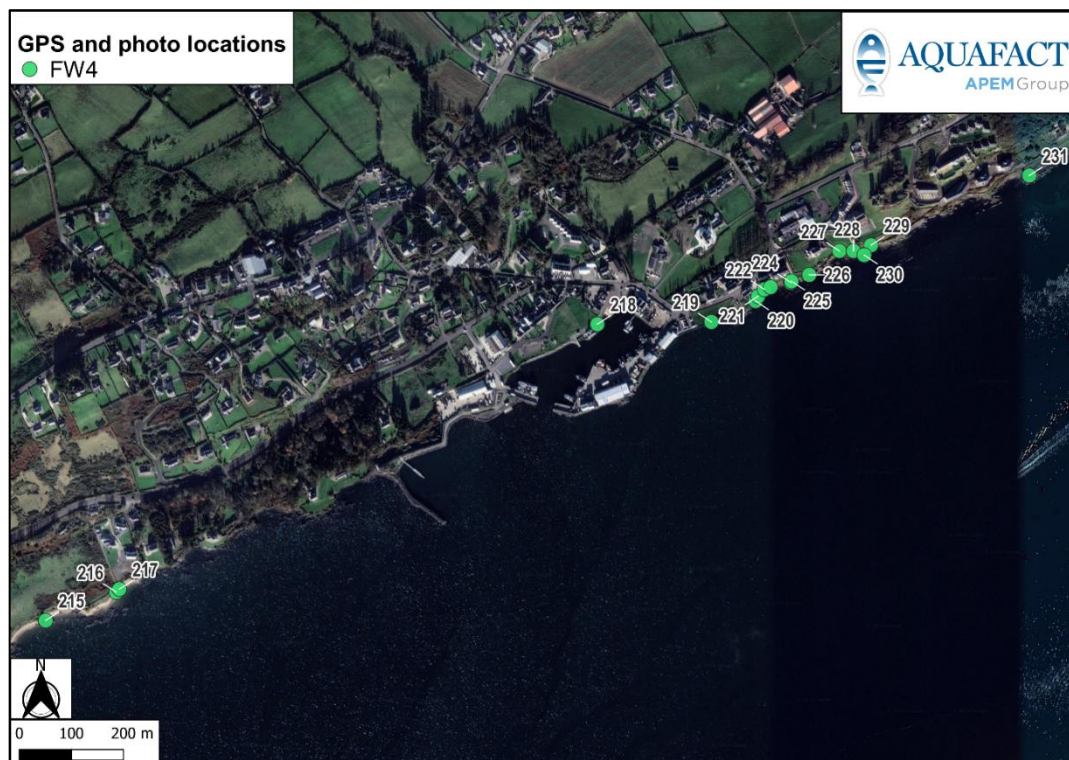
Figure 5-57: GPS and photo locations for features 215-222 and 224-231 from the Foyle West (FW) 4 transect (see Figure 5-43 for FW4 features).

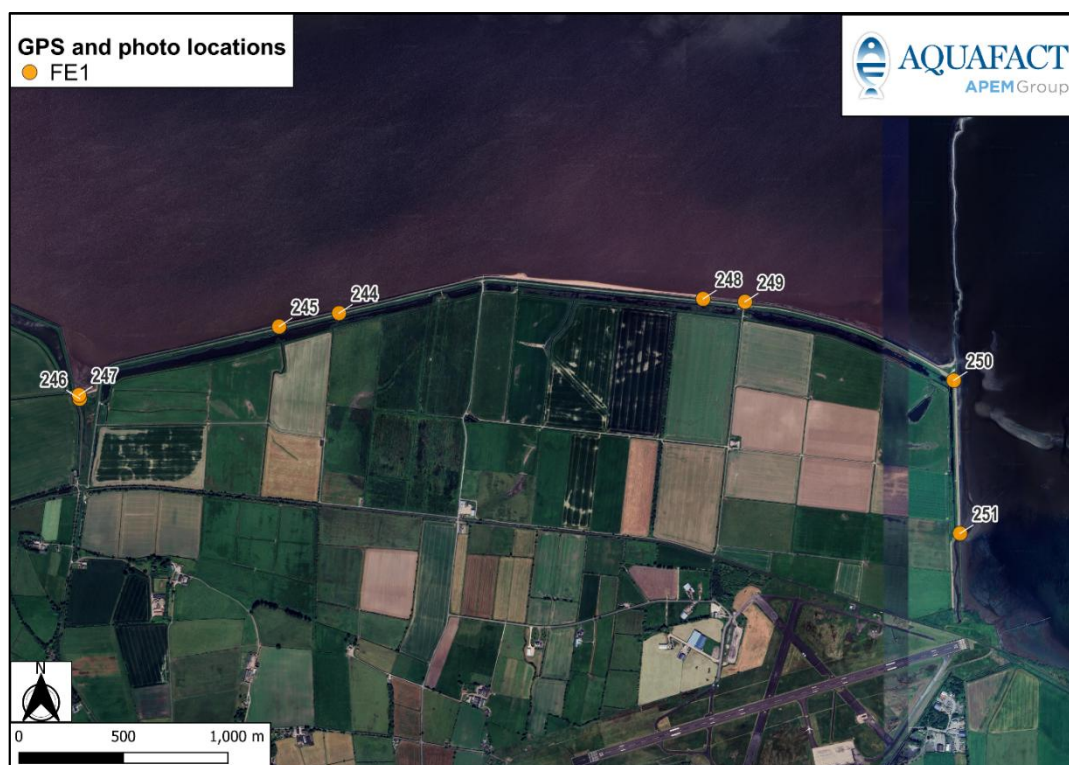
Figure 5-58: GPS and photo locations for features 244-251 from the Foyle East (FE) 1 transect (see Figure 5-43 for FE1 features).

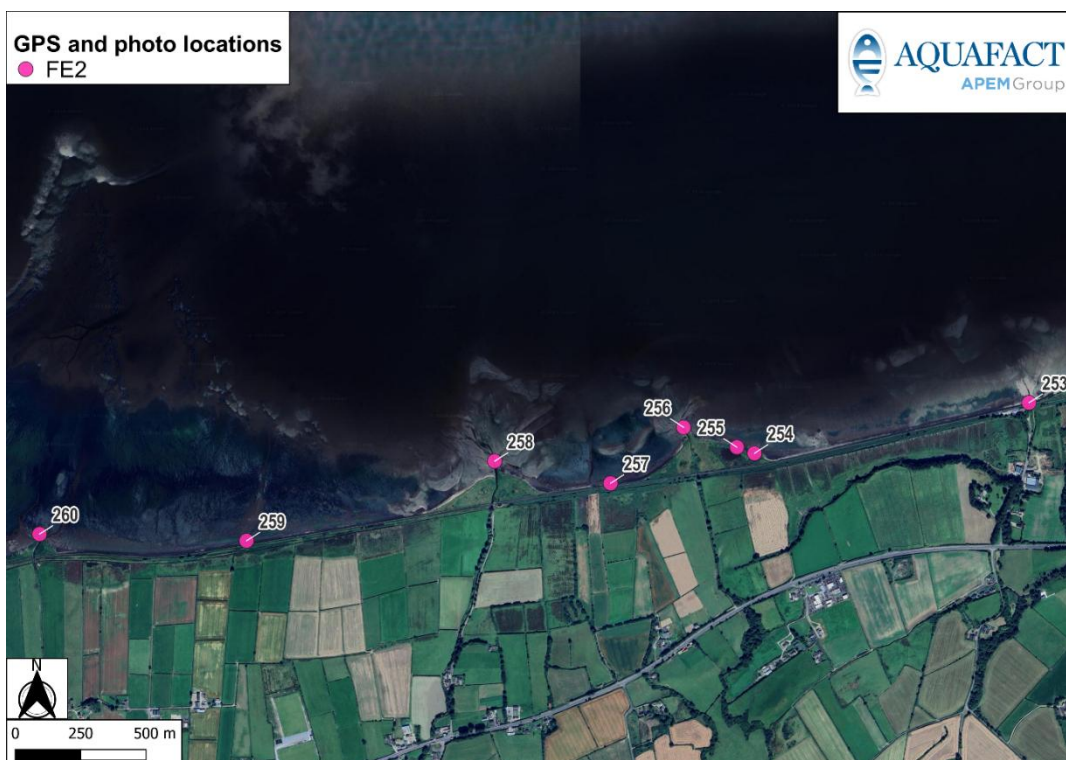
Figure 5-59: GPS and photo locations for features 253-260 from the Foyle East (FE) 2 transect (see Figure 5-43 for FE2 features).

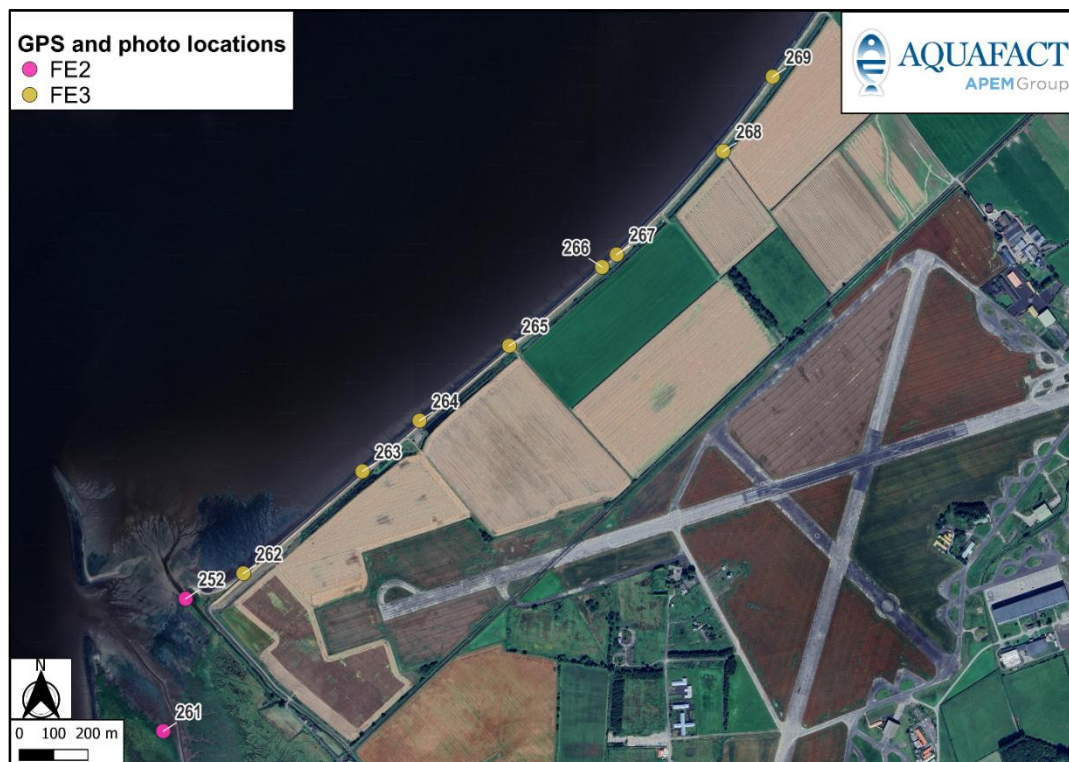
Figure 5-60: GPS and photo locations for features 252 and 261-269 from the Foyle East (FE) 2 transect and Foyle East (FE) 3 transect (see Figure 5-43 for FE2 and FE3 features).

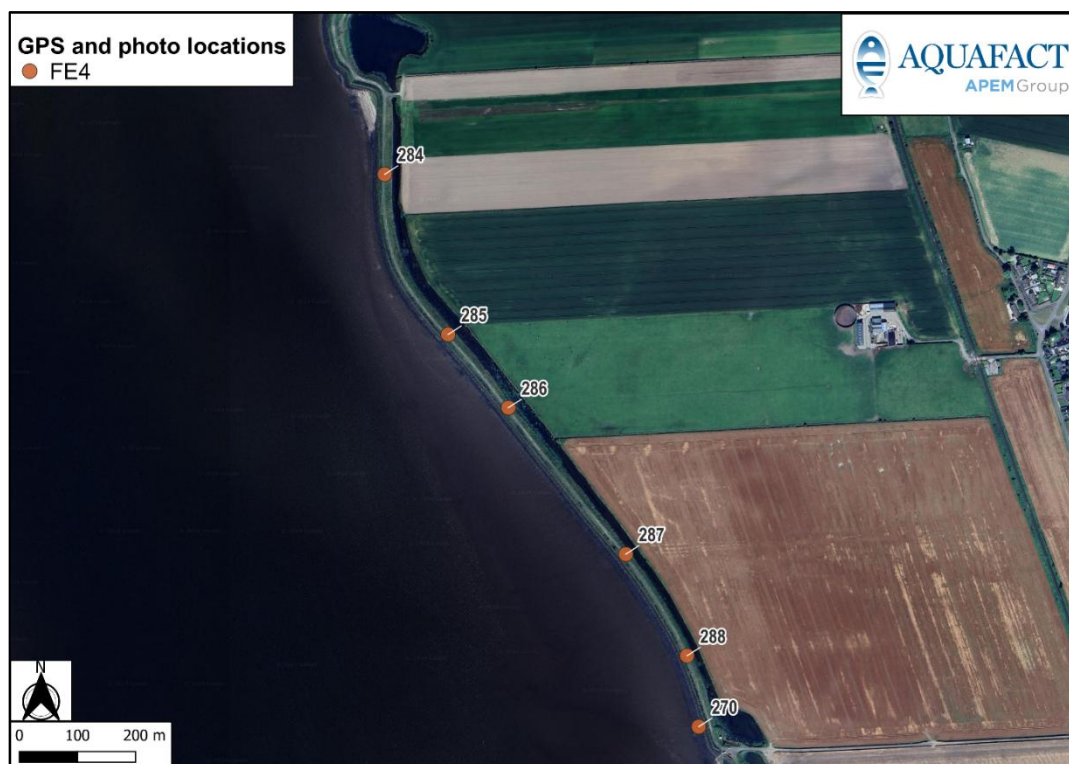
Figure 5-61: GPS and photo locations for features 270, and 284-288 from the Foyle East (FE) 4 transect (see Figure 5-43 for FE4 features).

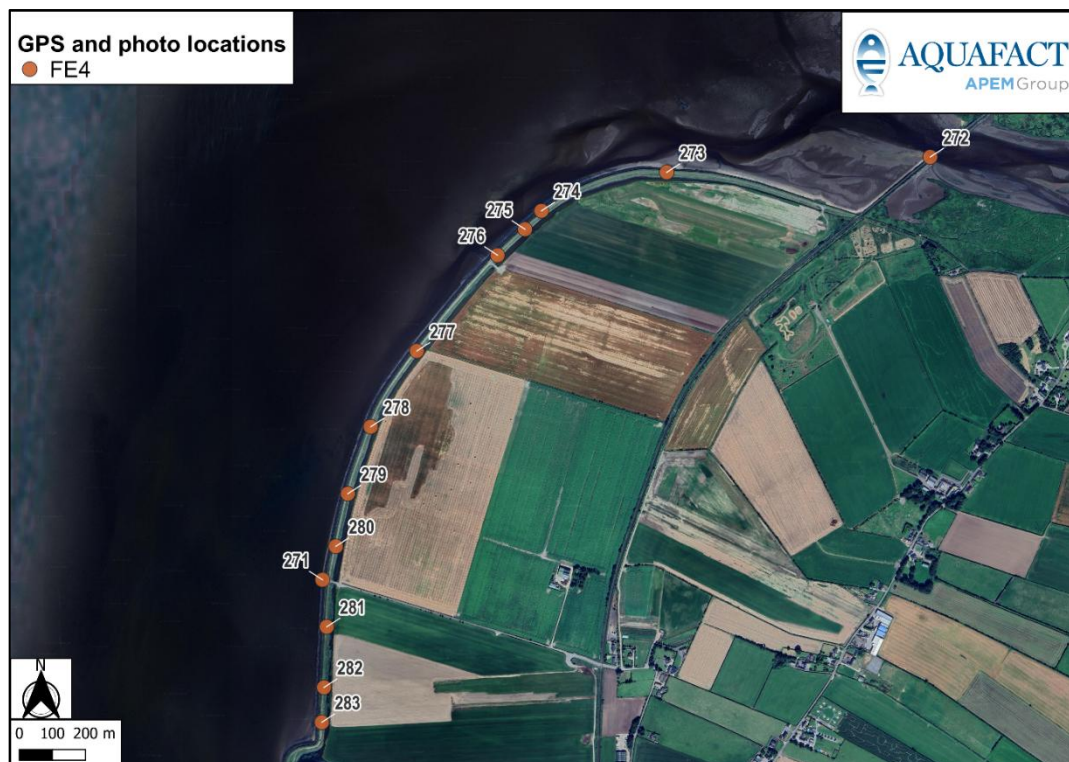
Figure 5-62: GPS and photo locations for features 271-283 from the Foyle East (FE) 4 transect (see Figure 5-43 for FE4 features).

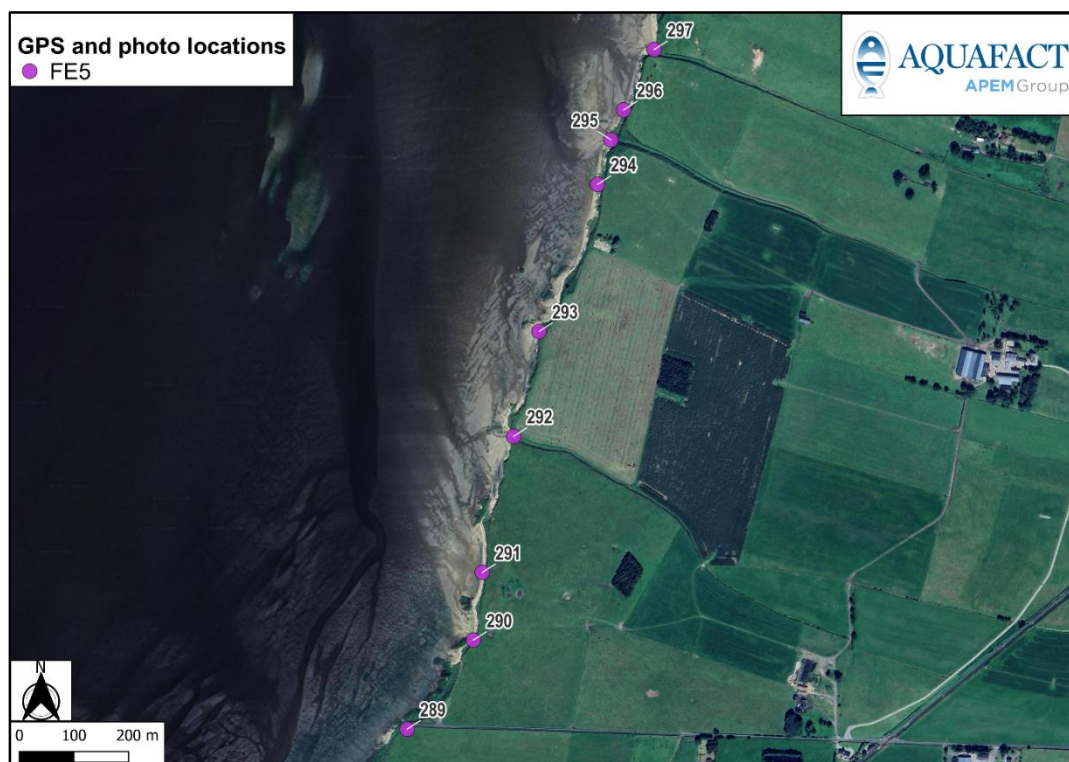
Figure 5-63: GPS and photo locations for features 289-297 from the Foyle East (FE) 5 transect (see Figure 5-43 for FE5 features).

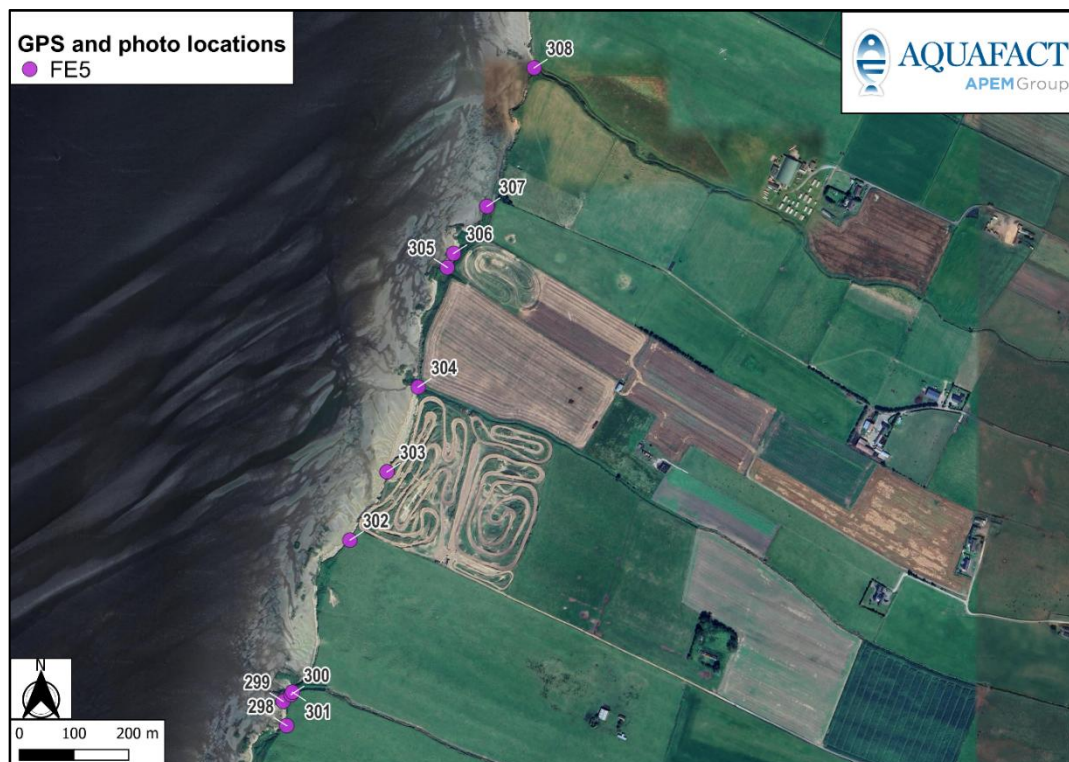
Figure 5-64:GPS and photo locations for features 298-308 from the Foyle East (FE) 5 transect (see Figure 5-43 for FE5 features).

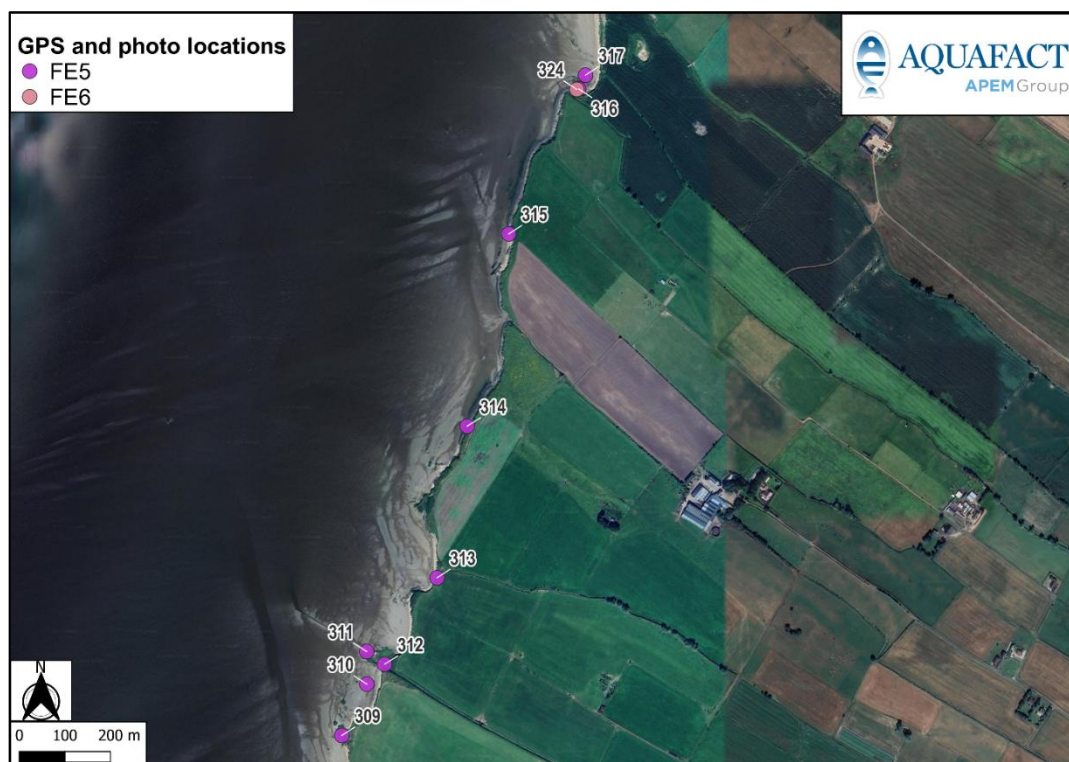
Figure 5-65:GPS and photo locations for features 309-317 and 324 from the Foyle East (FE) 5 transect and Foyle East (FE) 6 transect (see Figure 5-43 for FE5 and FE6 features).

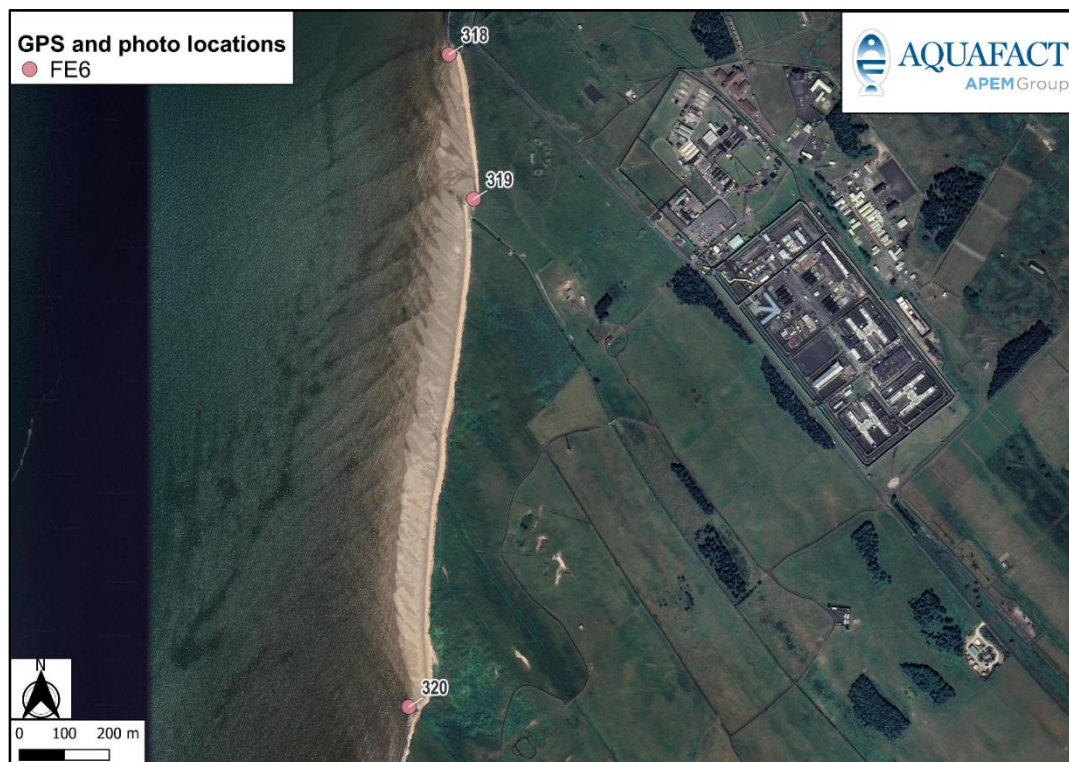
Figure 5-66: GPS and photo locations for features 318-320 from the Foyle East (FE) 6 transect (see Figure 5-43 for FE6 features).

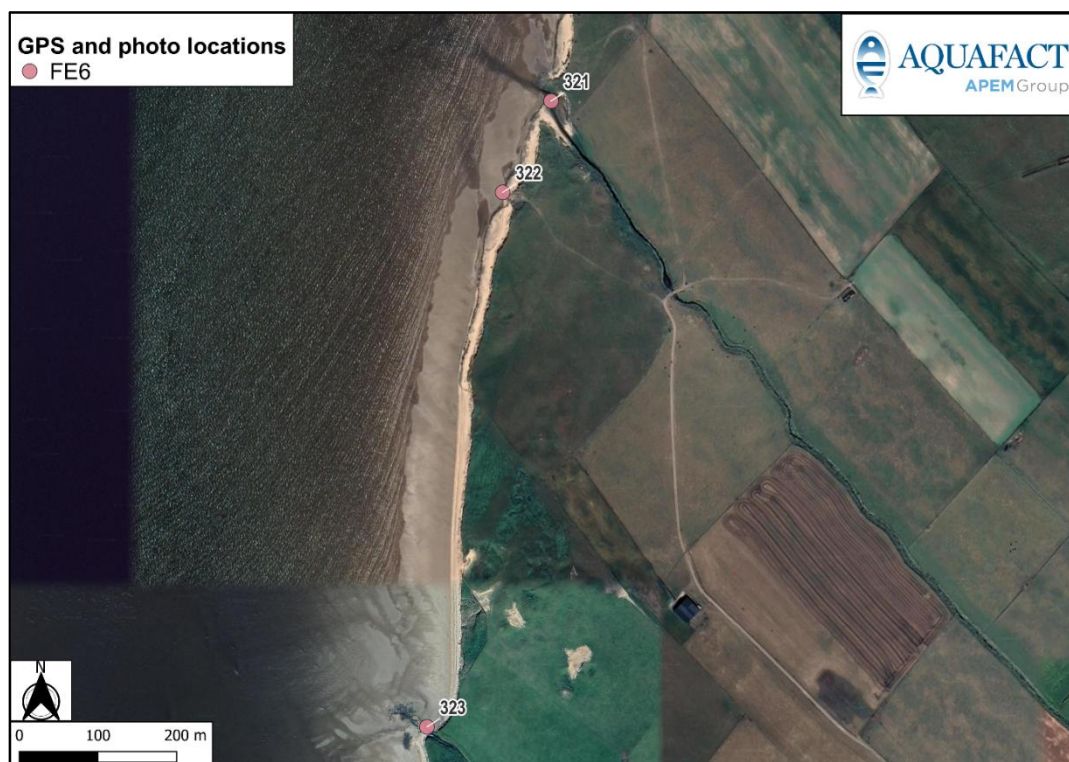
Figure 5-67: GPS and photo locations for features 321-323 from the Foyle East (FE) 6 transect (see Figure 5-43 for FE6 features).

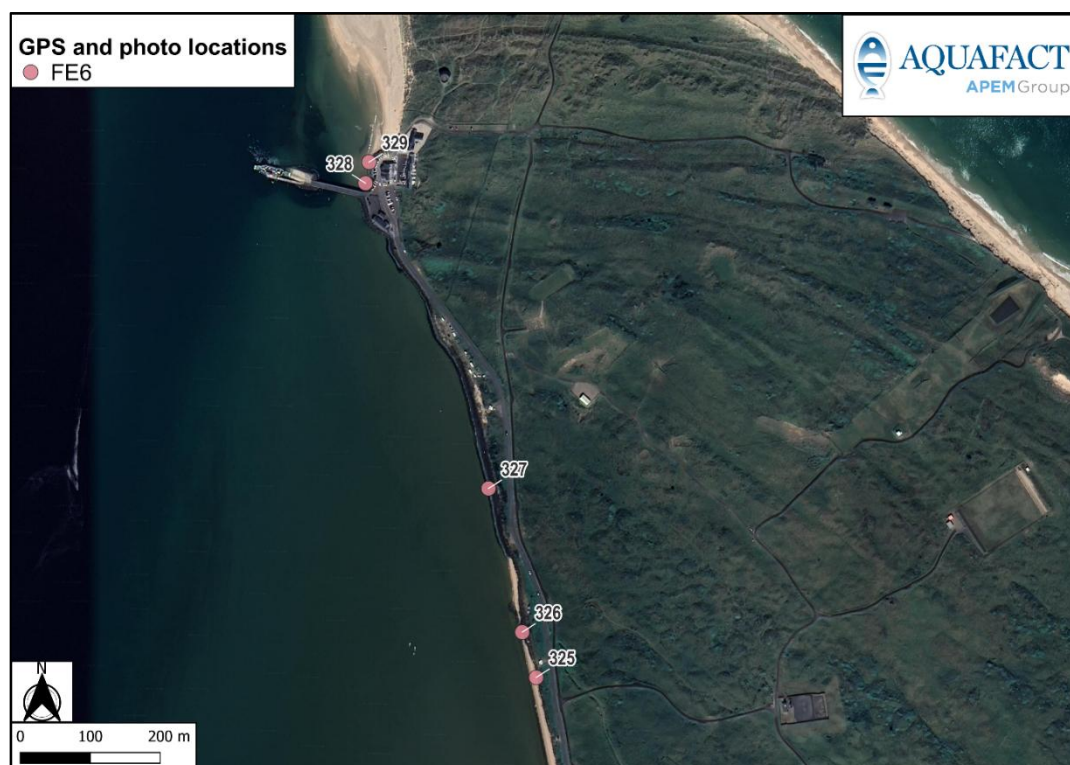
Figure 5-68: GPS and photo locations for features 325-329 from the Foyle East (FE) 6 transect (see Figure 5-43 for FE6 features).

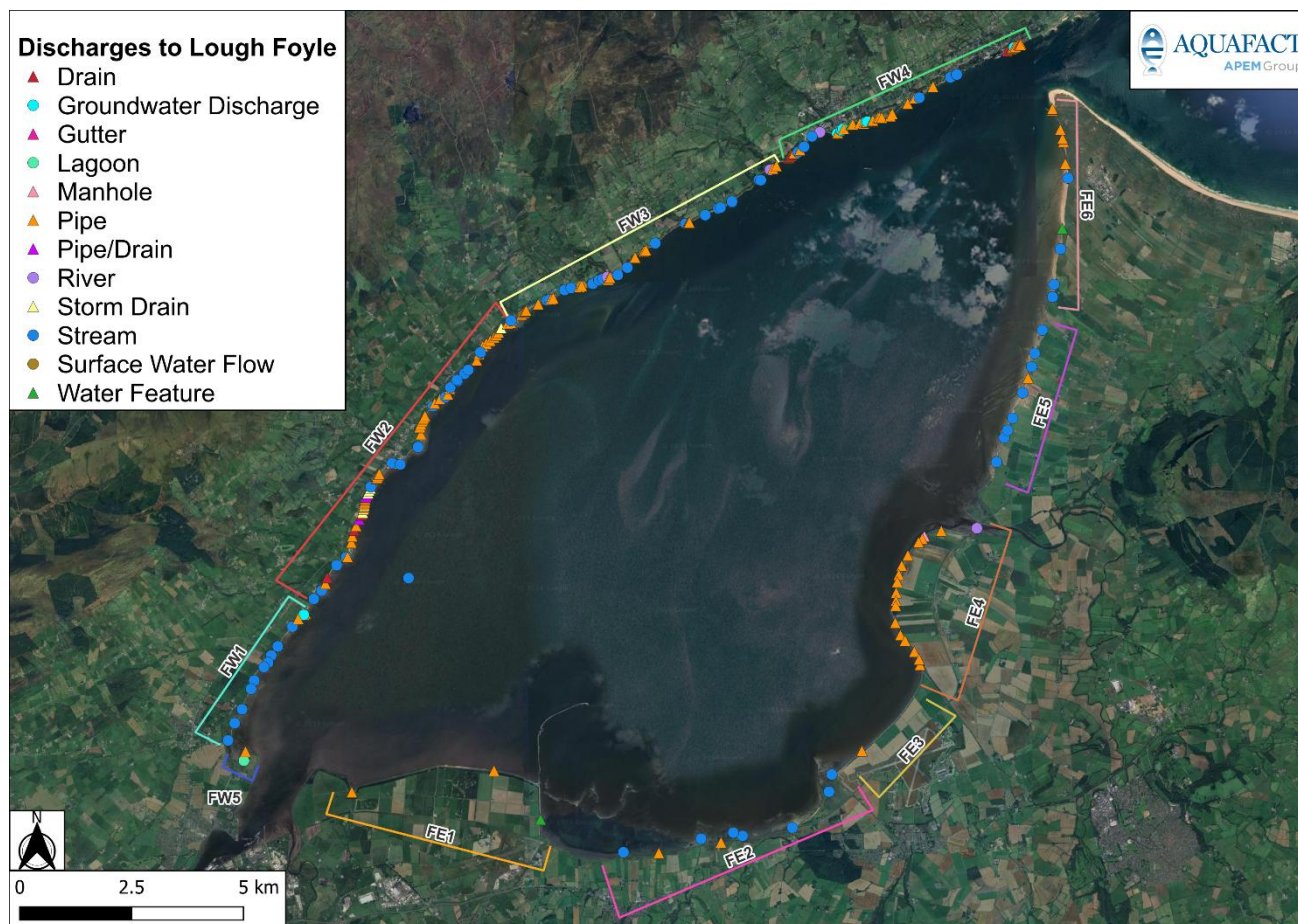
Figure 5-70: Location of all discharges into Lough Foyle. Foyle East (FE) transects 1-6 and Foyle West (FW) transects 1-5 as defined by the 2023 shoreline survey (see Figure 5-43 for FW and FE features).

Of the 329 features identified by the 2023 shoreline survey, 241 were discharges. **Figure 5-70** shows all discharges into Lough Foyle contributing catchment and **Table 5-13** provides cross-referenced details for industrial discharges, drains, pipes, rivers, and stream discharges. These were five drains, eight groundwater discharges, one gutter, one wall of drainage pipes, one lagoon, one manhole, 127 pipes, the beginning and end of a pipe wall, three rivers, seven storm drains, 74 streams, one stream/pond, one surface water flow, one water course, one water pool, and one well.

Figure 5-69 shows all rivers/streams that discharge into Lough Foyle. **Figure 5-70** shows all discharges into Lough Foyle contributing catchment and **Table 5-13** provides cross-referenced details for industrial discharges, drains, pipes, rivers, and stream discharges observed during the 2023 shoreline survey.

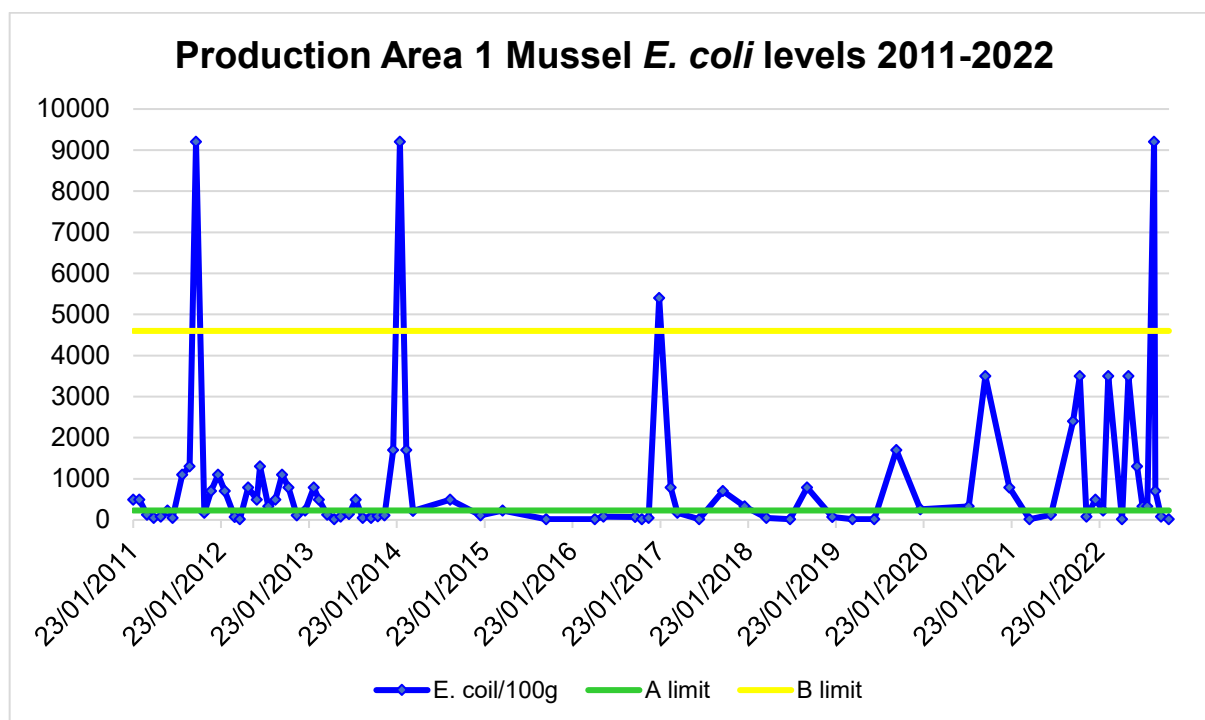
Figure 6-9: *Escherichia coli* levels from mussels at M1 from 2011 to July 2022 (source: SFPA).

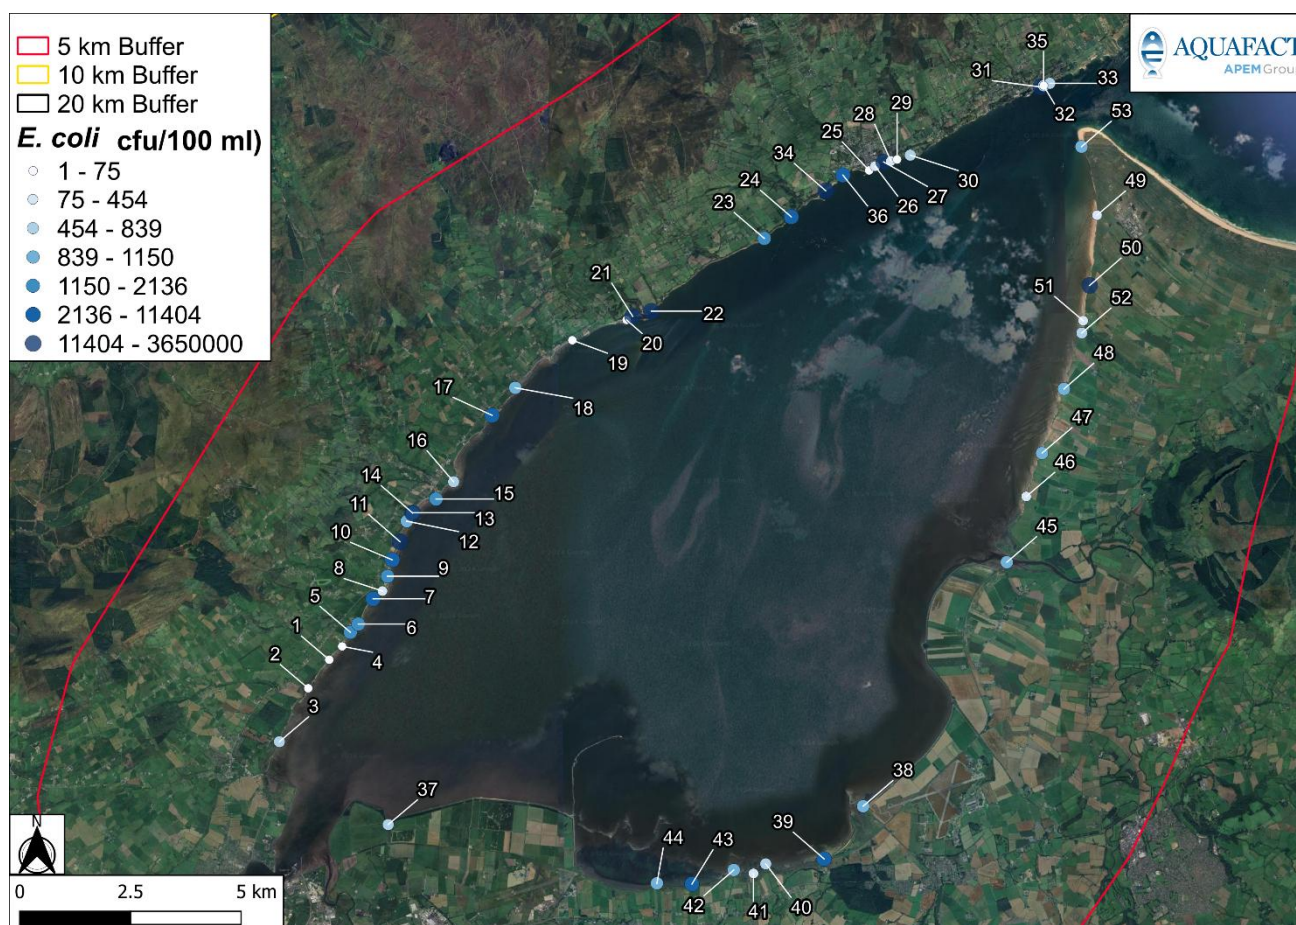
Figure 6-17: Location and magnitude of *Escherichia coli* (*E. coli*) results from the water samples taken during the 2023 shoreline survey (numbering cross-referenced to Table 6-6).

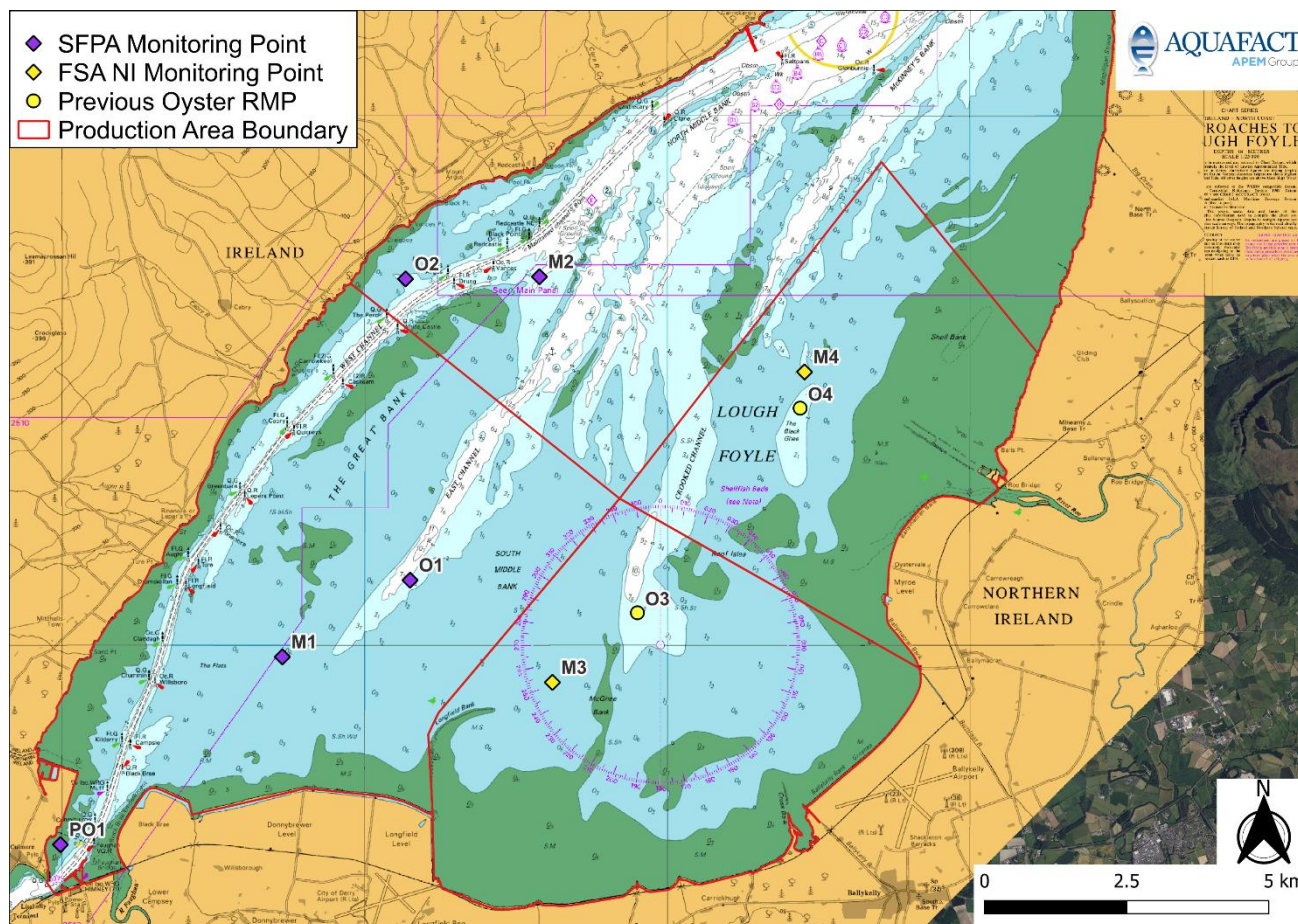
Figure 9-1: Locations of FSA and SFPA representative monitoring points (RMPs) and production areas. See Table 9-1 for Lough Foyle RMP coordinates. Monitoring points O3 and O4 are no longer monitored, instead mussels from the M3 and M4 are used as a proxy to represent oysters in these fisheries.
