Sanitary Survey - Review

Lyme Bay - 2024

| Document Title | Sanitary Survey Review of Lyme Bay |
| Document Number | J0591/22/12/14 |

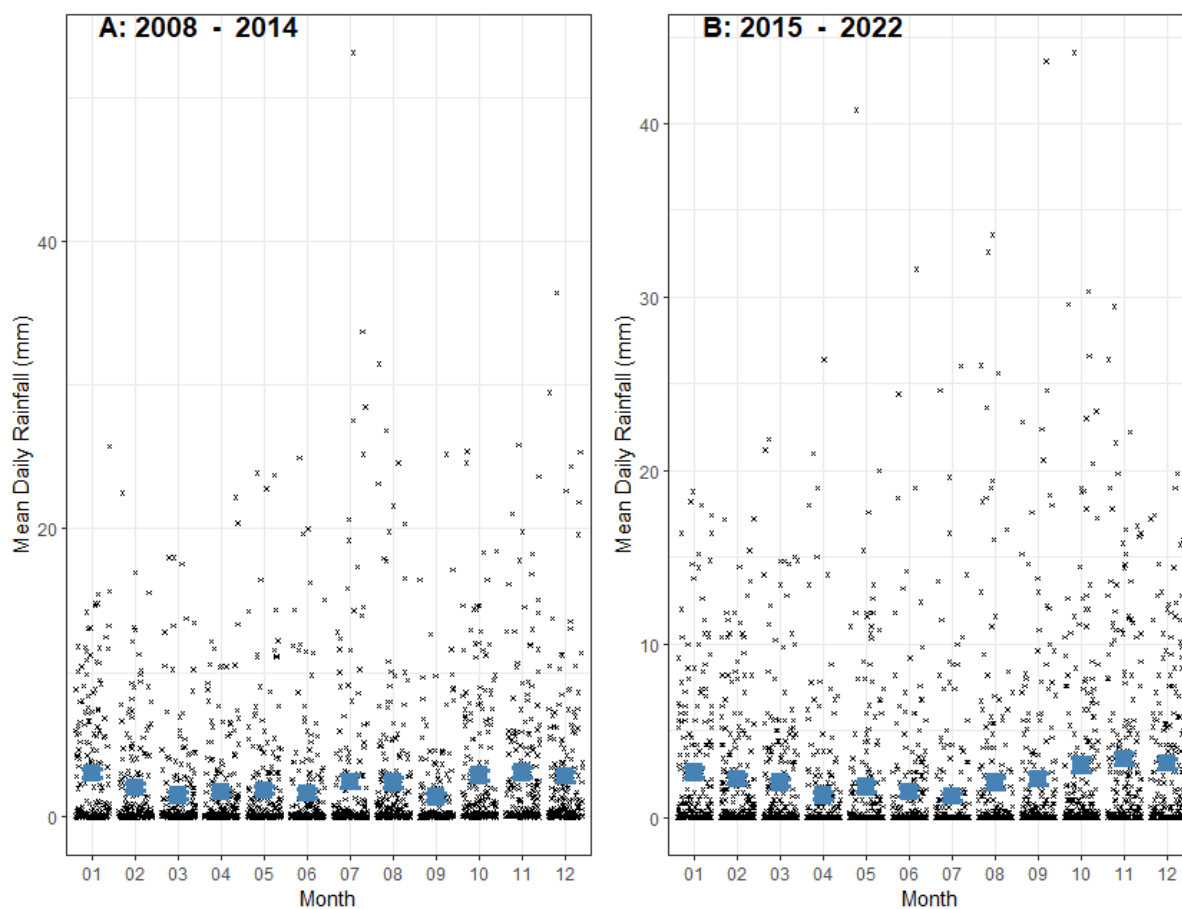
Archive Daily Rainfall from the Bredy Farm RG monitoring station (#354876) at NGR: SY5072889984
Data provided by the Environment Agency, licenced under the Open Government Licence v3.0

Figure 5.1 Mean daily rainfall per month for the Bredy Farm RG monitoring station (NGR: SY5072889984) for the periods (A) 2008 – 2014 and (B) 2015 – 2022.

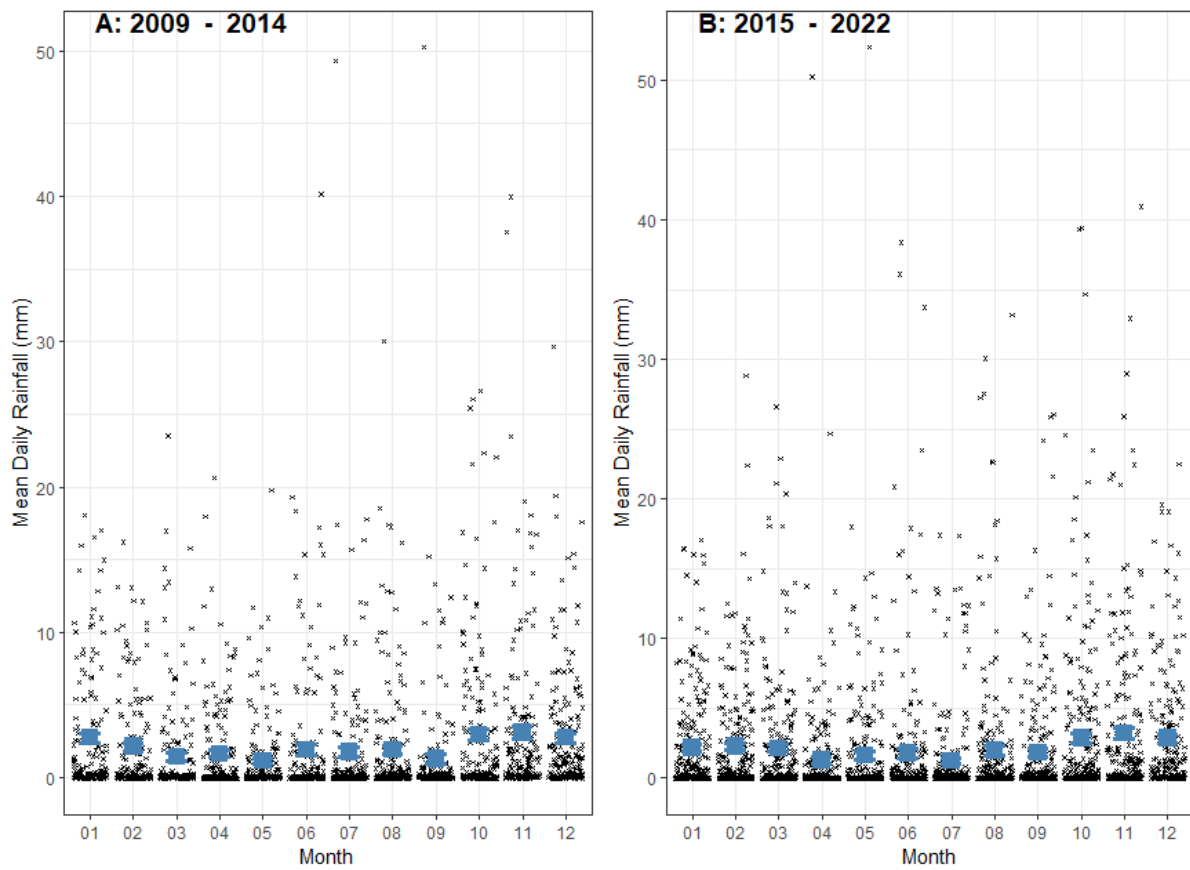
Archive Daily Rainfall from the Exmouth Maer Lane RG monitoring station (#354876) at NGR: SY0242080390
Data provided by the Environment Agency, licenced under the Open Government Licence v3.0

Figure 5.2 Mean daily rainfall per month for the Exmouth Maer Lane RG monitoring station (NGR: SY0242080390) for the periods (A) 2009 – 2014 and (B) 2015 – 2022.

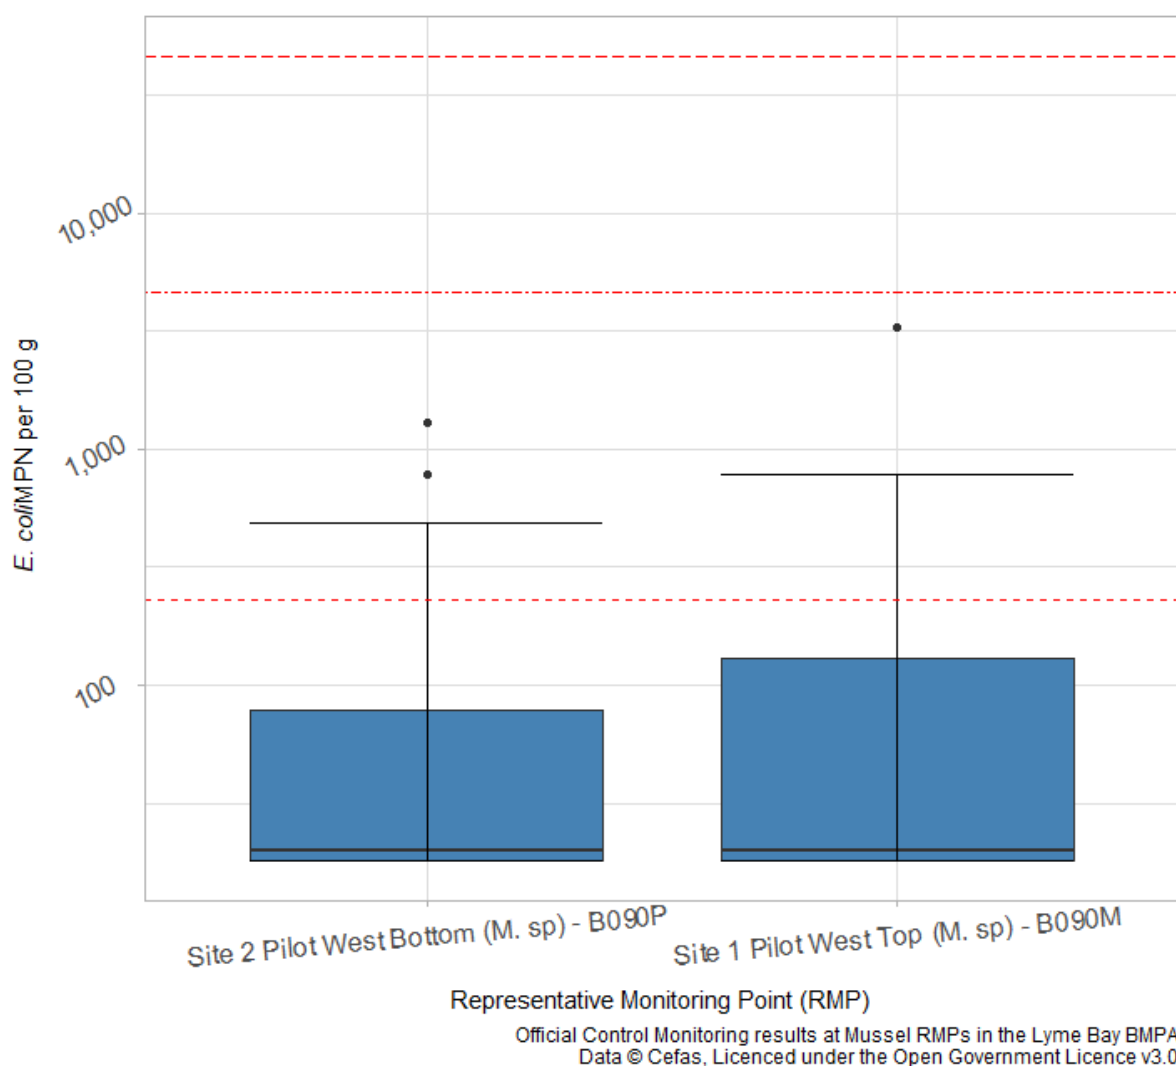
Figure 6.2 Boxplots of *E. coli* concentrations at mussel RMPs in the Lyme Bay BMPA since 2015. Central line indicates median value, box indicates lower-upper quartile range and whisker indicates minimum/maximum values, excluding outliers (points $>1.5 \times$ the interquartile range). Horizontal dashed lines indicate classification thresholds at 230, 4,600 and 46,000 MPN/100 g respectively.

Figure 6.2 presents a boxplot of *E. coli* monitoring results from the two RMPs in the BMPA. One-way analyses of variance (ANOVA) tests were performed on the data to investigate the statistical significance of any differences between the monitoring results from the two RMPs. The median and interquartile range for each of the sites were calculated and found to be very similar. Analysis of these indicates that it is unlikely that the differences between them have any statistical significance ($p > 0.05$)⁴.

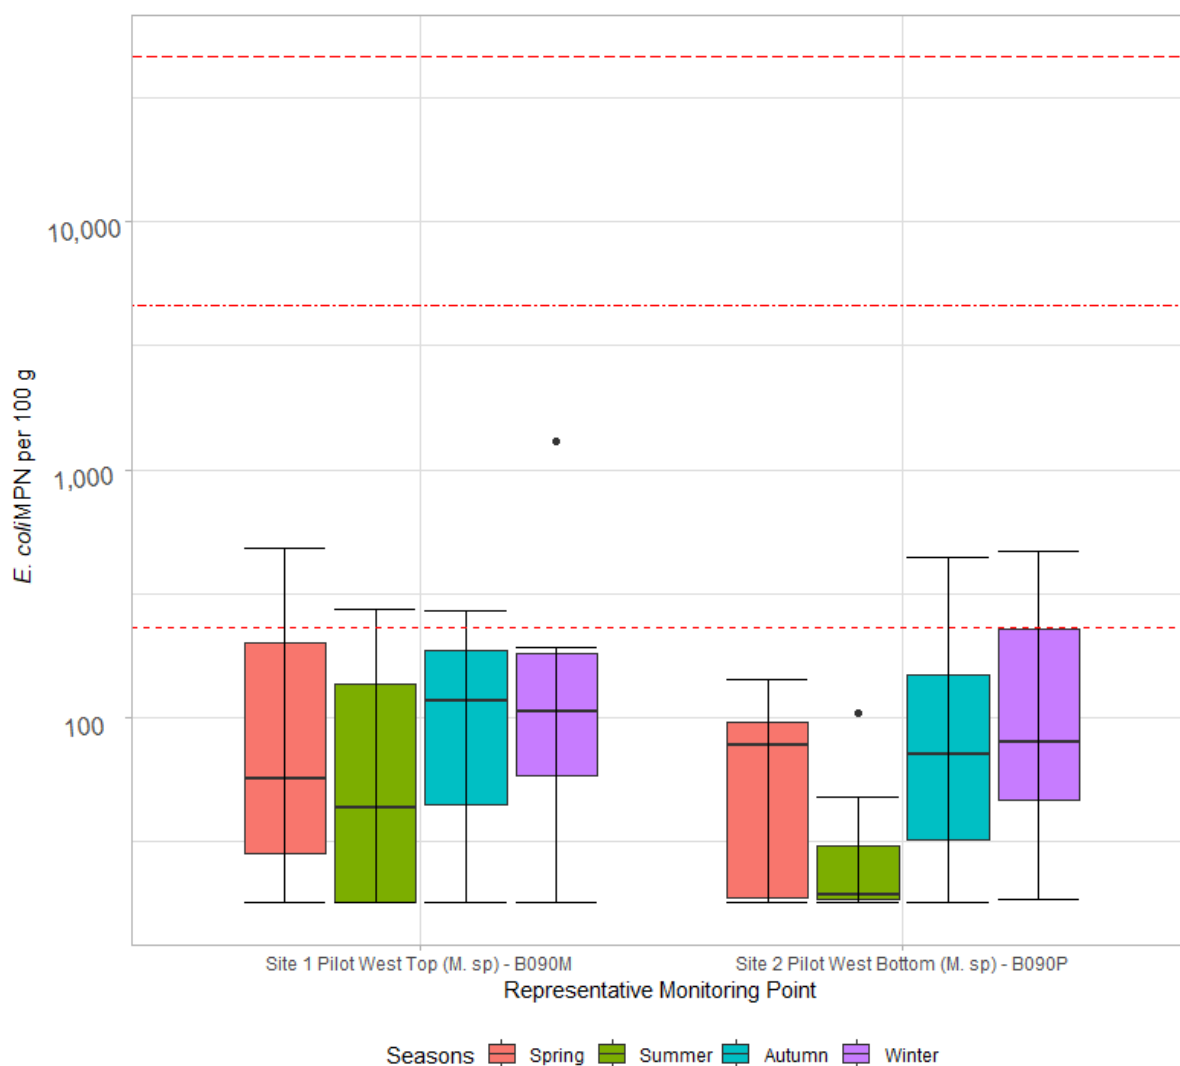
Figure 6.4 Boxplots of E. coli levels per season at mussel RMPs sampled within the Lyme Bay. Horizontal dashed lines indicate classification thresholds at 230, 4,600 and 46,000 MPN/100 g respectively.

The seasonal patterns of *E. coli* levels at the two RMPs within Lyme Bay were investigated and are shown in Figure 6.4. The data for each year were averaged into the four seasons, with, spring from March – May, summer from June – August, autumn from September – November and winter comprising data from December – February the following year. Two-way ANOVA testing was used to look for significant differences in the data, using both season and RMP (if there is more than one RMP for a given species) as independent factors (i.e., pooling the data across season and RMP respectively), as well as the interaction between them (i.e., exploring seasonal differences within the results for a given RMP). Significance was taken at the 0.05 level.

At both RMPs, median results are slightly higher in autumn and winter months, with summer generally returning the lowest *E. coli* concentrations. However, no statistically significant differences in the data were found, either when the data were pooled between RMPs or the RMPs considered individually. The desk-based assessment found that discharges of pollution to coastal waters in this BMPA were likely to be highest in summer months due to increased population size and vessel numbers because of tourism. The lower results in summer months are likely to be reflective of the additional UV irradiance of the water column, stimulating increased die-off of bacterial contamination during summer.
