Carcinus Ltd  
Consultancy and Survey Specialists

# Sanitary Survey - Review

*Poole Harbour – 2021*

Document No. – *J0591/21/05/24*

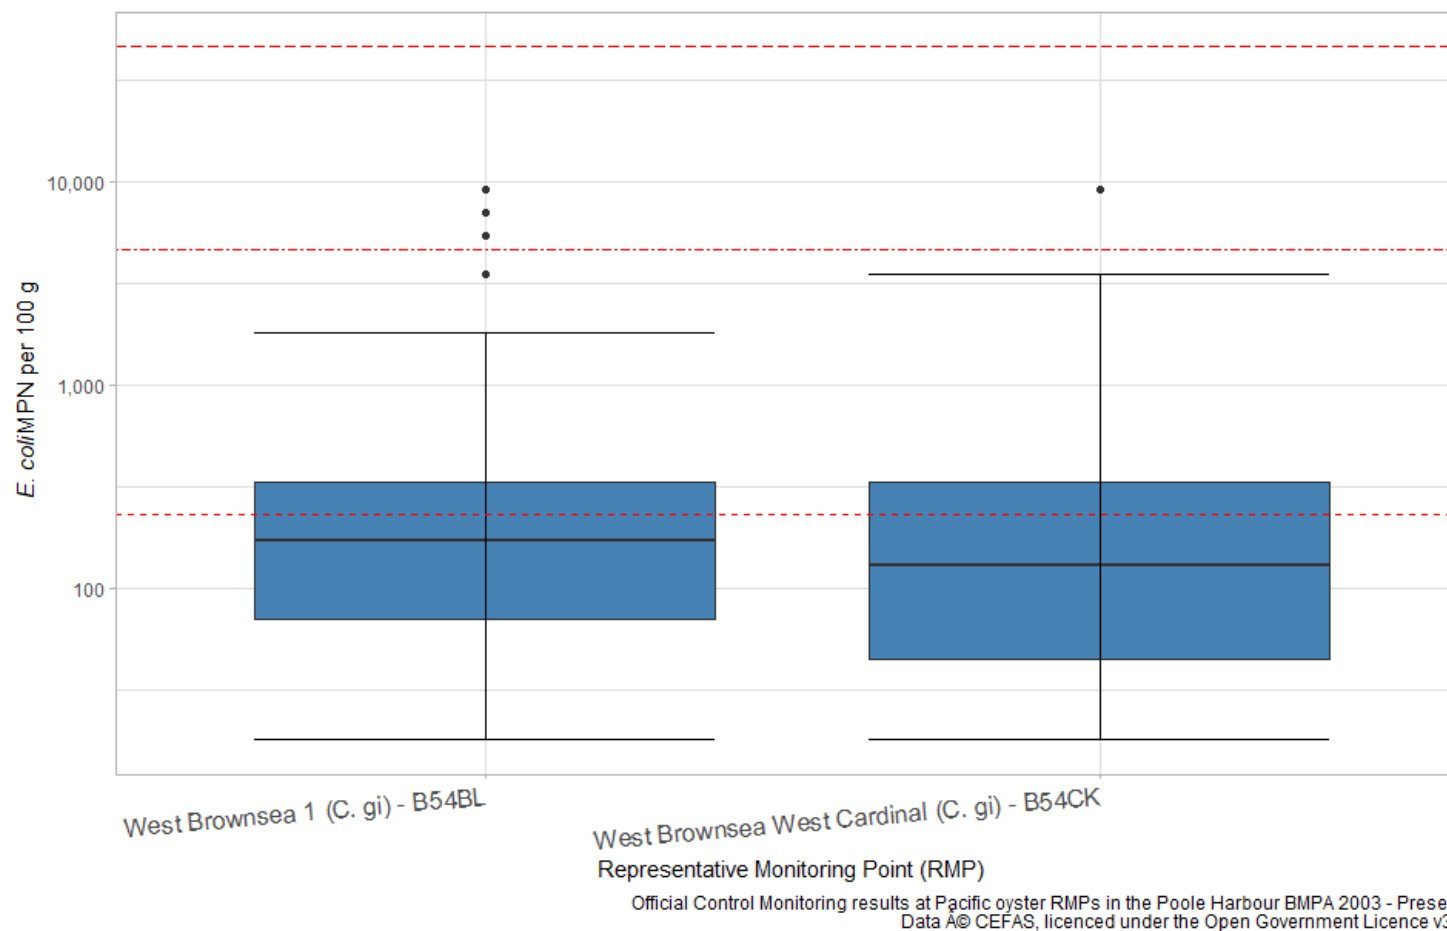
Figure 6.3 Boxplots of *E. coli* levels at Pacific oyster RMPs sampled within the Poole Harbour BMPA 2003 – Present. Central line indicates median value, box indicates lower – upper quartile range and whisker indicates minimum / maximum values excluding outliers (points > 1.5x the interquartile range).

Figure 6.2 and Figure 6.3 present boxplots of *E. coli* monitoring results from mussel and Pacific oyster RMPs respectively. One-way analyses of variance (ANOVA) tests were performed on the data to investigate the statistical significance of any differences between monitoring results from the various RMPs. All statistical analysis described in this section was undertaken in R (R Core Team, 2020). These tests revealed that Barrel 'O' (B54BS) returned significantly higher monitoring results than Hamworthy (B054P) ( $p < 0.00001$ ), South Deep (B54AS) ( $p < 0.00001$ ), Round island (B54BM) ( $p < 0.0001$ ), Rockley (B54BR) ( $p = 0.034$ ), West Brownsea West Cardinal (B54CL) ( $p < 0.001$ ), Brands Bay (B54CM) ( $p < 0.001$ ) and Whitley Lake (B54CP) ( $p = 0.028$ ). Results from all RMPs show large variance, which could explain why no further significant differences were found in the data despite some visual differences in both the geometric means (Figure 6.1) and medians (Figure 6.2). No significant difference was found between the two Pacific oyster RMPs ( $p = 0.8$ ).

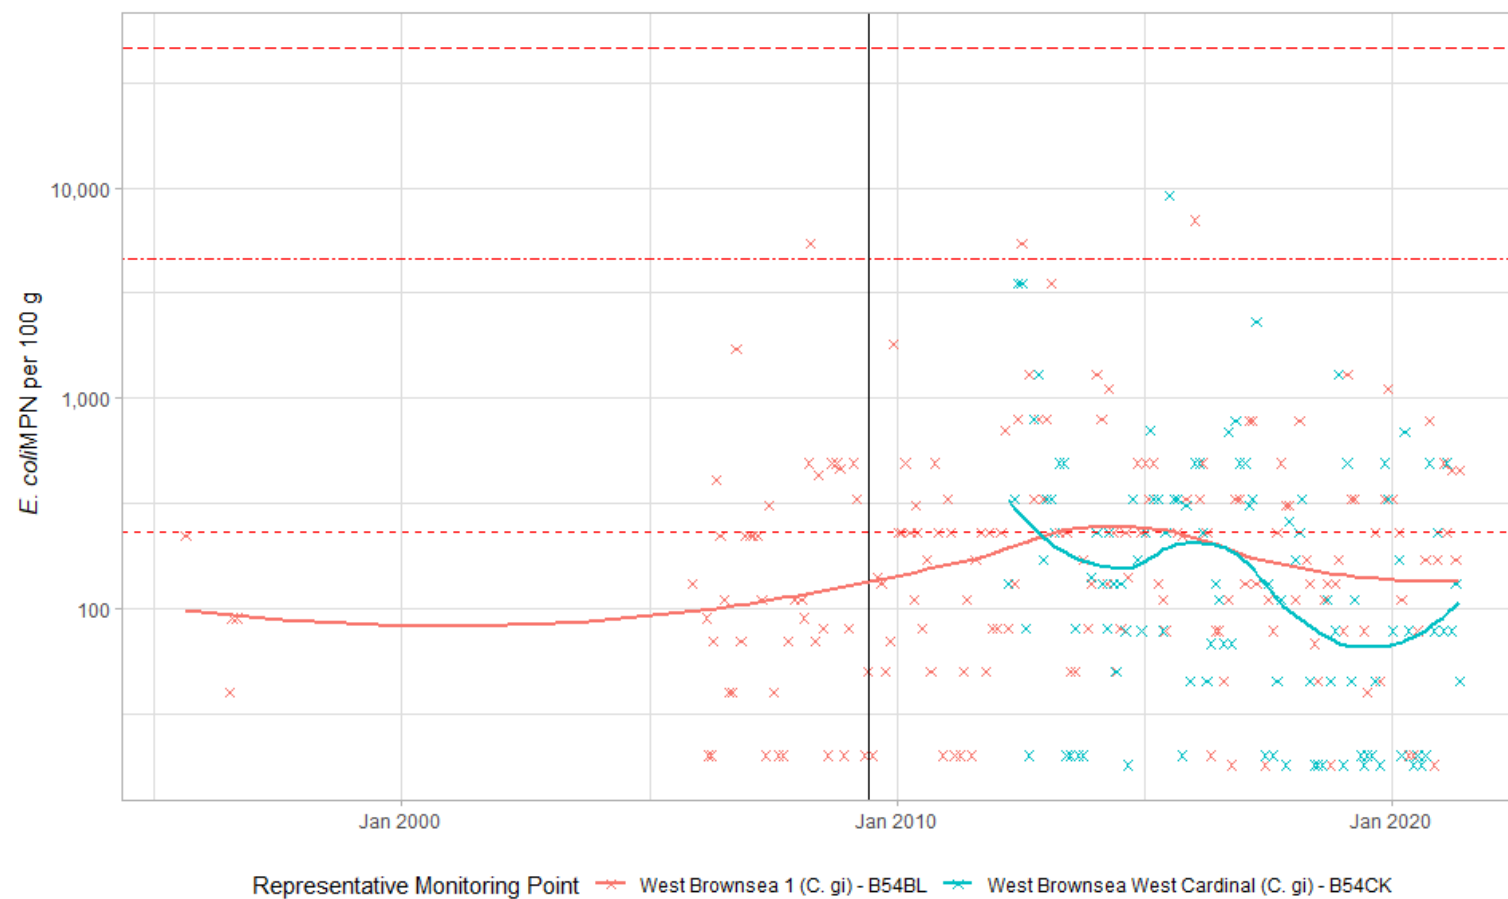
Figure 6.5 Timeseries of *E. coli* levels at Pacific oyster RMPs sampled in the Poole Harbour BMA 2003 – Present. Scatter plots are overlaid with a loess model fitted to the data.

Monitoring results from Pacific oyster RMPs (Figure 6.5) also indicate a general stability in the levels of *E. coli* recorded in shellfish flesh samples. The trend lines indicate a pattern of slowly decreasing *E. coli* results (i.e., improving water quality) from approximately 2015, similar to the mussel RMPs.

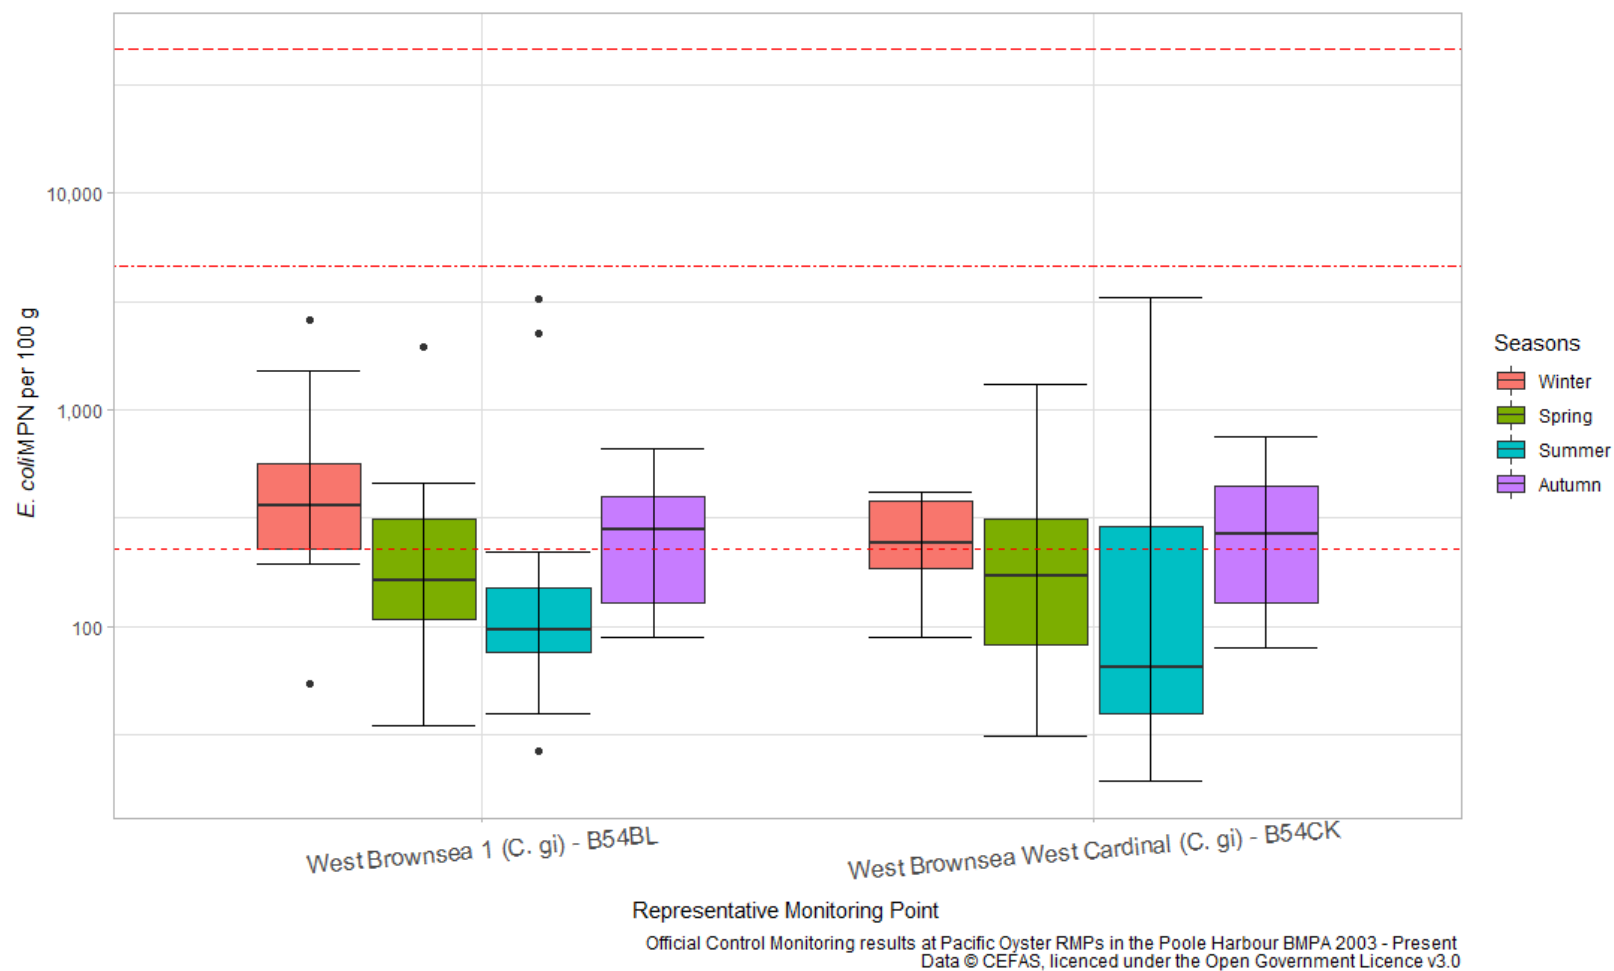
Figure 6.7 Boxplots of *E. coli* levels per season at Pacific oyster RMPs sampled within the Poole Harbour BMPA 2003 – Present.

The seasonal patterns of *E. coli* levels at the various RMPs within the Poole Harbour BMPA were investigated and are presented in Figure 6.6 (mussel RMPs) and Figure 6.7 (Pacific oyster RMPs). The data for each year were averaged into the four seasons, with Winter comprising data from January – March, Spring from April – June, Summer from July – September and Autumn from October – December. Two-way ANOVA testing was used to look for significant differences in the data, using both season and RMP as independent factors (i.e. pooling the database across RMP and season respectively), as well as the interaction between them (i.e. exploring seasonal differences within a given RMP). Significance was taken at the 0.05 level.

Two-way ANOVA tests did not indicate any statistically significant seasonal differences in the levels of *E. coli* when data were pooled between RMPs, or when seasonal differences for a specific RMP were considered ( $p > 0.05$ ).
