# Sanitary Survey - Review

## *River Crouch – 2022*

Document No. – *J0591/21/10/11*

<b>Client</b>	Food Standards Agency (FSA)
<b>Project Title</b>	Sanitary Survey Review
<b>Document Title</b>	Sanitary Survey - Sanitary Survey Review - River Crouch
<b>Document Number</b>	J0591/21/10/11
<b>Revision</b>	4.0
<b>Date</b>	31 May 2022

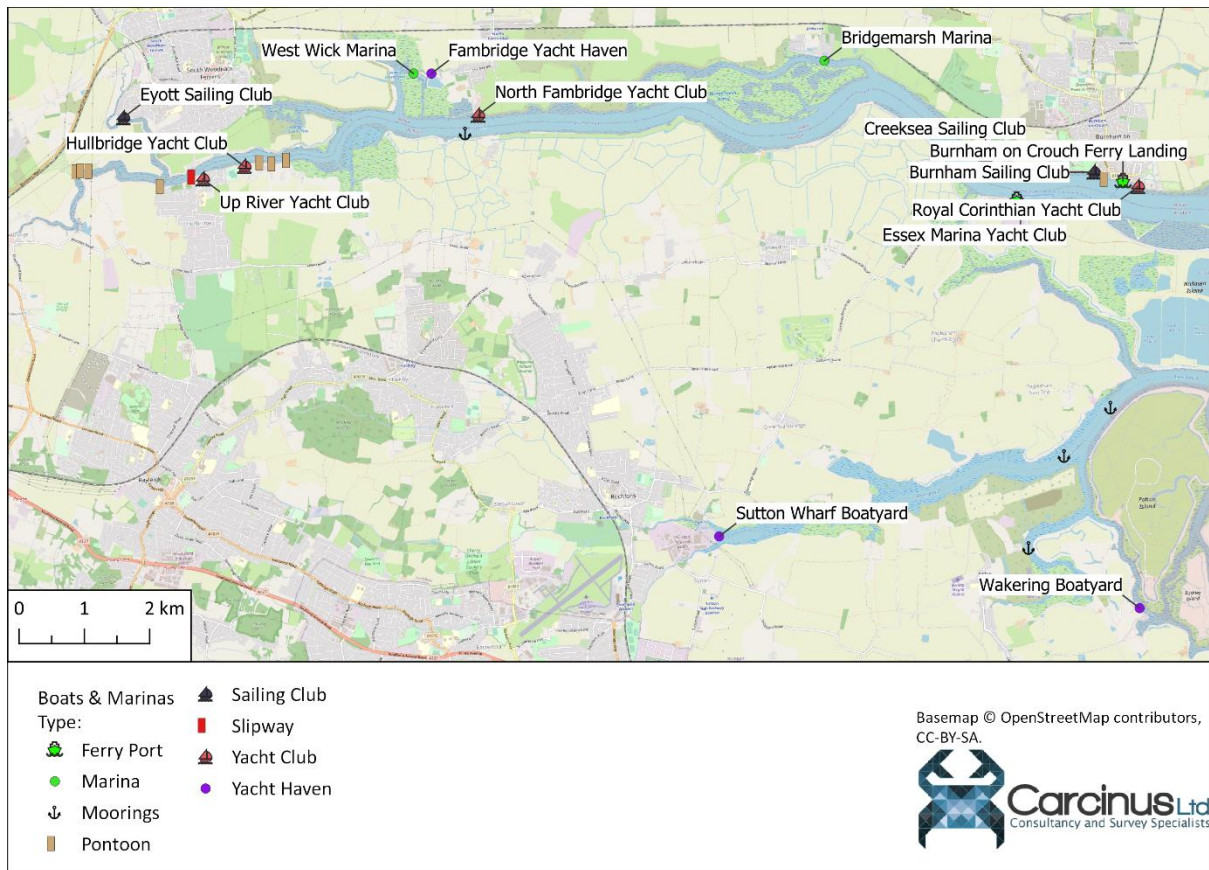
*Figure 3.6 Locations of moorings, marinas and other boating activities within the Crouch/Roach estuary complex.*

The discharge of sewage from boats is a potentially significant source of bacteriological contamination of the shellfish beds within the Crouch BMPA. Boating activities in the Crouch/Roach estuary complex have been derived through analysis of satellite imagery and

various internet sources and compared to that described in the original sanitary survey. Their geographical positions are presented in Figure 3.6.

The original sanitary survey identifies that most of the marinas and moorings are located in the Crouch. All the marinas etc. identified in the 2012 report are still in use, based on recent satellite imagery. None of the marinas present contain pump-out facilities, and therefore private vessels of a sufficient size are likely to make overboard discharges from time to time. This is most likely to occur around the areas of moorings and main navigational channels rather than around the pontoons/marinas, as it is considered antisocial in the marina setting where on-shore toilets are readily available. The level of recreational boating activity within the estuary complex will be highest during the summer months, and therefore the greatest impact on the bacteriological health of the shellfishery will also be during this period.

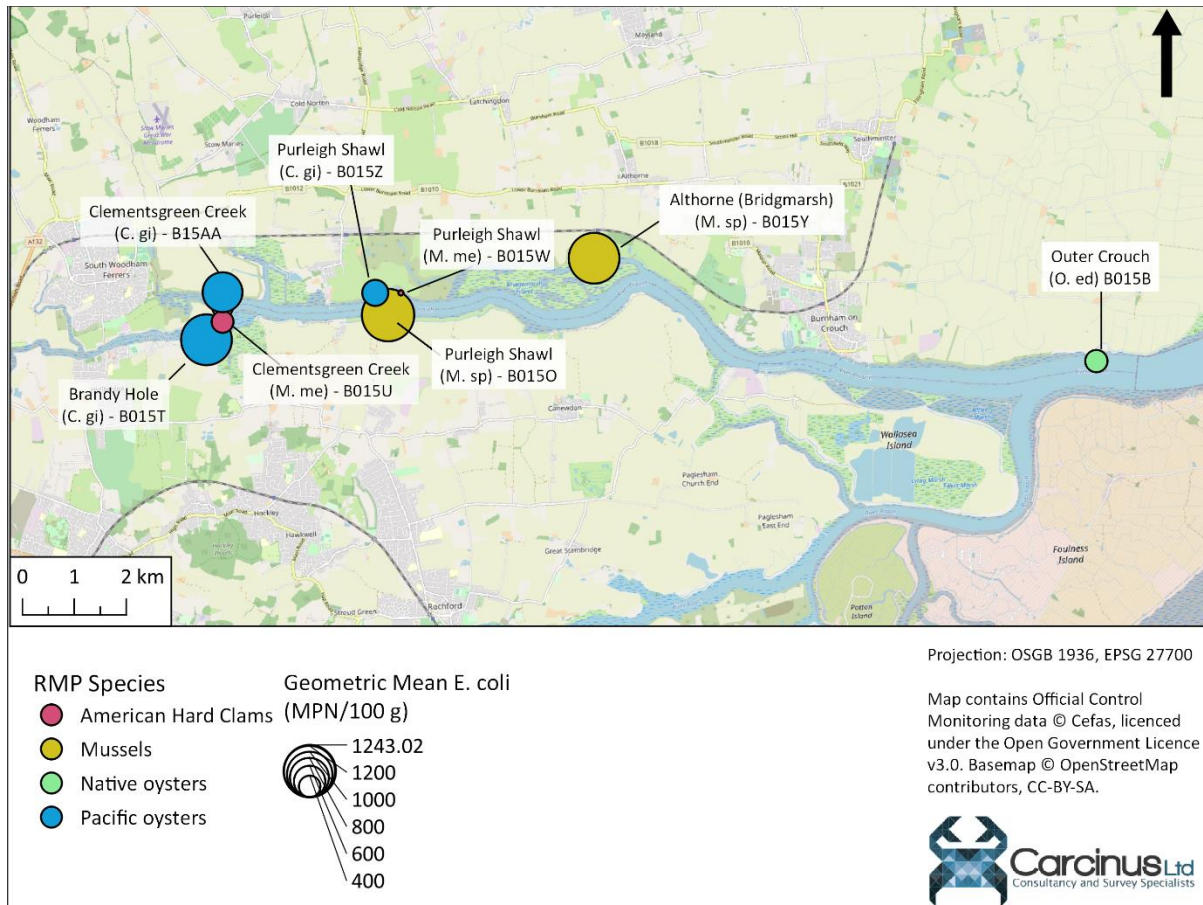
**Figure 6.1** Geometric mean *E. coli* monitoring results from Official Control monitoring at bivalve RMPs within the Crouch BMPA.

Relative to other BMPAs around the country, the mean results from samples collected from RMPs in the Crouch are low, with only two RMPs (Purleigh Shawl – B015Z & Brandy Hole – B015T) having a mean result of >1,000 MPN/100 g, and no RMP ever returning a result >46,000 MPN/100 g. There are two instances of an RMP being co-located for more than one species. In this case, the hard clam RMP has returned a much lower result than the RMPs of other species. This pattern is to be expected, as a Cefas report, commissioned by the FSA (Cefas, 2014) into the use of indicator species in UK BMPAs found that hard clams tend to accumulate *E. coli* less readily than other species (Cefas, 2014). There does also appear to be some geographic pattern, with those RMPs situated nearer to the head of the estuary returning higher results, likely due to the concentration of consented discharges in and around Woodham Ferrers. As such, a general recommendation of locating RMPs at the upstream end of classification zones is given, unless point sources warrant a different location.

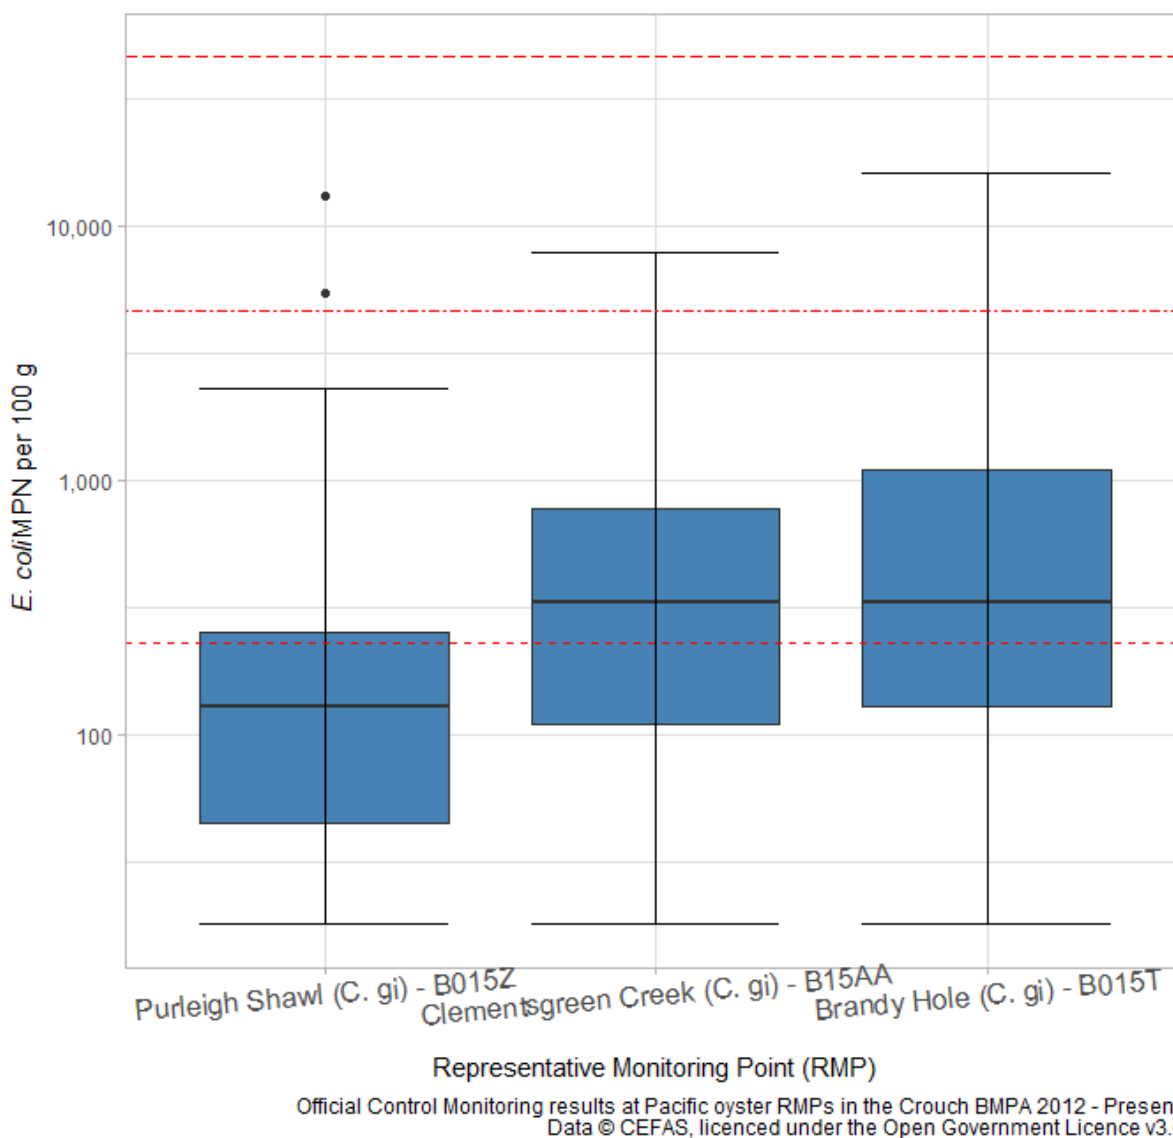
*Figure 6.2 Boxplots of *E. coli* levels at Pacific oyster RMPs sampled within the Crouch BMPA 2012 – Present. Central line indicates median value, box indicates lower-upper quartile range and whisker indicates minimum/maximum values excluding outliers (points  $>1.5 \times$  the*

interquartile range). Horizontal red lines indicate classification thresholds of 230, 4,600 and 46,000 MPN/100 g.

The ANOVA tests revealed that results from Brandy Hole (B015T) were significantly greater than those from Purleigh Shawl (B015Z) ( $p = 0.025$ ). No other significant differences were found in the data for Pacific oyster or any of the other monitored species.

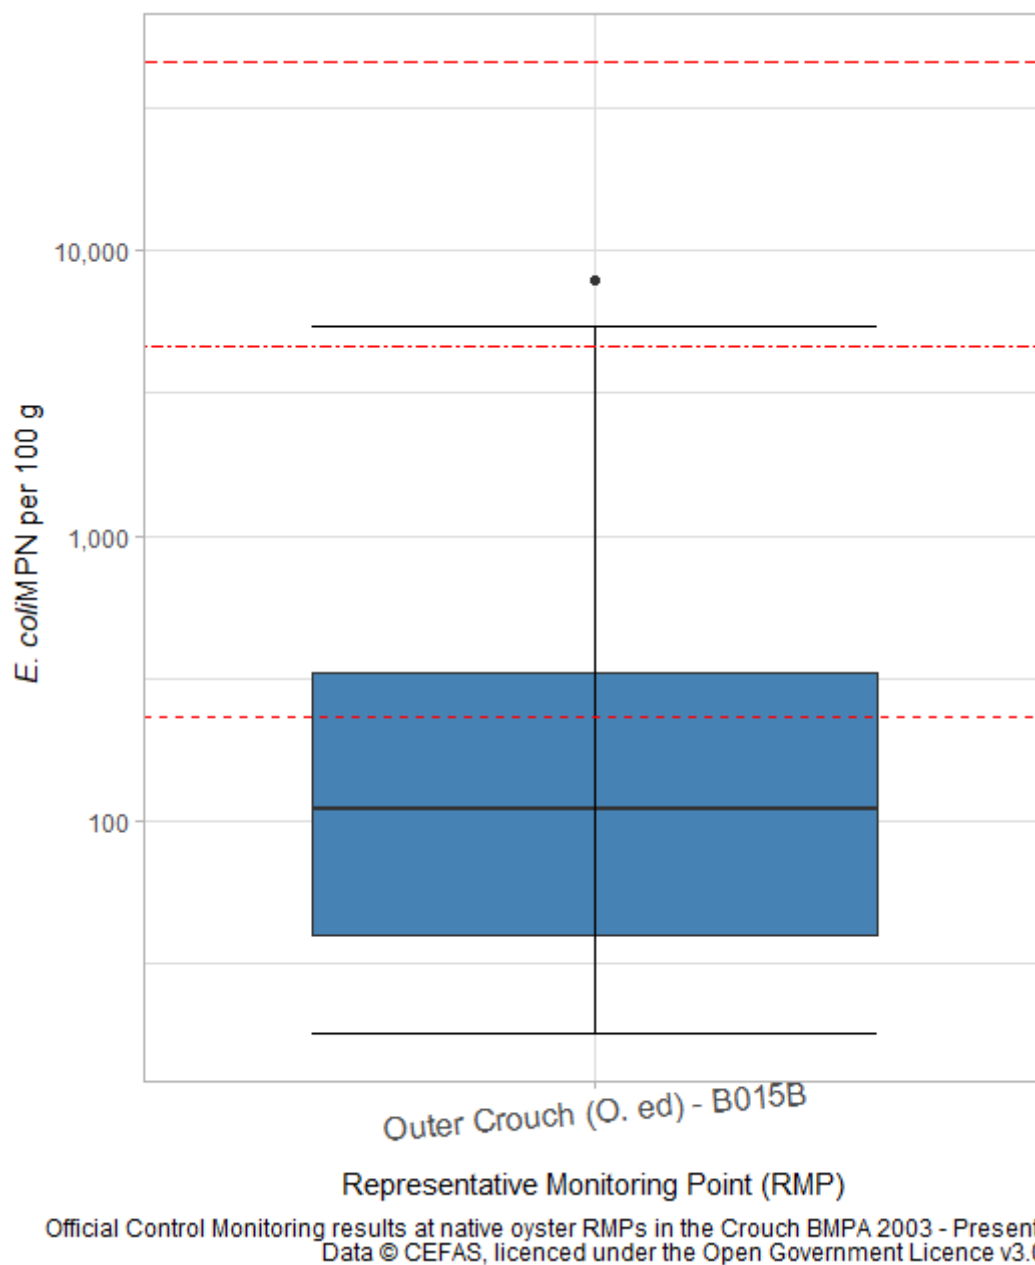
Figure 6.3 Boxplots of *E. coli* levels at native oyster RMPs sampled within the Crouch BMA 2003 – Present. Central line indicates median value, box indicates lower-upper quartile range and whisker indicates minimum/maximum values excluding outliers (points  $>1.5 \times$  the interquartile range). Horizontal red lines indicate classification thresholds of 230, 4,600 and 46,000 MPN/100 g.

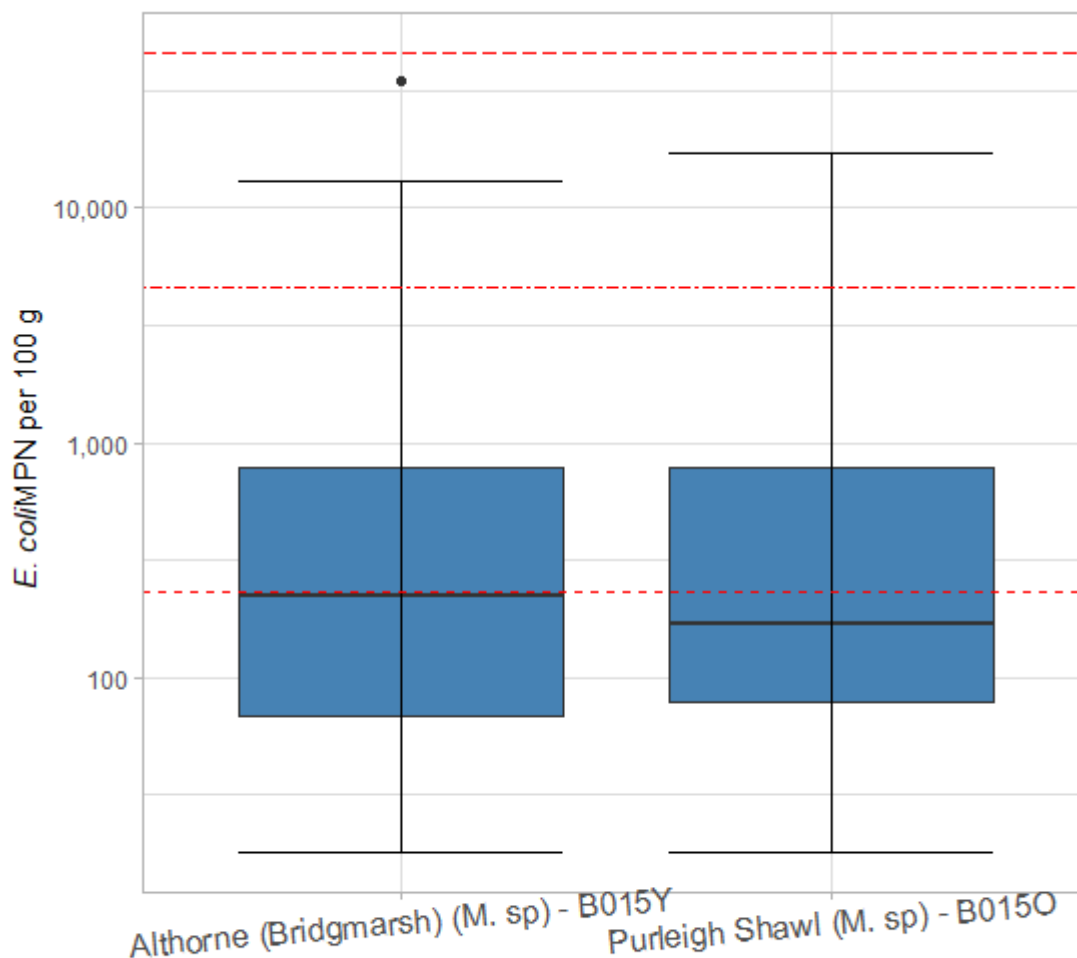
Figure 6.4 Boxplots of *E. coli* levels at mussel RMPs sampled within the Crouch BMPA 2012 – Present. Central line indicates median value, box indicates lower-upper quartile range and whisker indicates minimum/maximum values excluding outliers (points  $>1.5 \times$  the interquartile range). Horizontal red lines indicate classification thresholds of 230, 4,600 and 46,000 MPN/100 g.

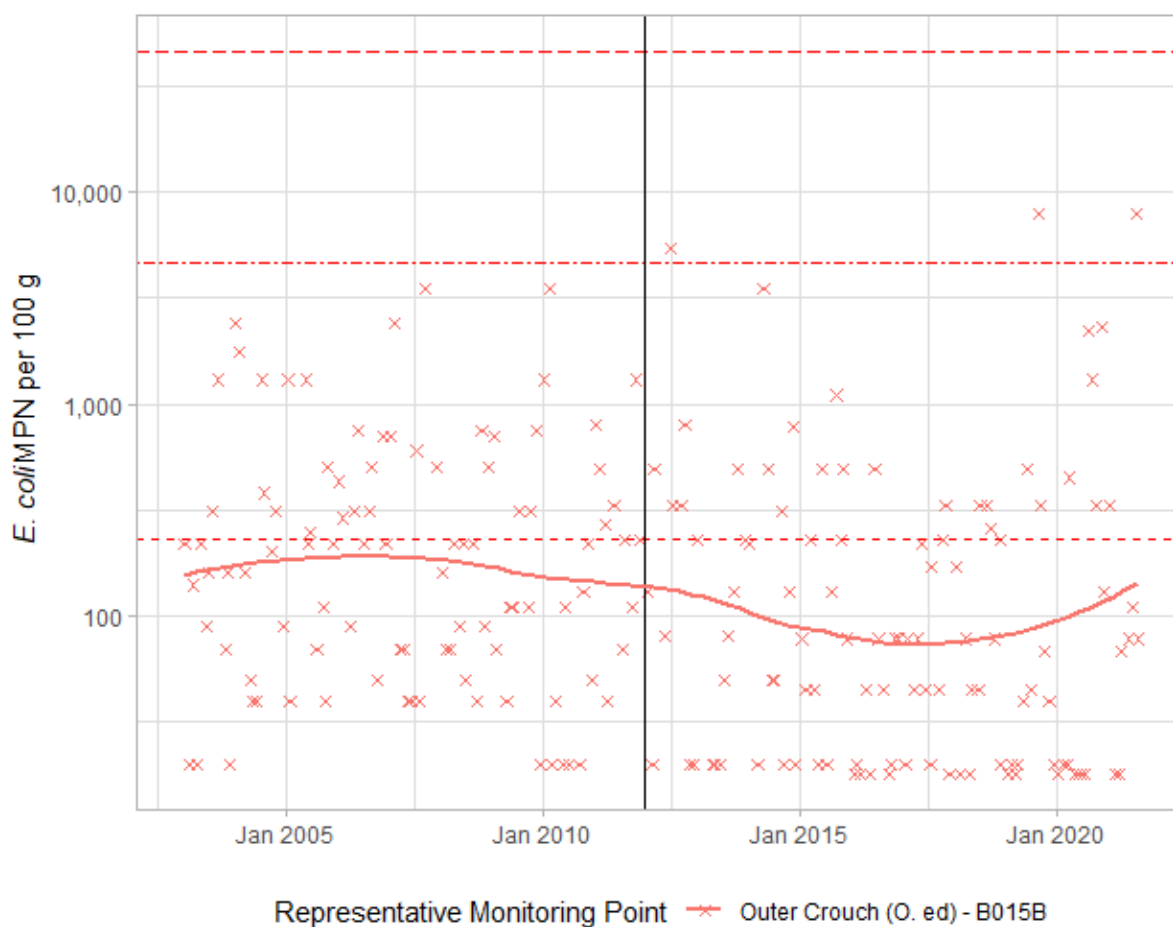
*Figure 6.7 Timeseries of *E. coli* levels at native oyster RMPs sampled in the Crouch BMTA 2003 – Present. Scatter plots are overlaid with a loess model fitted to the data. Horizontal red lines indicate classification thresholds of 230, 4,600 and 46,000 MPN/100 g.*

Water quality at the Outer Crouch (B015B) RMP has been generally good, with the trend line always falling below the low threshold of 230 MPN/100 g and only three results exceeding 4,600 MPN/100 g (Figure 6.7). Water quality gradually improved between 2003 and ~2017, as evidenced by declining monitoring results.

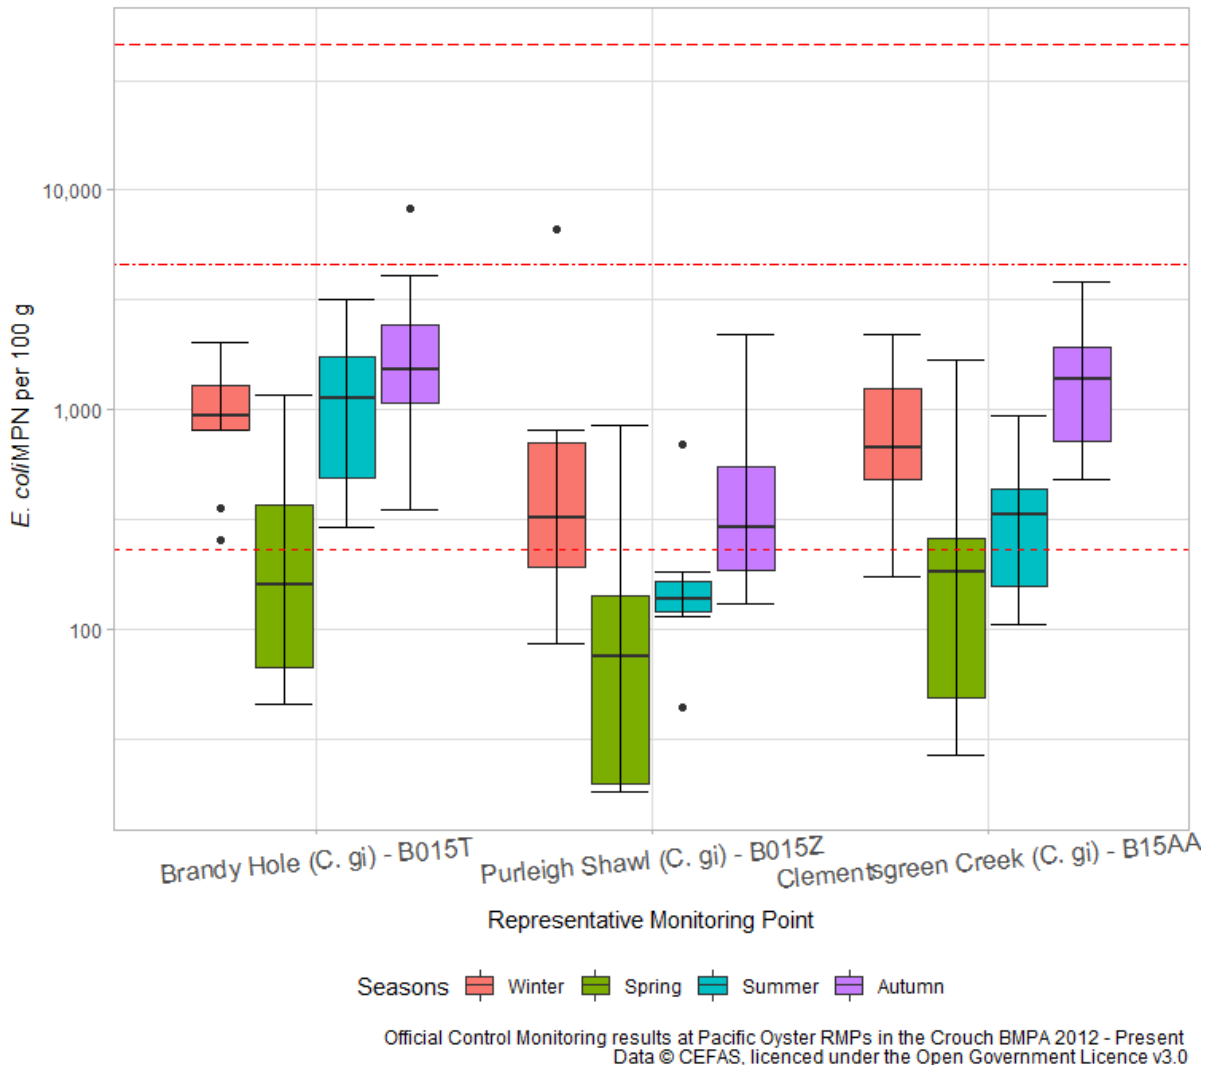
*Figure 6.10 Boxplots of *E. coli* levels per season at Pacific oyster RMPs sampled in the Crouch BMPA 2012 – Present. Horizontal red lines indicate classification thresholds of 230, 4,600 and 46,000 MPN/100 g.*

any significant seasonal differences, where results from autumn were significantly greater than at other times ( $p = 0.0084$ ).

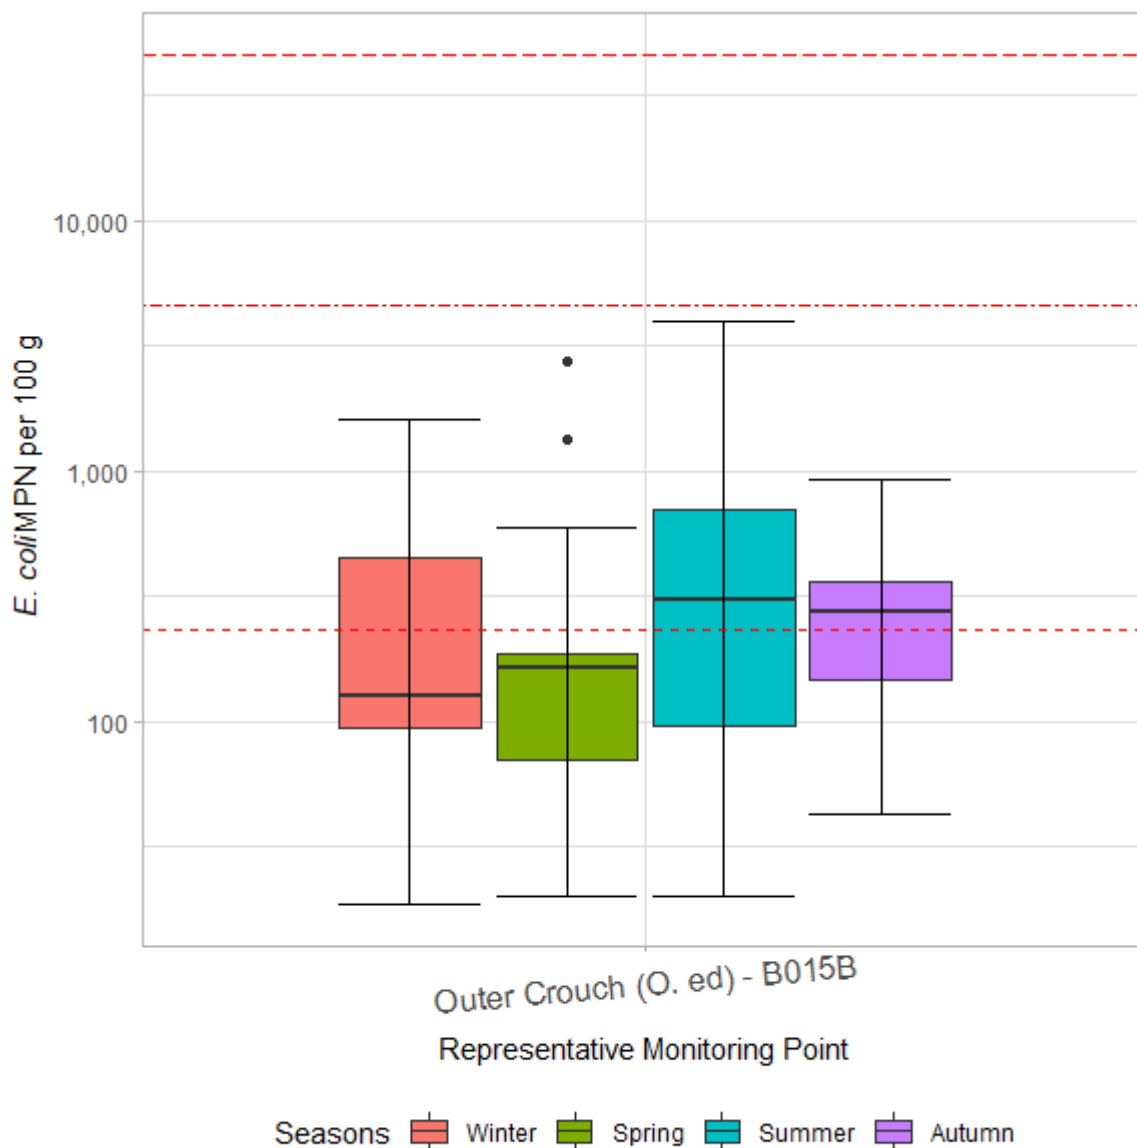
Figure 6.11 Boxplots of *E. coli* levels per season at native oyster RMPs sampled in the Crouch BMA 2003 – Present. Horizontal red lines indicate classification thresholds of 230, 4,600 and 46,000 MPN/100 g.

No significant differences between seasons were found in the data from native oysters (Figure 6.11), mussels (Figure 6.12) or hard clams (Figure 6.13), either when data was pooled across RMP or considered for an individual RMP.

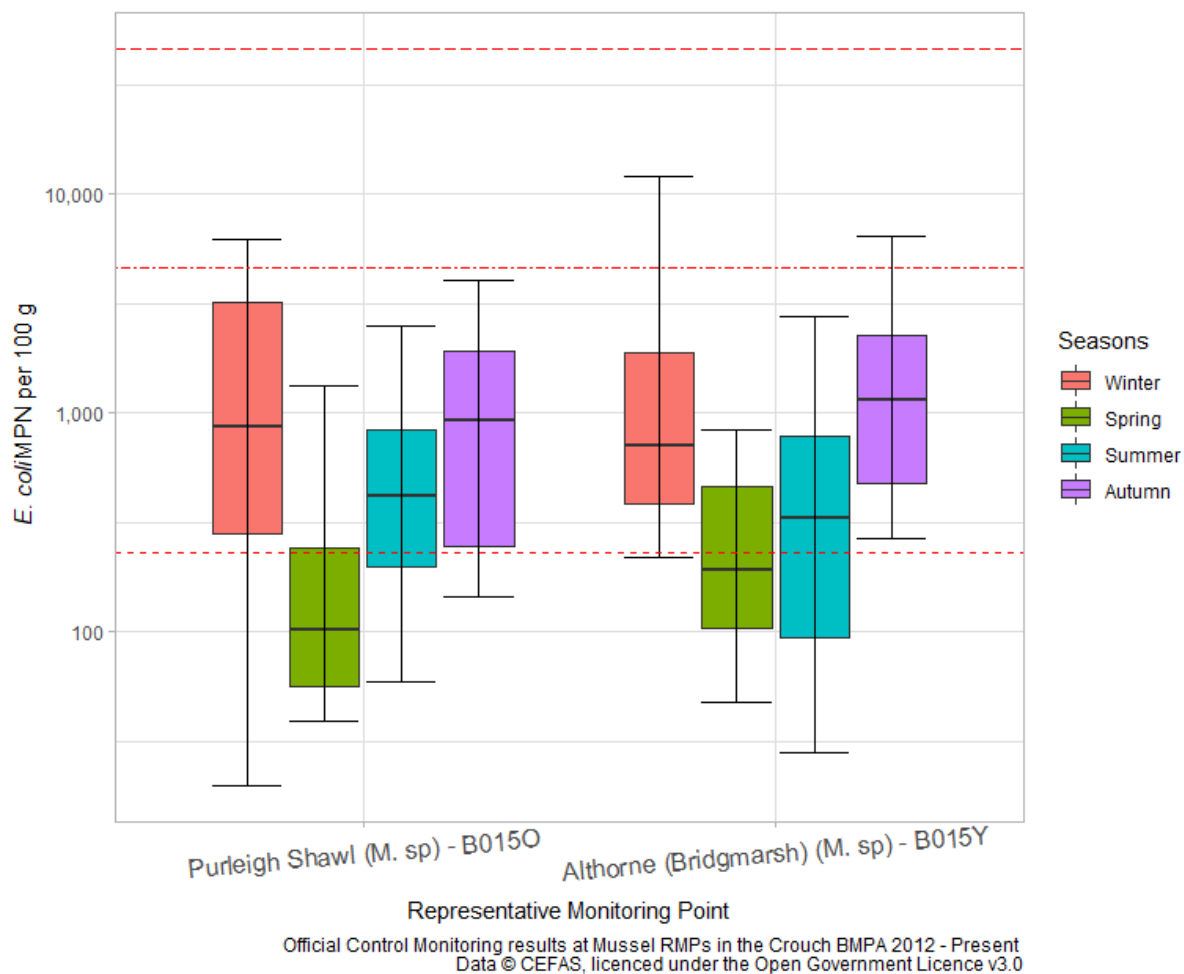
**Figure 6.12** Boxplots of *E. coli* levels per season at mussel RMPs sampled in the Crouch BMPA 2012 – Present. Horizontal red lines indicate classification thresholds of 230, 4,600 and 46,000 MPN/100 g.
