Sanitary Survey- Review

Southampton Water – 2023

| Document Title | Sanitary Survey Review - Southampton Water |
| Document Number | J0591/23/01/13 |

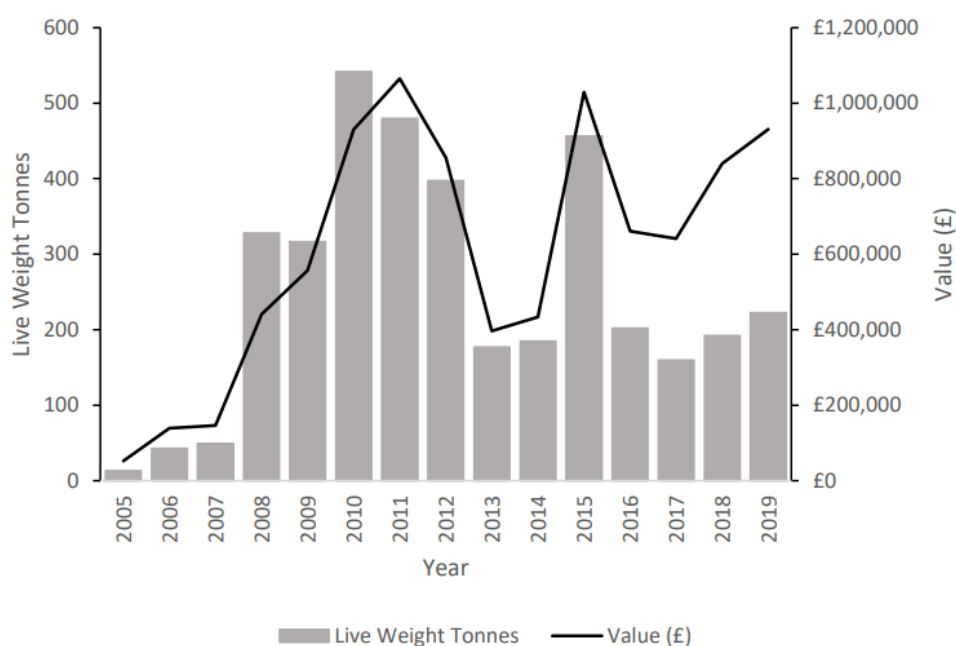
Figure 2.2 Landings of manila clam into the S-IFCA District from 2005 - 2019. Figure produced by S-IFCA based on data from the Marine Management Organisation and provided during initial consultations.

The landings of this species across the whole S-IFCA district are provided in Figure 2.2. S-IFCA's district extends from the Devon/Dorset border in the west to the Hampshire/Sussex border in the east. Within this area are the Lyme Bay, Medina, Poole Harbour, Beaulieu, Portland Harbour, Solent, Southampton Water, Chichester Harbour and Portsmouth

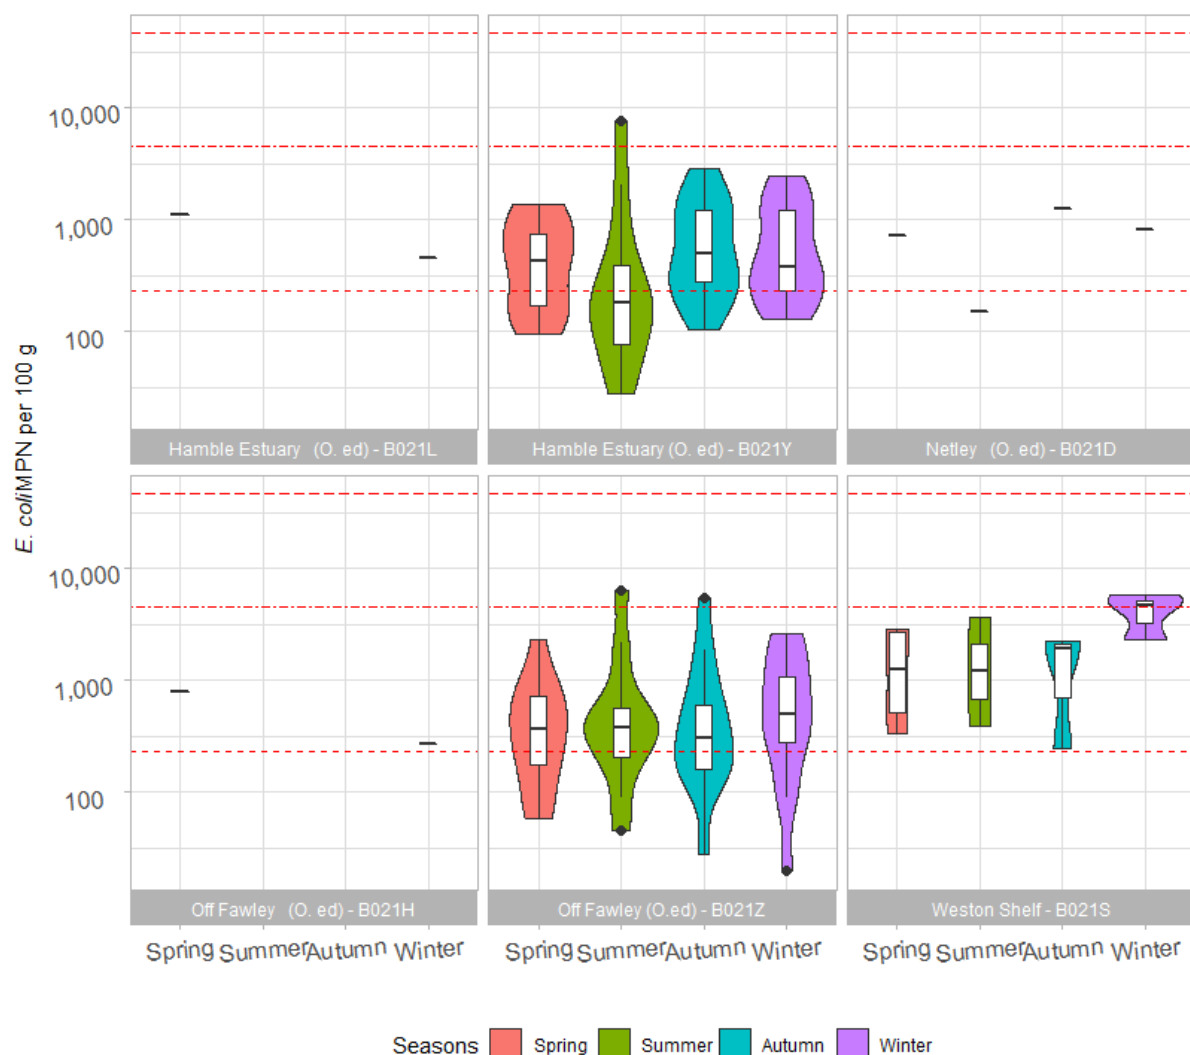
Figure 6.9 Box plots of E. coli levels per season at native oyster RMPs sampled within the Southampton Water BMPA. Boxplots are overlaid on violin plots of the data showing the distribution of the data. Horizontal dashed lines indicate classification thresholds at 230, 4,600 and 46,000 MPN/100 g respectively.
