Sanitary Survey - Review

Swansea Bay – 2023

Document No. – J0591/22/08/08

Client	Food Standards Agency (FSA)
Project Title	Sanitary Survey Review
Document Title	Swansea Bay
Document Number	J0591/22/08/08
Revision	4.0
Date	18 October 2023

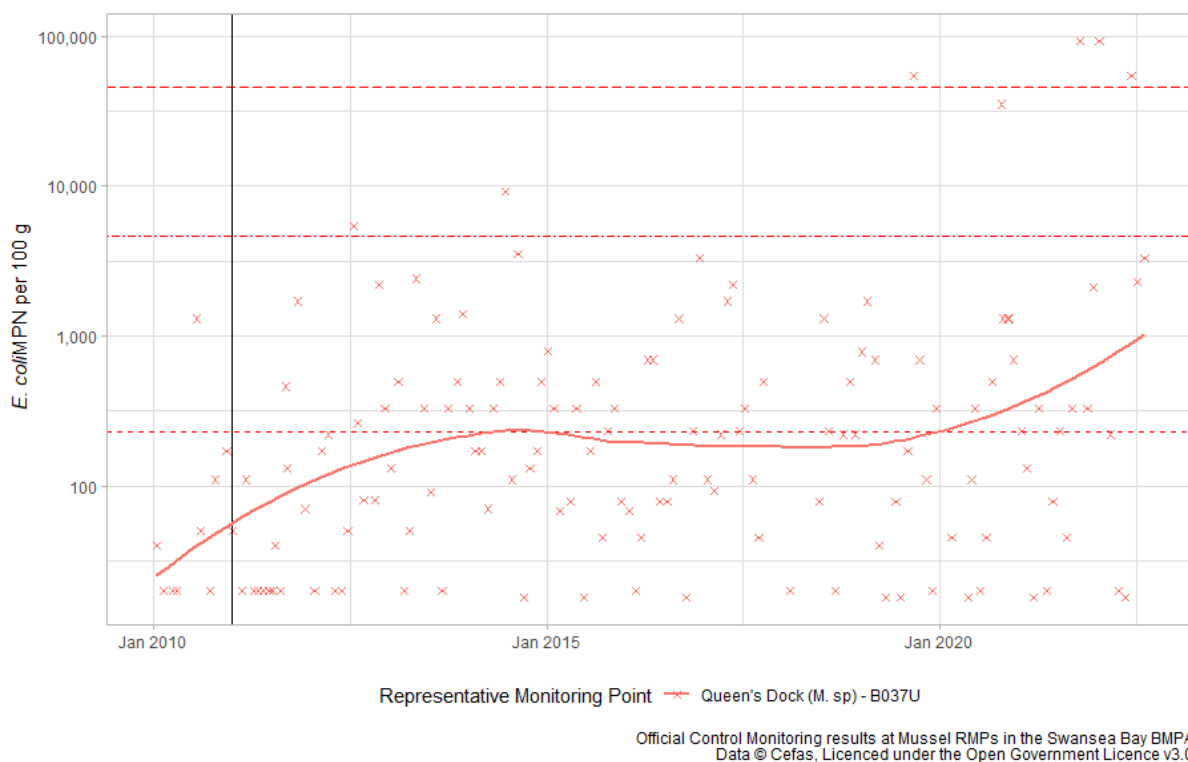
The overall temporal pattern in shellfish flesh monitoring results for the single RMP sampled within the Swansea Bay BMPA is shown in Figure 6.2. The loess model suggests that for much of the time period since the original sanitary survey, the concentrations of *E. coli* in shellfish samples have been within the Class B limit, with the trend line falling on or around the 230 MPN/100 g threshold. However, from late 2019 / early 2020, the loess model trends upwards, and includes four results above the maximum permitted threshold for classification (46,000 MPN/100 g) threshold. This repeated occurrence of high results ultimately led to the prohibition of the *Queen's Dock* CZ in April 2022.

*Figure 6.2 Timeseries of *E. coli* levels at mussel RMPs sampled in the Swansea Bay BMPA since the original sanitary survey. The scatter plot is overlaid with a loess model fitted to the data. Horizontal lines indicate classification thresholds at 230, 4,600 and 46,000 MPN/100 g.*

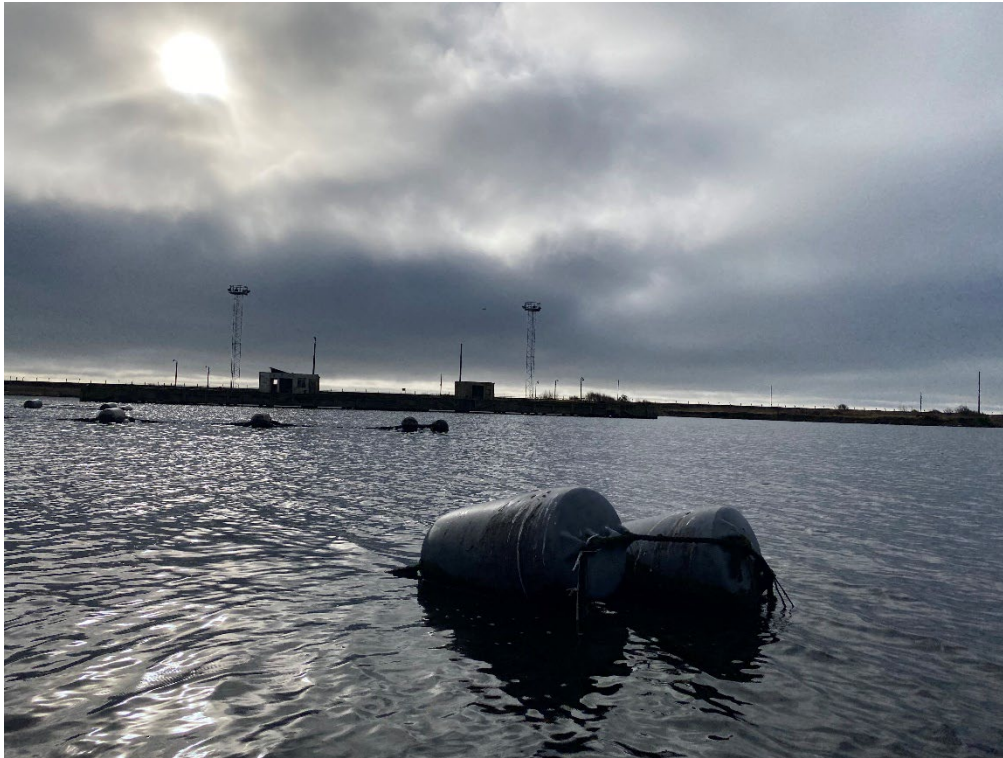
Figure 5 RMP for mussel farm in Queens Dock. Location of water sample SCPH23007 and Shellfish flesh sample OC001.

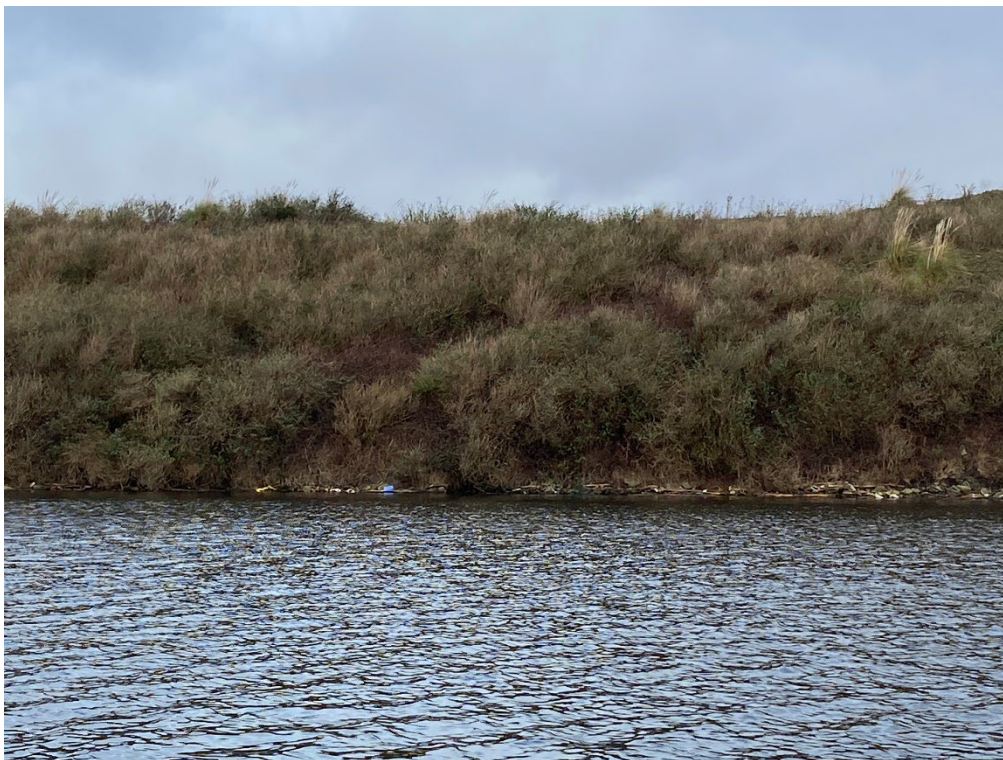
Figure 6 Anthropogenic litter seen from onboard the boat whilst collecting water and shellfish samples at RMP, Queens Dock.

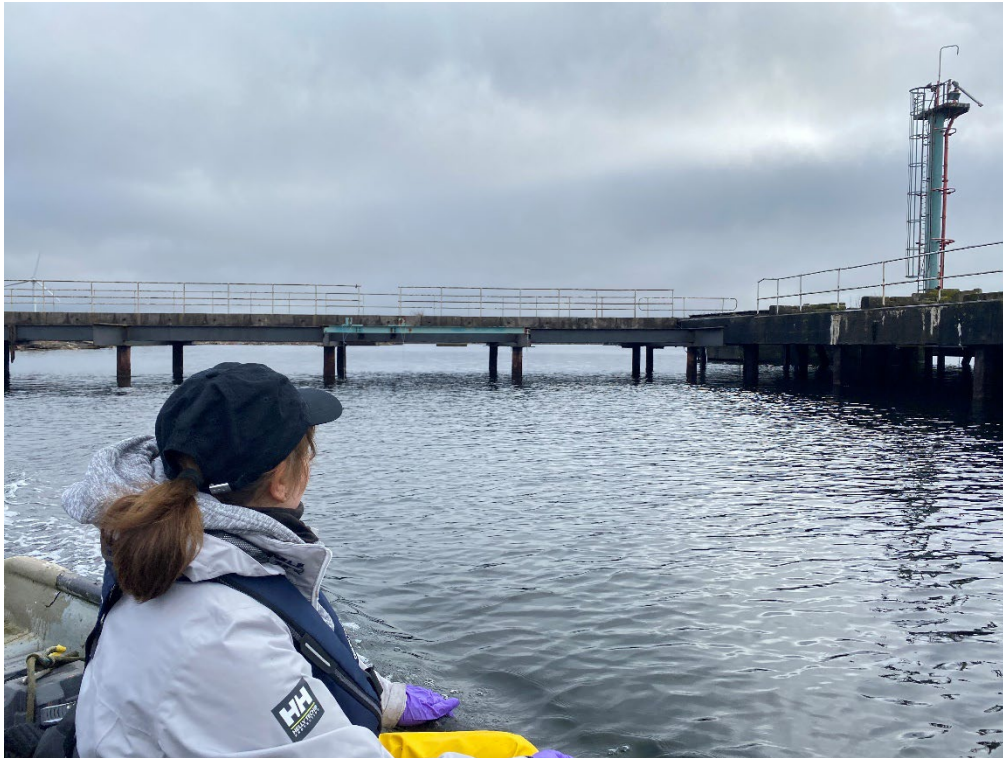
Figure 7 Mid point of Dock, location of water sample SCPH23007 and shellfish sample OC002.

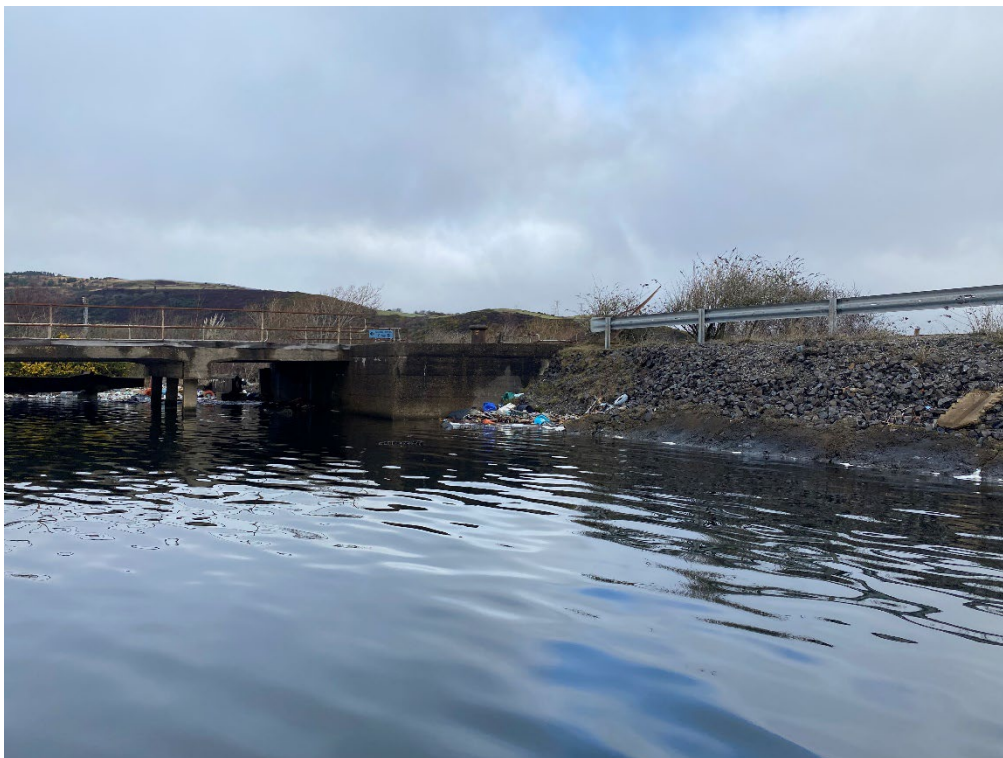
Figure 8 Dock Eastern End, location of water sample SCPH23008. Anthropogenic material was visible from the boat.

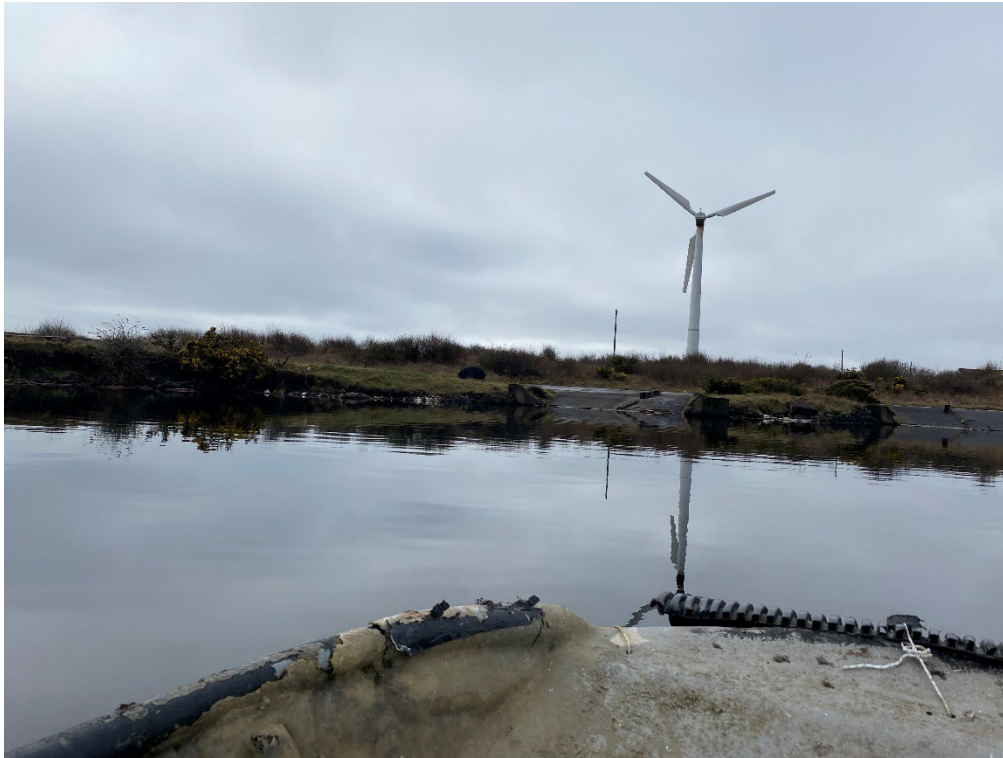
Figure 9 Western end of Dock, location of water sample SCPH23009.

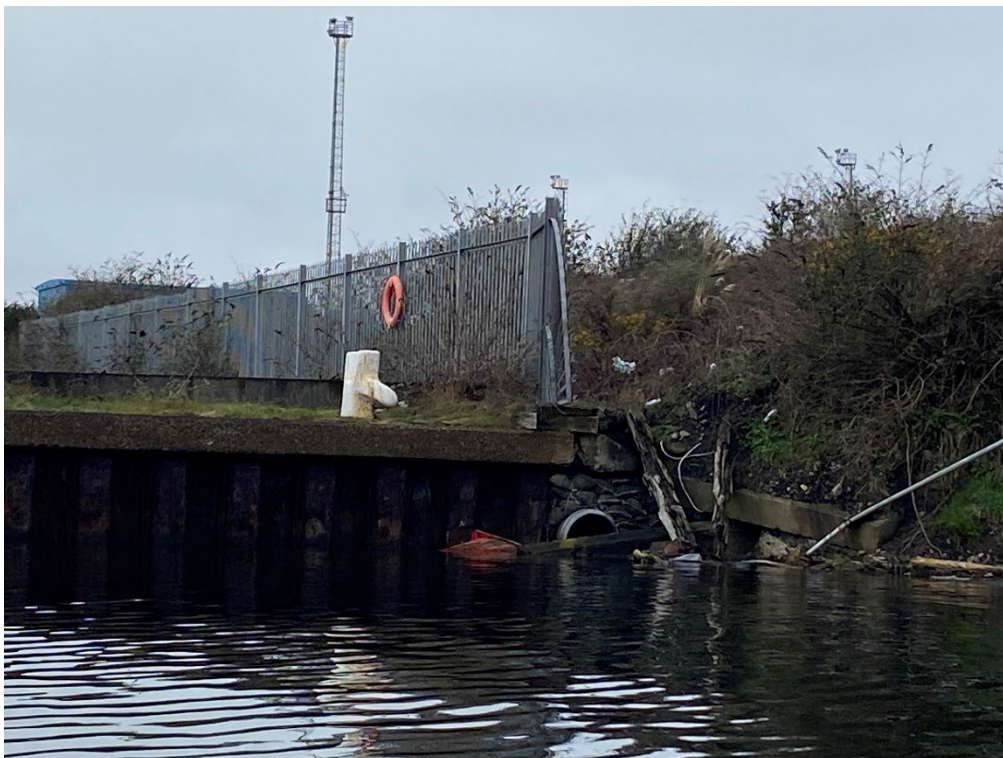
Figure 10 A pipe identified during the shoreline survey. Not observed to be flowing during the survey. No clear evidence of previous water flow. Location of water sample SCPH23010.

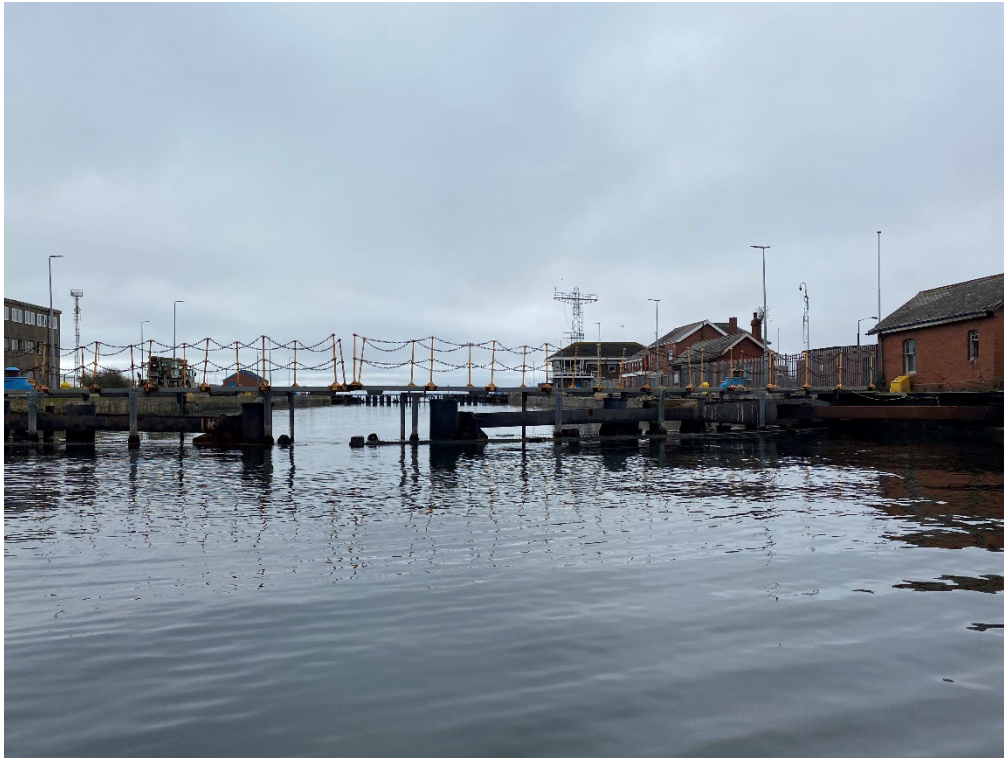
Figure 11 Lock gate. Location of water sample SCPH23011.

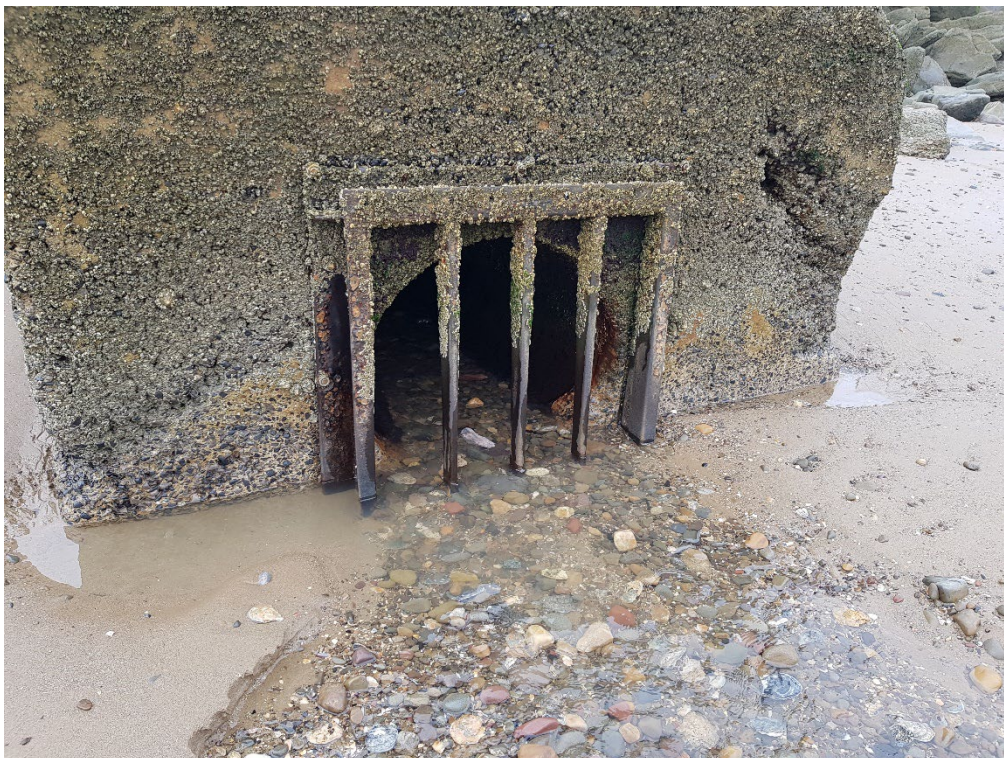
In addition, an intermittent discharge identified outside of the Dock and over the seawall in the desktop study was confirmed and observed to be flowing on the day of survey (waypoint 370). This returned an *E. coli* concentration of 4,900 CFU/100ml, and an intestinal *Enterococci* result of 1,210 CFU/100ml. Both values are considered reasonably high and could be deemed a cause for concern. However, given the location of the outfall in comparison to the CZ (the other side of the sea wall, discharging to Swansea Bay), it is unlikely to be a significant source of bacteriological contamination as there is no evidence to suggest this outfall has any connectivity to the Dock. Dwr Cymru Welsh Water (DCWW) modelling found that the discharges in this location had a 0 or < 1 % impact on Swansea Bay Shellfish Waters.

Figure 12 Outfall 1 seaward. Observed to be flowing during survey. Location of water sample SCPH23012.

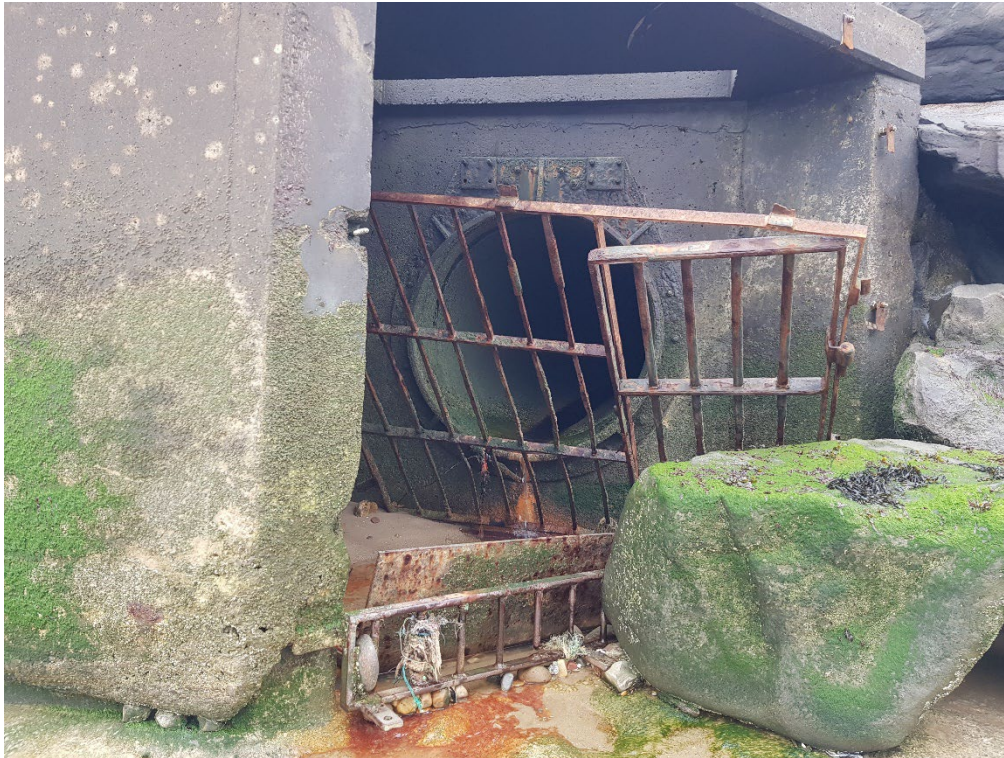
Further up the beach (~300 m from waypoint 370), a second outfall was sampled (waypoint 371). This outfall was not identified in the desk-based assessment. It should be noted that this outfall had a sulphurous smell and visible water staining inside/around the pipe (Figure 13; Figure 14). Whilst this may be indicative of potential contamination, low *E. coli* and intestinal *Enterococci* results were recorded. It should also be noted that given the location of these two outfalls on the beach, discharging into Swansea Bay, there is no evidence of connectivity to the CZ at Queen's Dock. Therefore a combination of location in comparison to the CZ and low water sample contamination results indicate these outfalls are unlikely to be a significant source of bacteriological contamination.

Figure 13 Outfall 2 seaward. Identified during shoreline survey. Flow observed on survey day. Anthropogenic material in surrounding area and water staining visible from flow of water. Location of water sample SCPH23013.

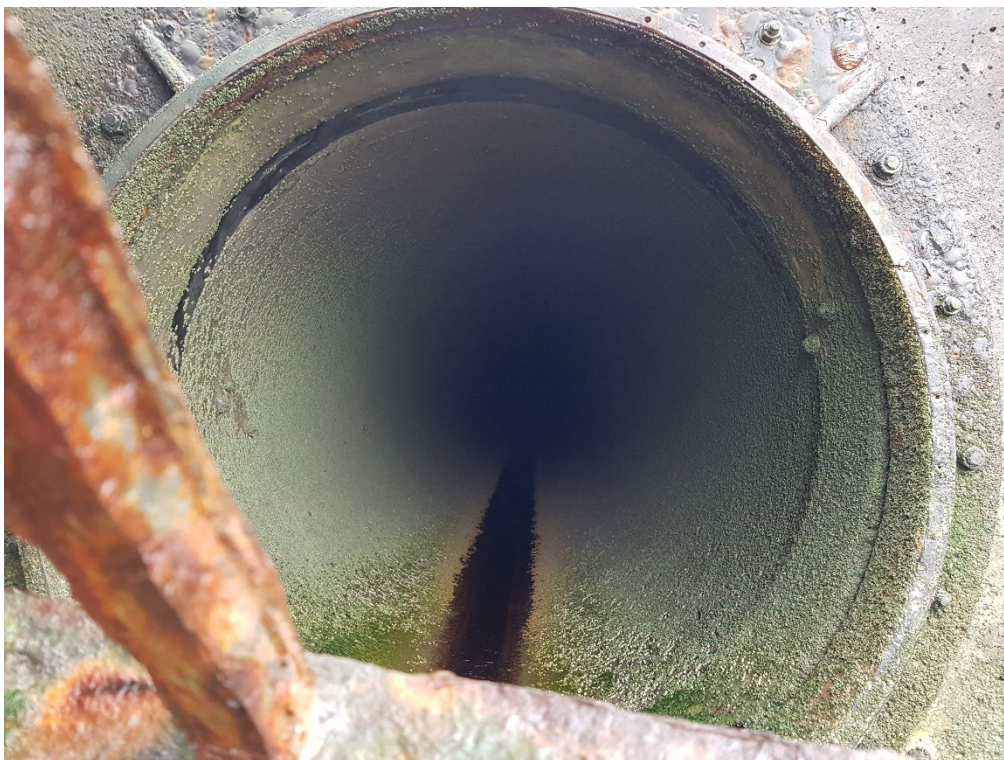
Figure 14 Outfall 2 seaward photo taken up inside the pipe.

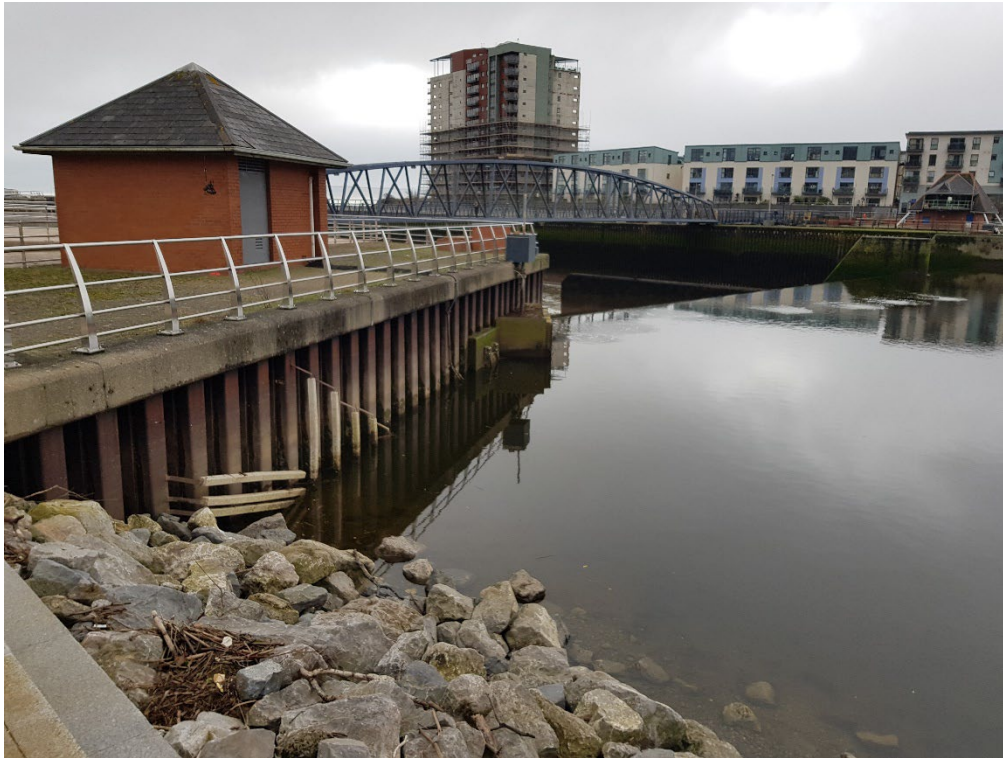
Figure 15 Tidal barrage outfall. Pumping station from desktop study confirmed. Closed on day of survey.

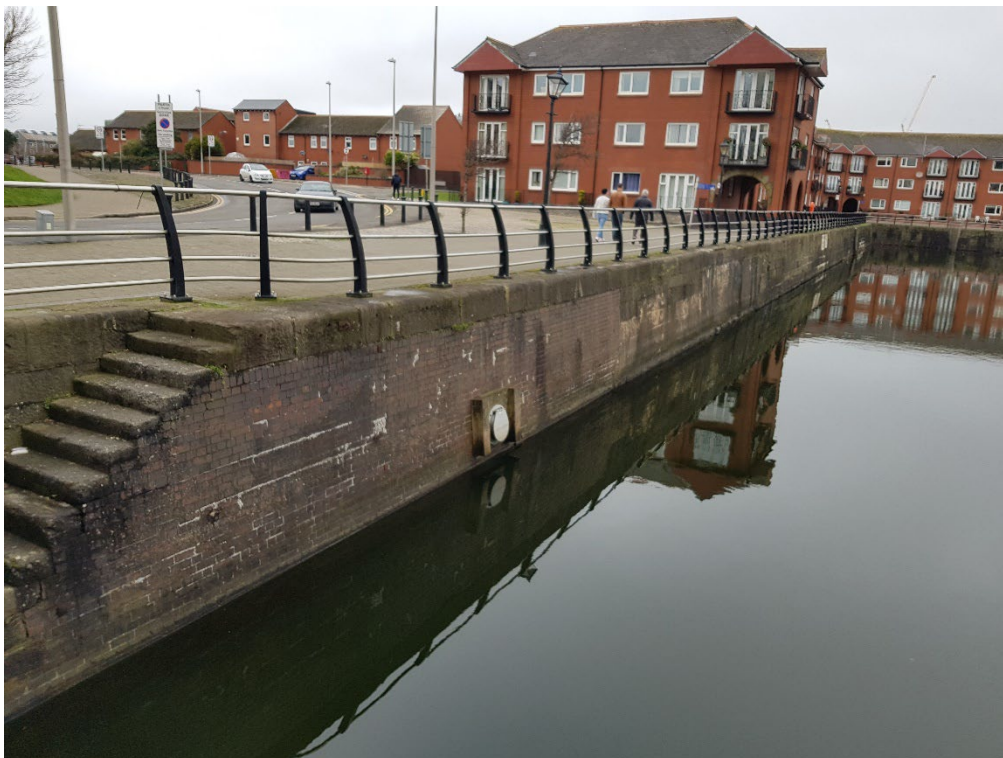
Figure 16 Outfall identified during shoreline survey walking route around harbour and up River Tawe. No flow observed during survey.

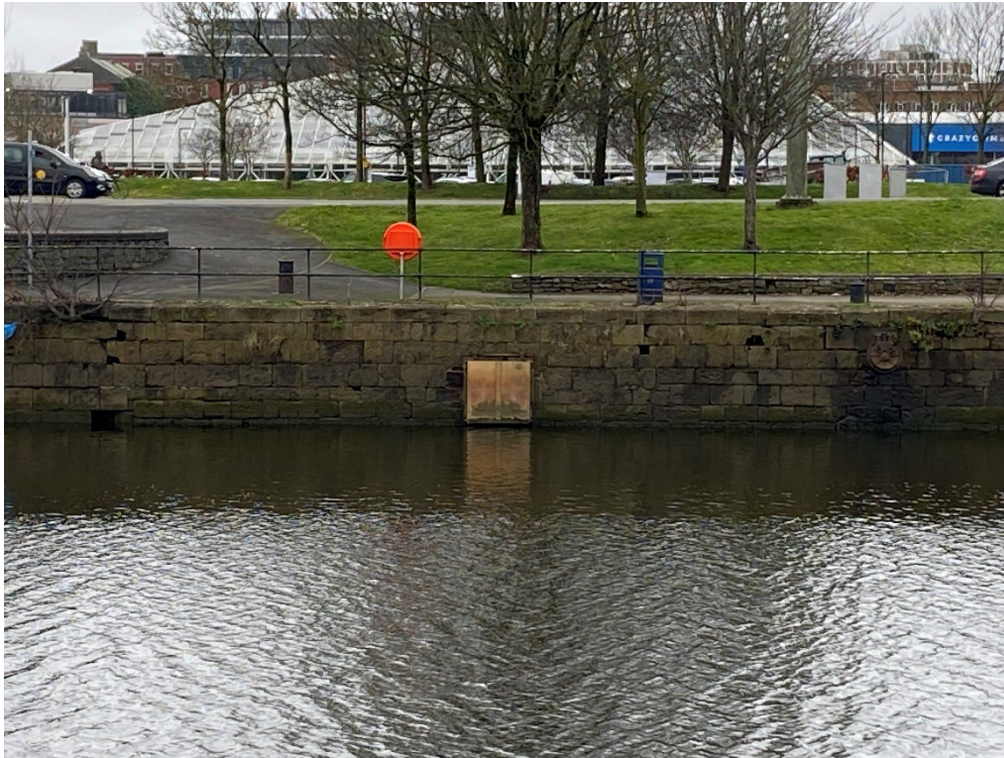
confirmed as previously identified. Although it was not flowing on the day of survey (waypoint 374), some evidence of staining below the outfall suggests recent previous flow.

Figure 17 Parc Tawe outfall confirmed. No flow observed during survey.

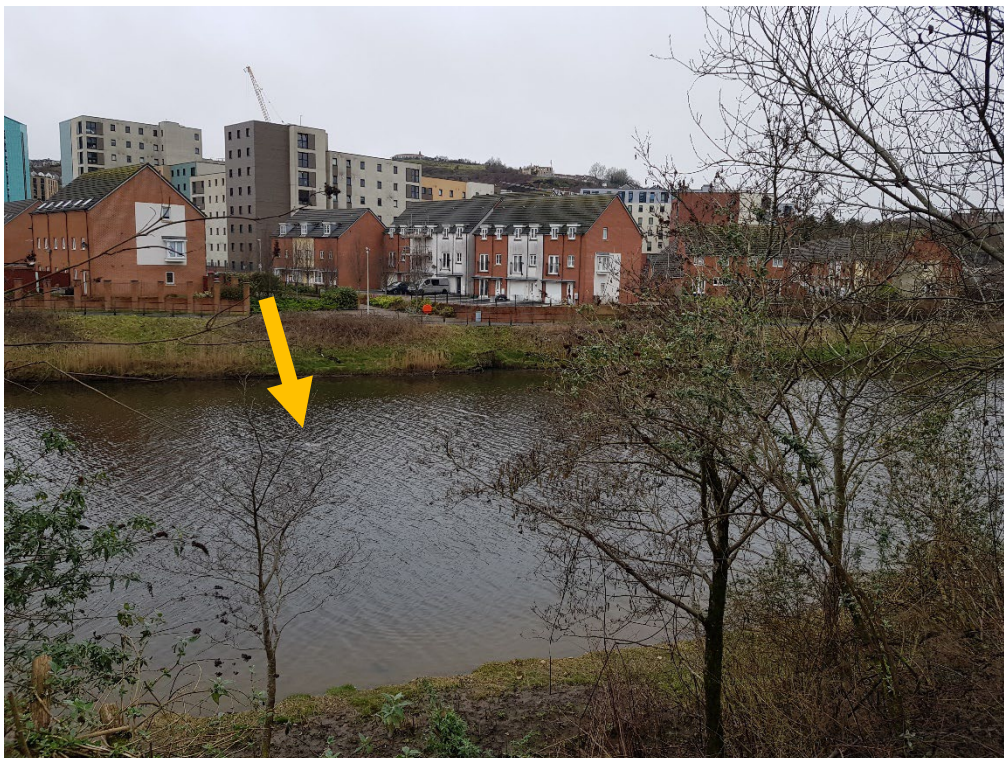
Figure 18 Outfalls observed along river bank near houses. Periodic bubbling was also seen in the centre of the river on the surface of the water in random locations as surveyors walked upstream.

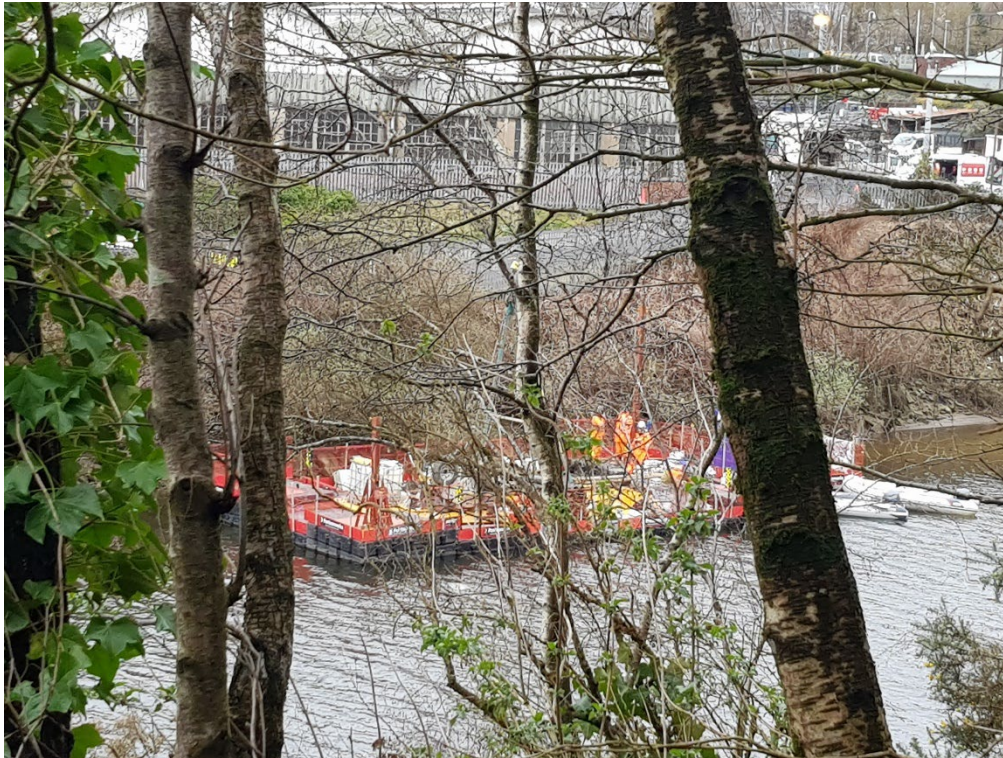
A small number of outfalls were visible upstream, but were difficult to assess further due to inaccessibility. A work plant was also noted in the River (Figure 19) but limited information could be seen on the works being carried out, and whether this may have any effect on water quality and contamination in the river itself. Surface road drainage was identified during the shoreline survey and observed to be flowing on the day (waypoint 376). A strong sulphurous smell and surface foam was visible (Figure 21) which could be indicative of potential contamination. This road drainage was set back about 50 m away from the watercourse, and any runoff into the river is likely to experience significant dilution before passing close to the CZ.

Figure 19 Work plant identified in the river during shoreline survey. Active on day of survey. Unclear what work was being done.

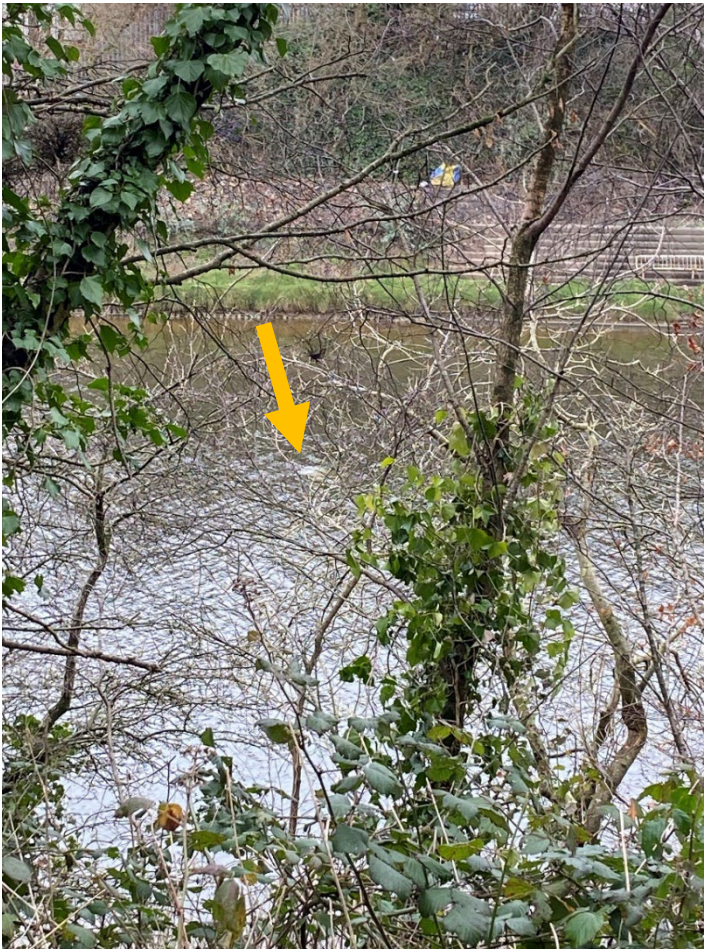
Figure 20 Second photo of the periodic bubbling on the surface of the water further upstream.

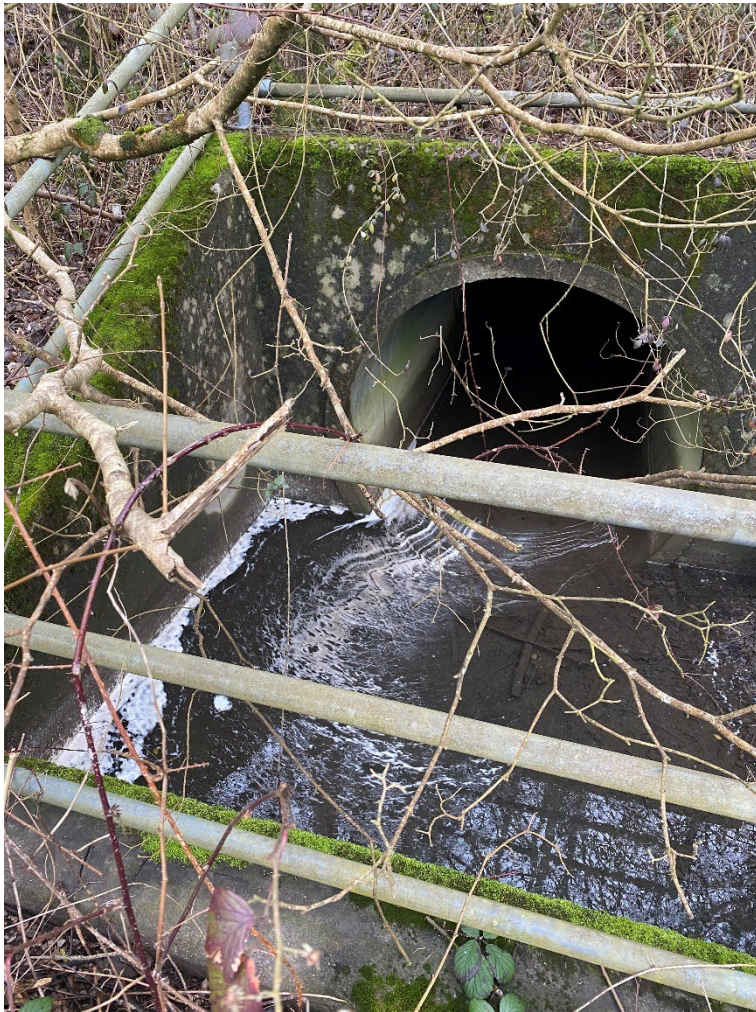
Figure 21 Surface road drainage identified during the shoreline survey path route up the River Tawe. Observed to be flowing on the day of survey with a strong smell and surface foam.
